Appendices

Appendix A:
ADA Path of Travel Assessment Diagrams

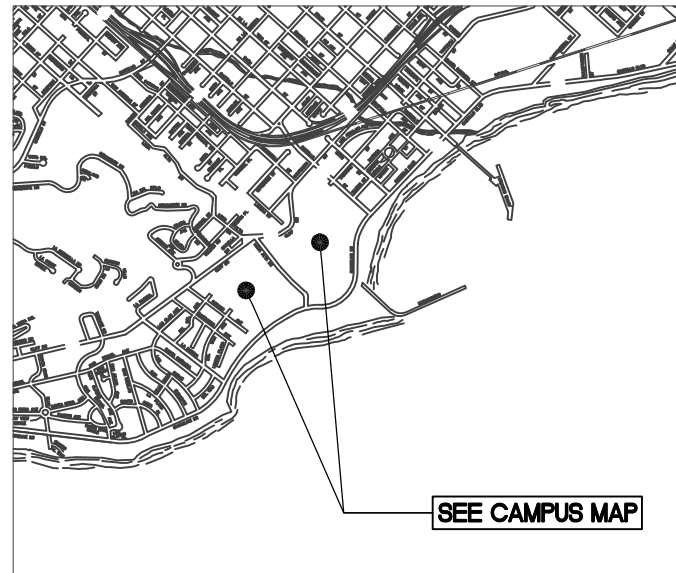
- SC-0 SCHOTT CENTER - CAMPUS MAP
- SC-1 SCHOTT CENTER - EXISTING PARKING
- SC-2 SCHOTT CENTER - ACCESSIBLE PARKING STALLS
- SC-3 SCHOTT CENTER - CROSS SLOPES
- SC-4 SCHOTT CENTER - CURB RAMPS
- SC-5 SCHOTT CENTER - LONGITUDINAL SLOPES
- SC-6 SCHOTT CENTER - PATH OF TRAVEL
- SC-7 SCHOTT CENTER - POTENTIAL HAZARDOUS FEATURES
- SC-8 SCHOTT CENTER - RAMPS AND STAIRS
- SC-9 SCHOTT CENTER - OVERALL

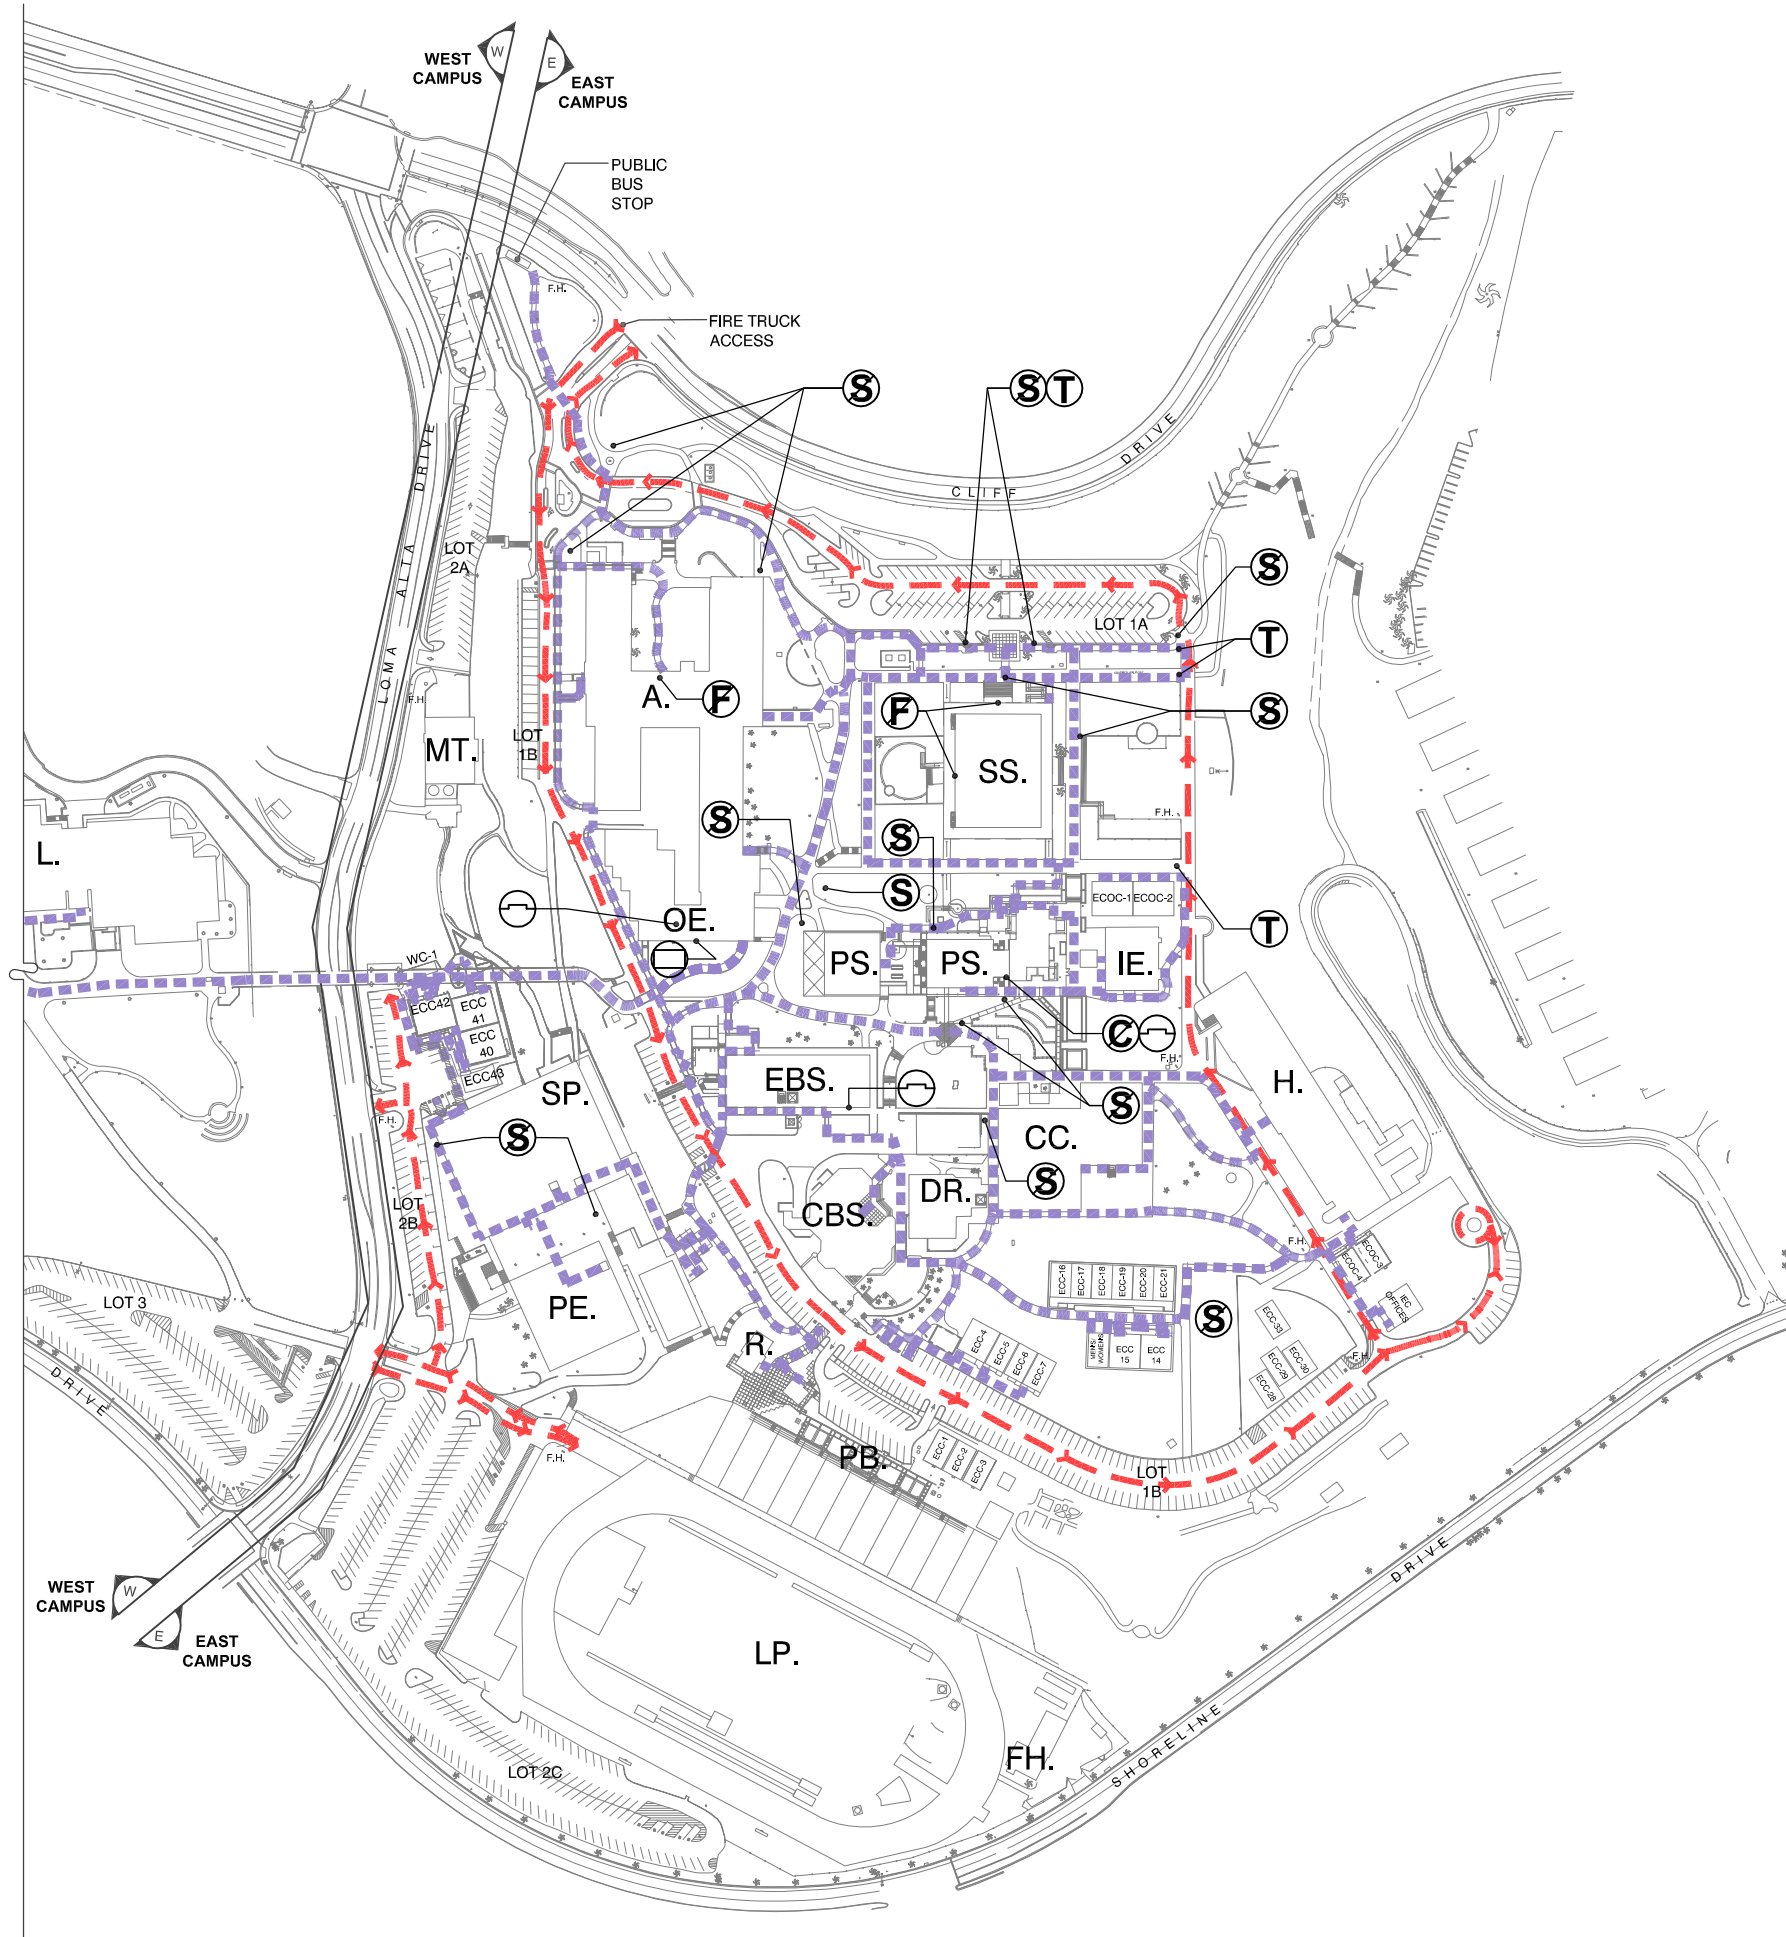
- T** UNCLEAR PATH OF TRAVEL
(E.G. SEPARATION OF PEDESTRIAN PATH VS. VEHICULAR PATH IS UNCLEAR)
- S** NON-COMPLIANT PATH OF TRAVEL SIGNAGE
- S** PATH OF TRAVEL SIGNAGE MISSING
- ⊖** ROOM I.D. NON-COMPLIANT OR MISSING
- ⊖** DOOR THRESHOLD NON-COMPLIANT
- ⊖** DOOR CLEARANCE NON-COMPLIANT
- F** ENTRYWAY FLOOR SURFACE NON-COMPLIANT
- ←** FIRE LANE
- ADA PATH OF TRAVEL

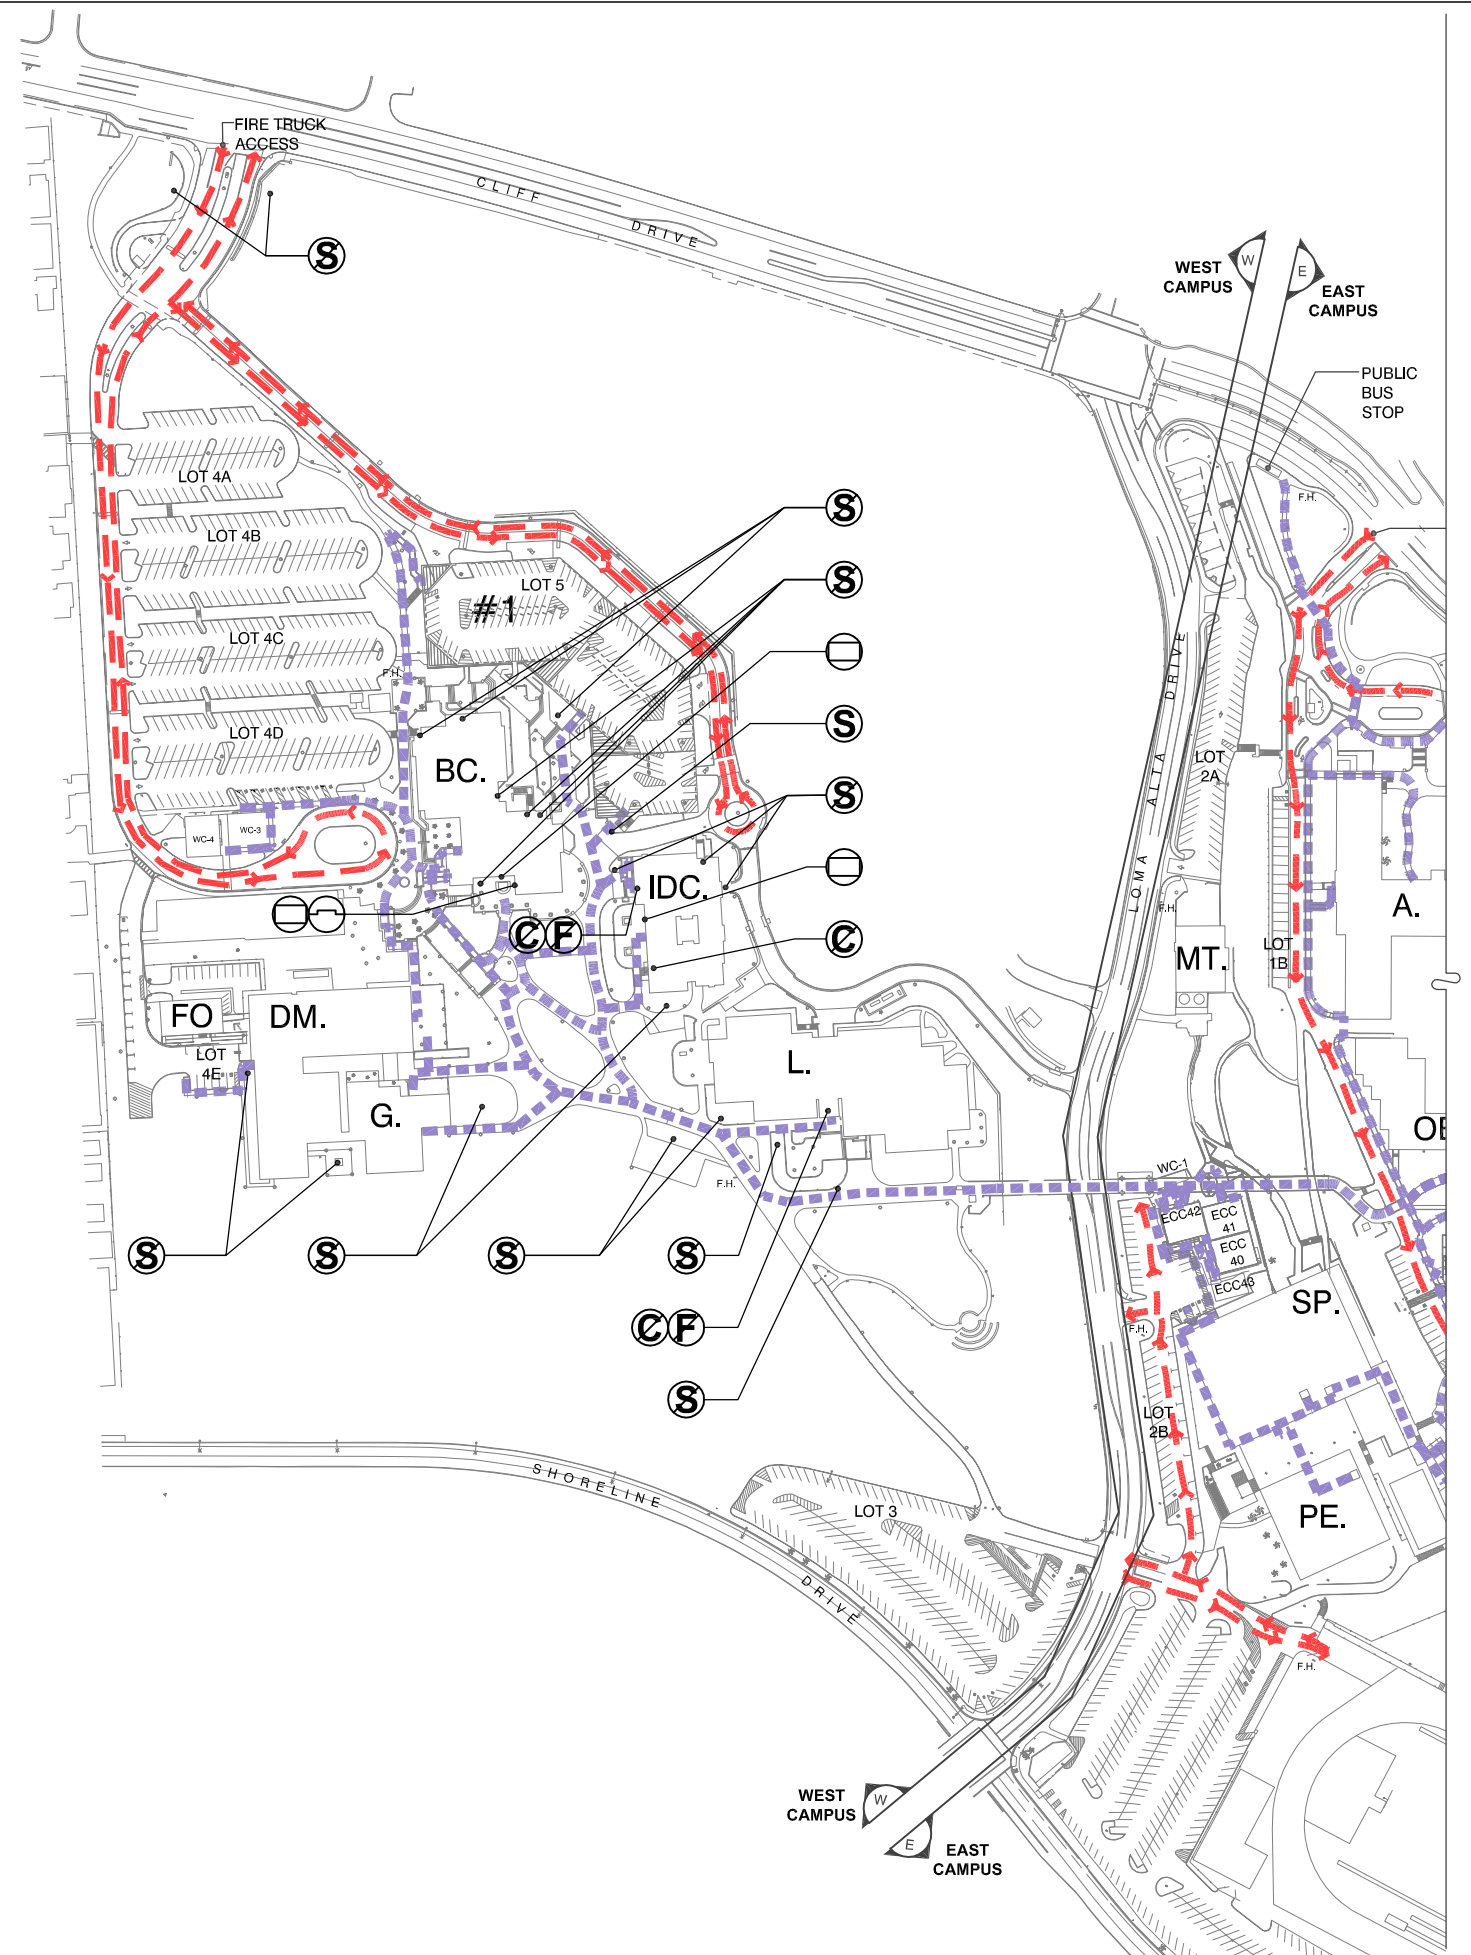
- T** UNCLEAR PATH OF TRAVEL
(E.G. SEPARATION OF PEDESTRIAN PATH VS. VEHICULAR PATH IS UNCLEAR)
- S** NON-COMPLIANT PATH OF TRAVEL SIGNAGE
- S** PATH OF TRAVEL SIGNAGE MISSING
- ⊖** ROOM I.D. NON-COMPLIANT OR MISSING
- ⊖** DOOR THRESHOLD NON-COMPLIANT
- ⊖** DOOR CLEARANCE NON-COMPLIANT
- F** ENTRYWAY FLOOR SURFACE NON-COMPLIANT
- ←** FIRE LANE
- ADA PATH OF TRAVEL

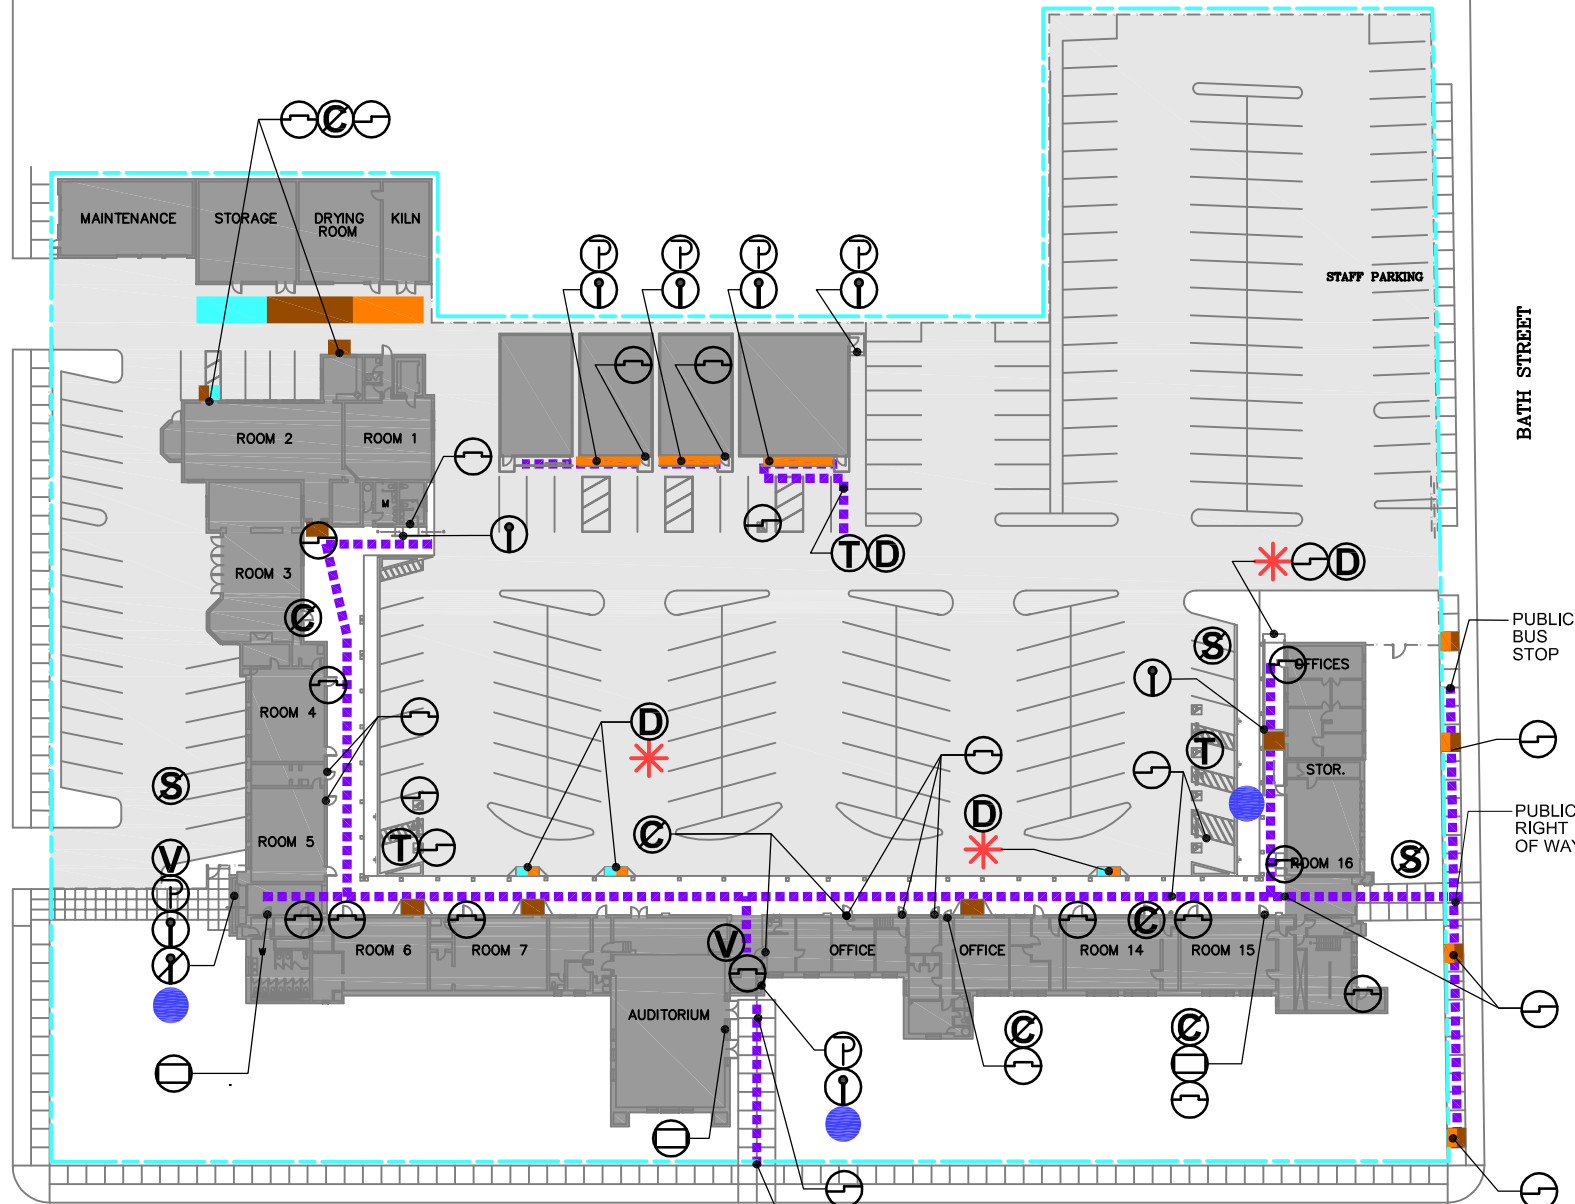
- NONCOMPLIANT CURB RAMP
- NO CURB RAMP OR REQUIRED RAMP MISSING
- PROPERTY LINE
- EXISTING FENCE
- ADA PATH OF TRAVEL

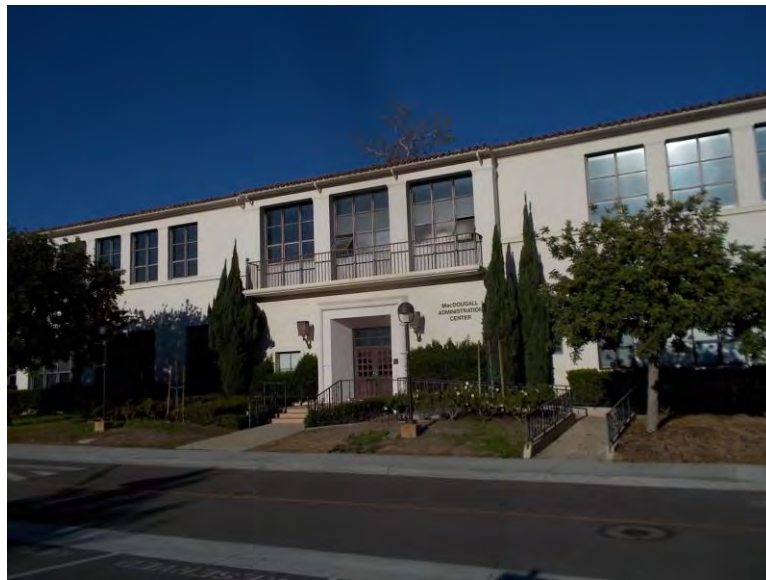
Prepared by
RJC Inc.

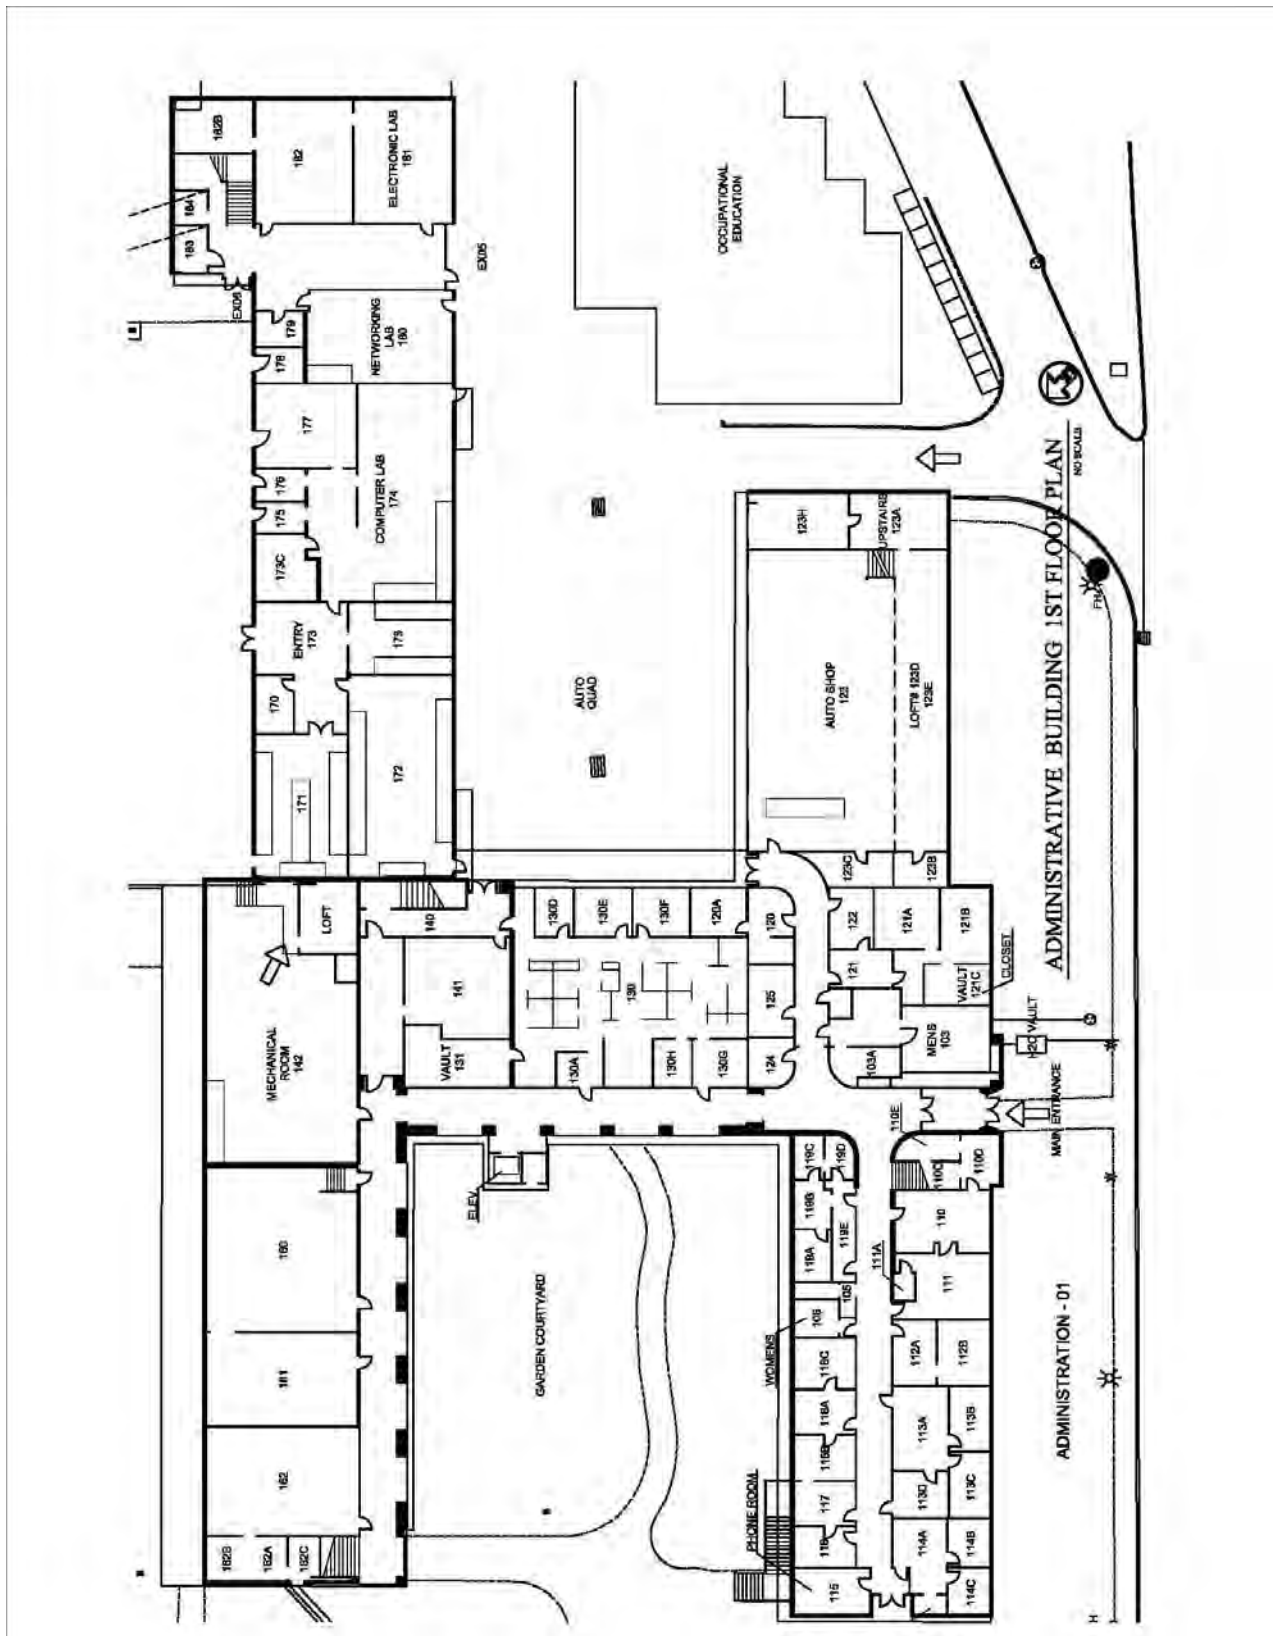
APPENDIX A BUILDING PLANS

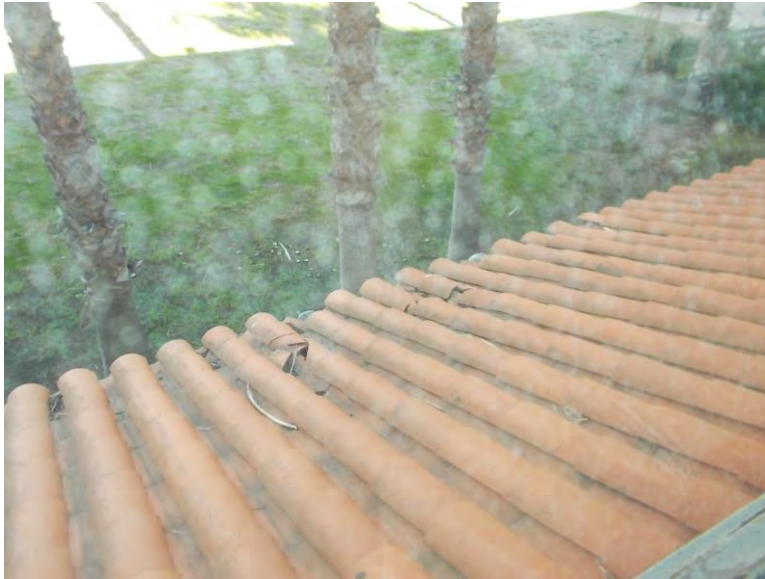
R1. Northeast roof overhang with damaged tiles.

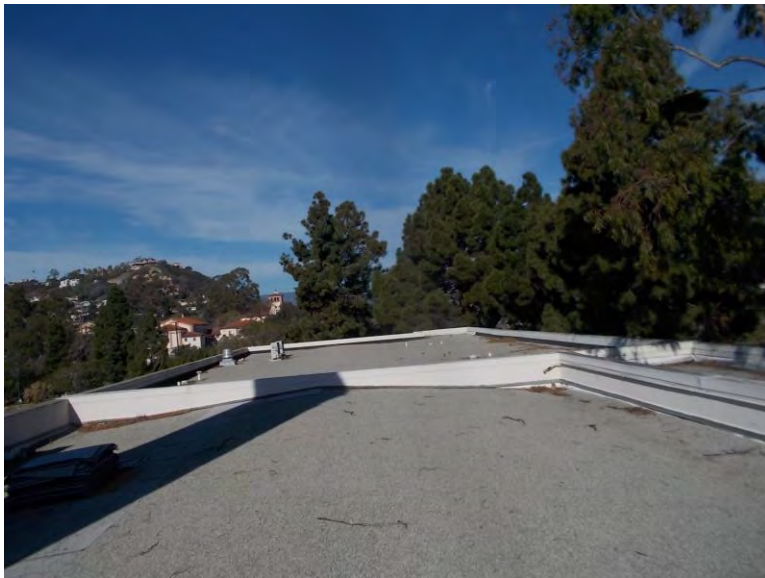
R2. Northeast wing built-up roof.

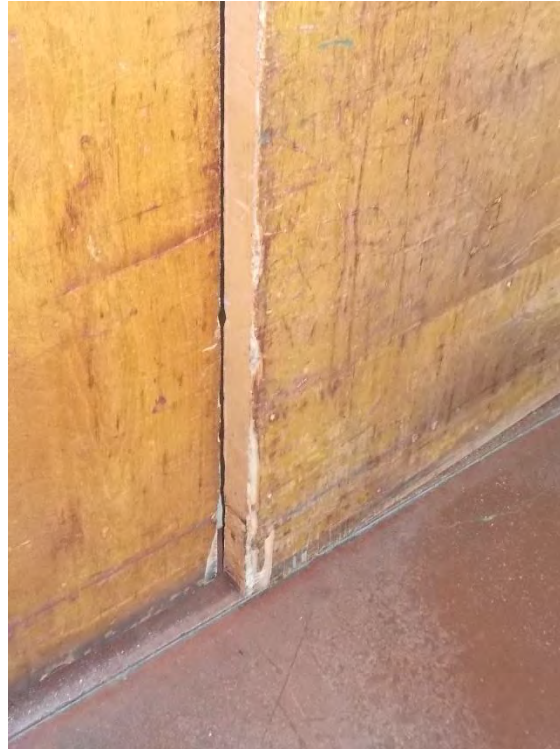
D2. Edge Damage at entrance doors.

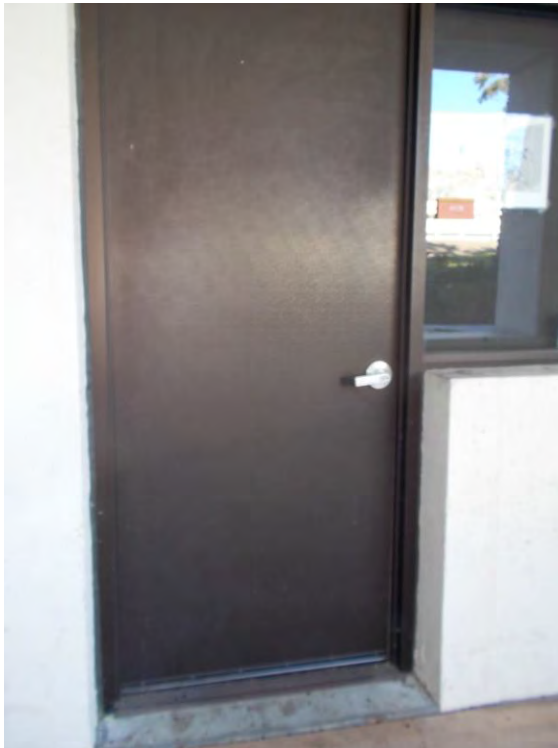
D3. Painted office door at north east side of building, with non-compliant threshold.

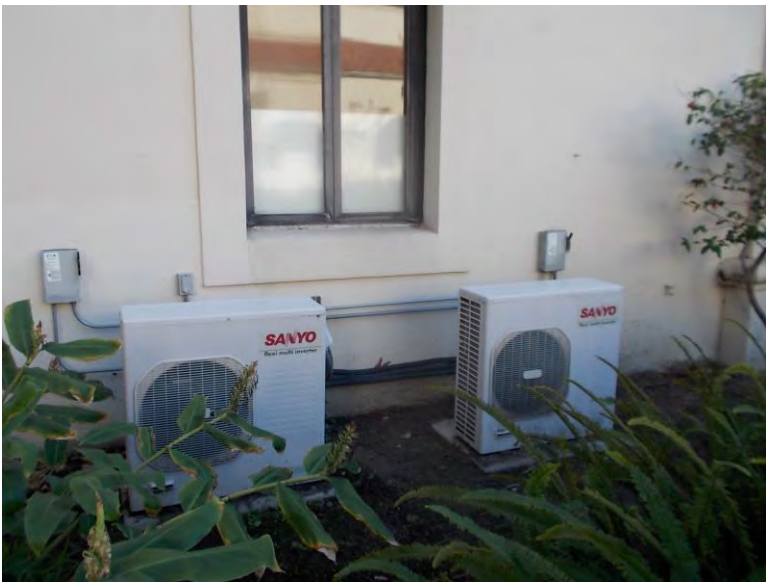
M4. Split heat pump systems for air conditioning offices.

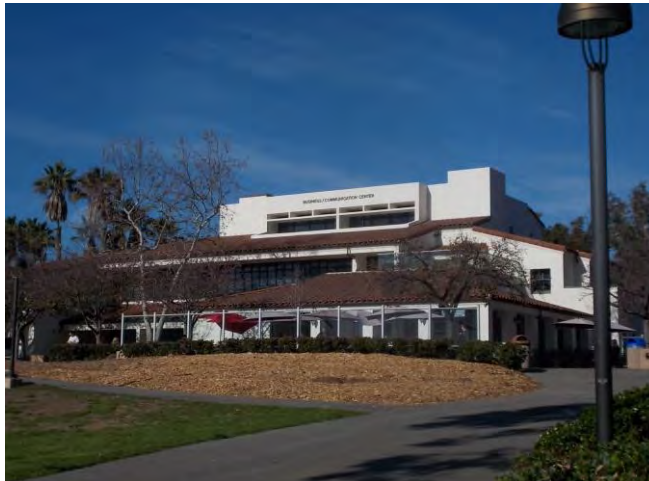
RJC Project No: 2015.46

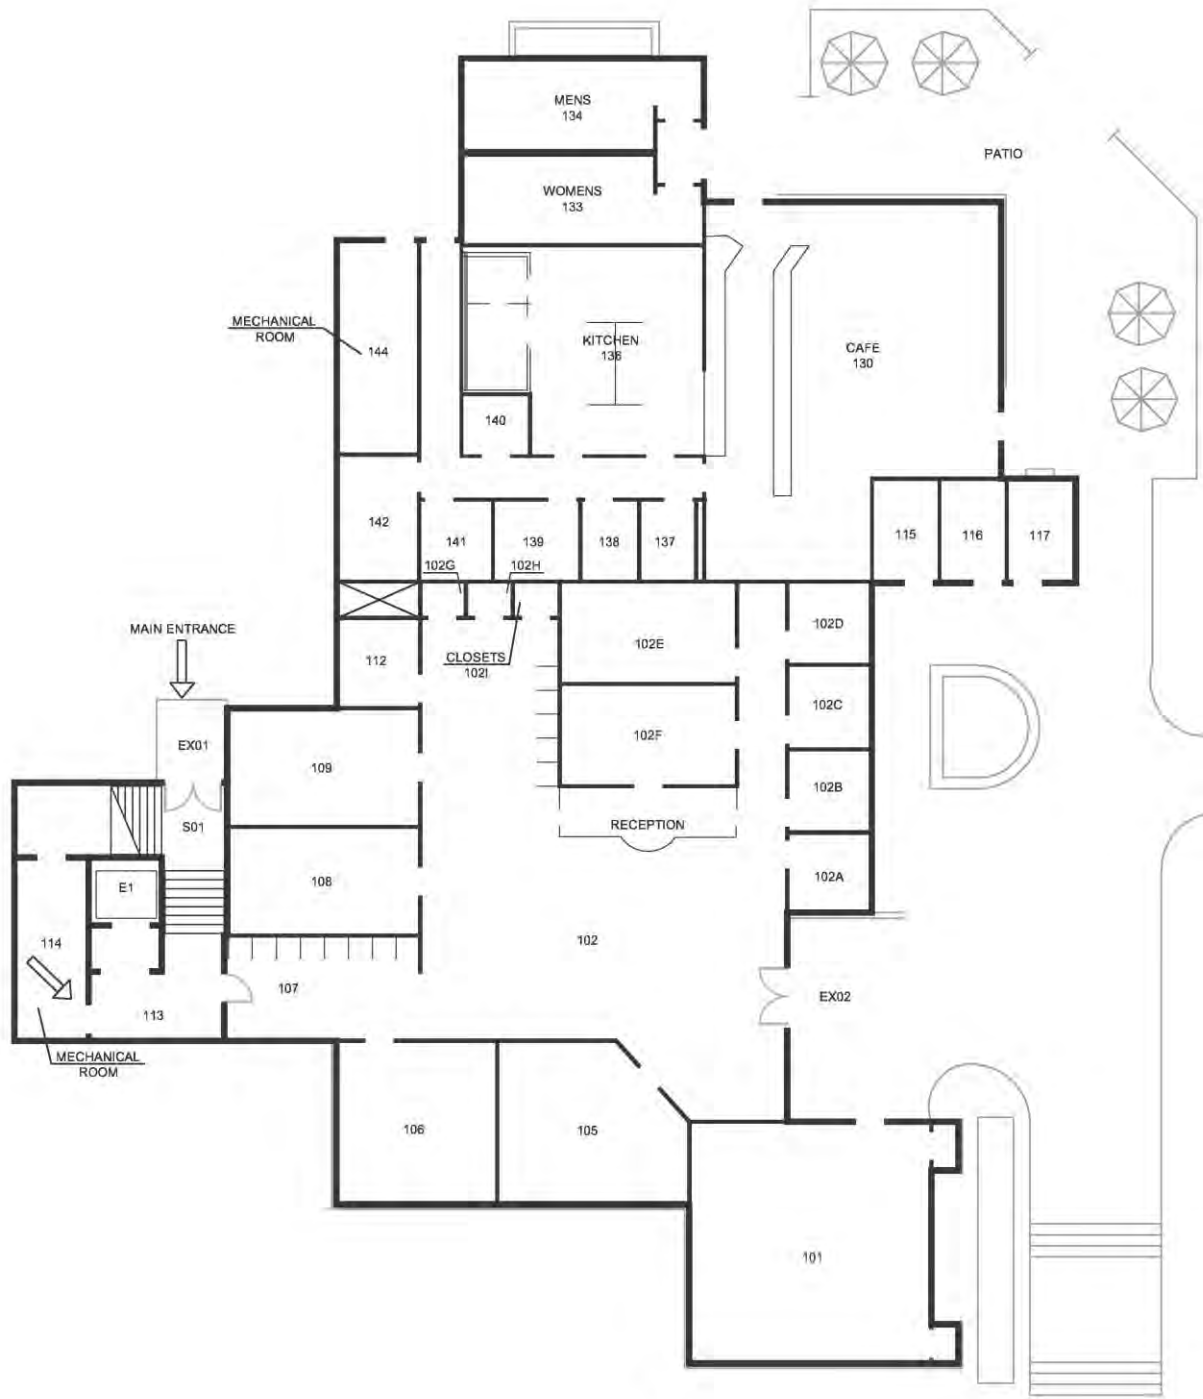
BUSINESS COMMUNICATIONS 1ST FLOOR PLAN

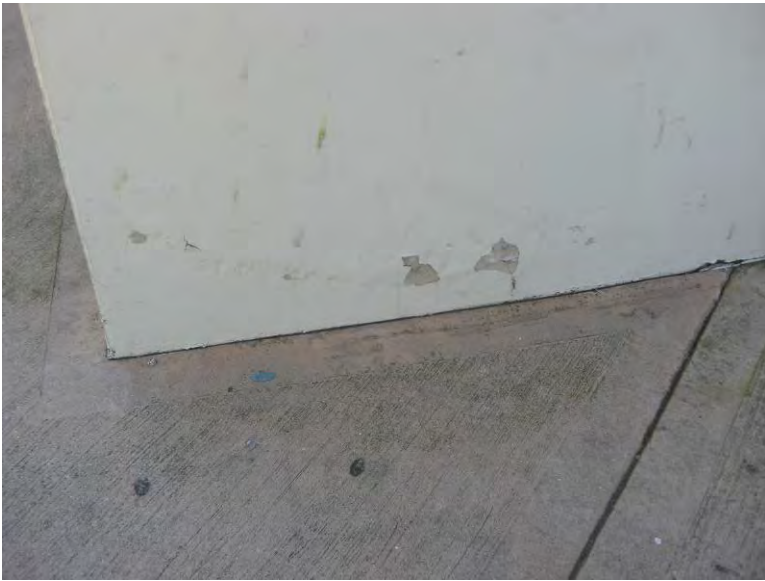
AE1. Exterior wall with paint damage.

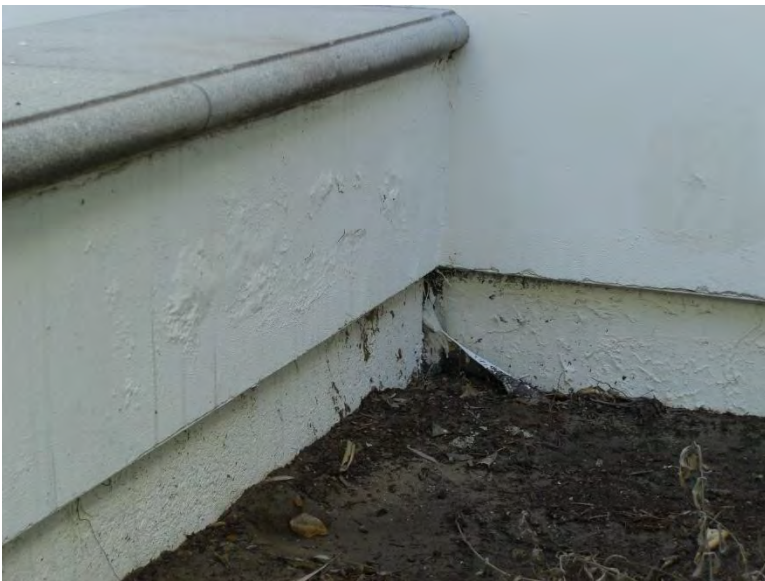
AE2. East exterior wall with bubbling paint.

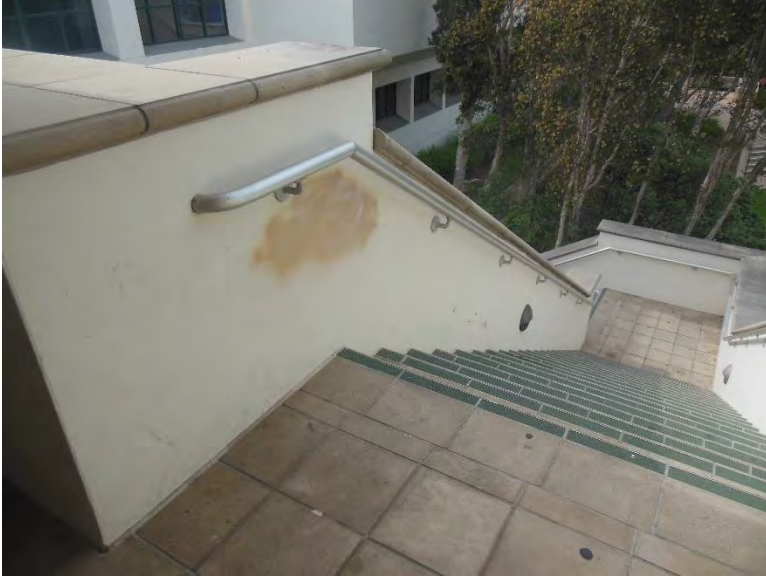
AE3. Exterior east staircase with paint damage.

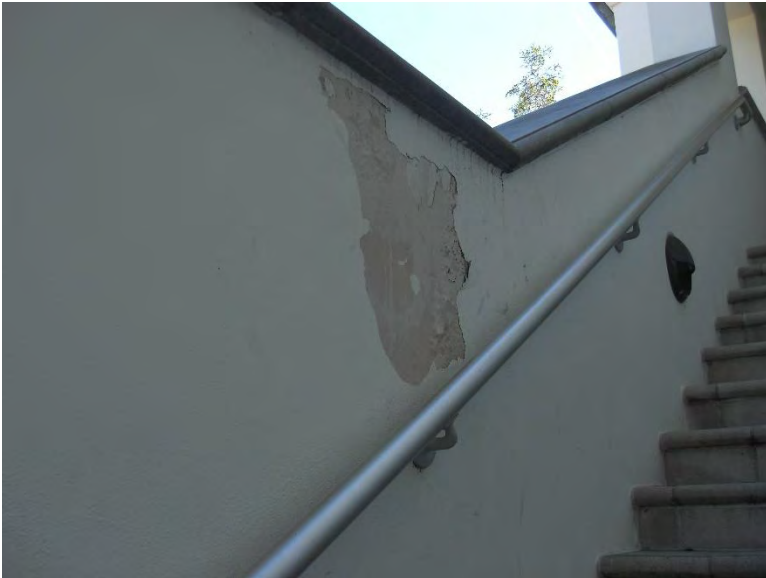
AE4. Exterior east staircase with peeling paint.

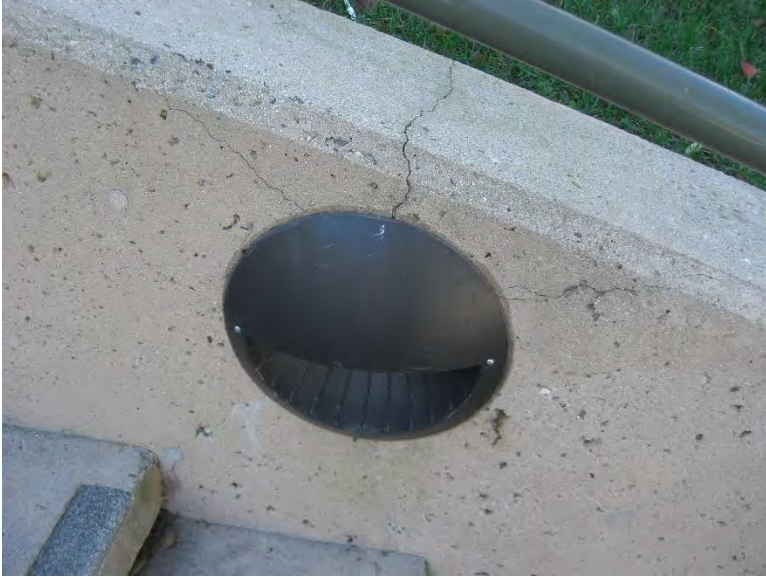
AE5. Cracked concrete wall at exterior stair.

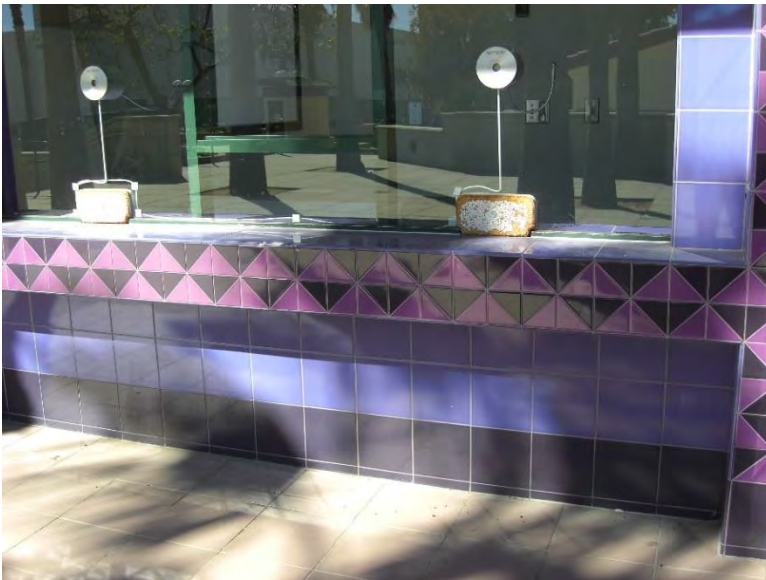
AE6. Forum ticket booth exterior ceramic tile finish.

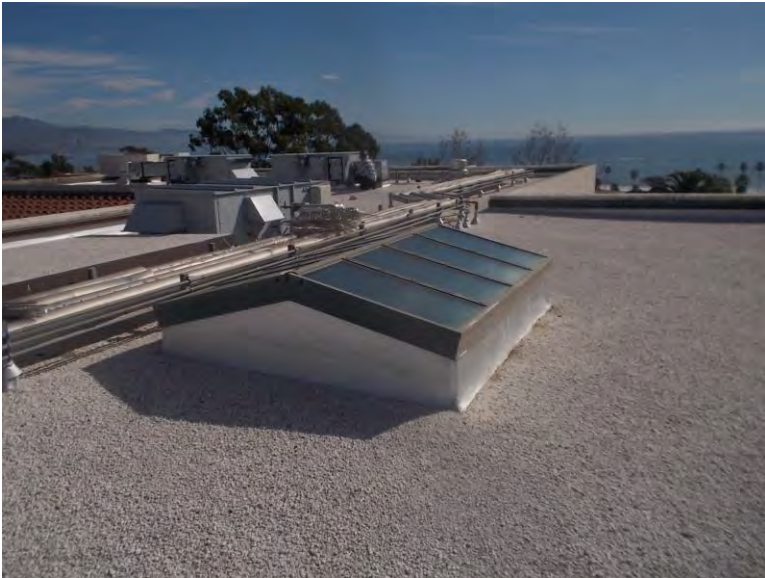
R1. Skylight at built-up roof system, in good to excellent condition.

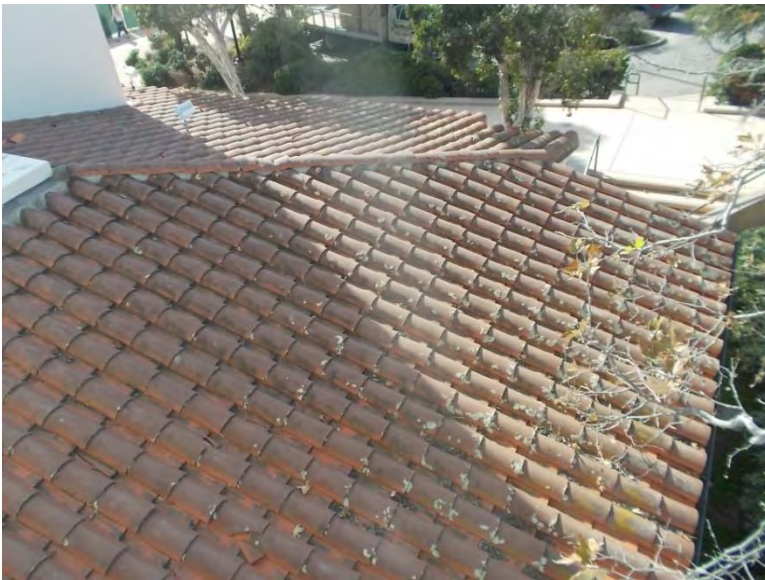
R2. Mission clay original roof tile.

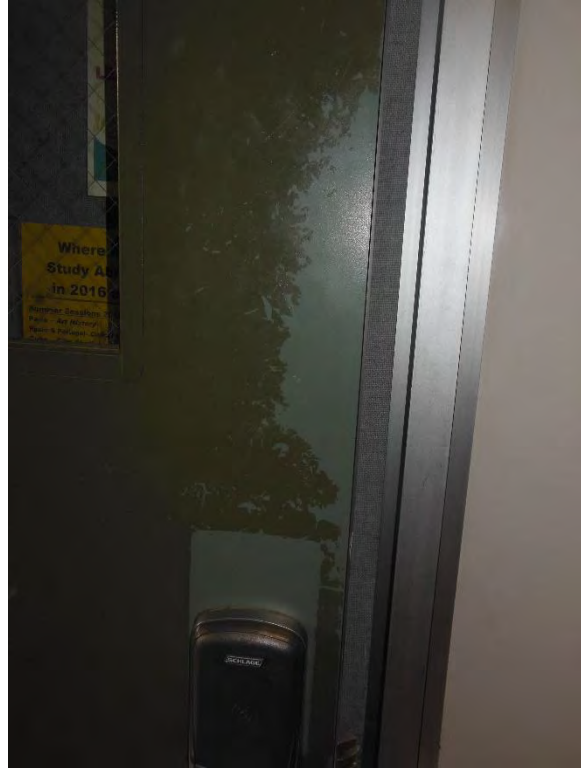
D6. Exterior classroom door; paint finish damaged.

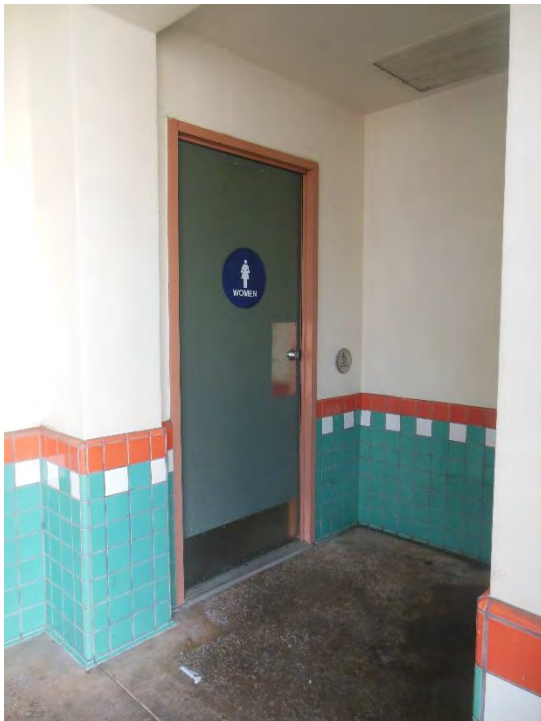
D5. Café restroom doors are missing wall mounted room ID signage. Low level access button for electronic door operator is required by code.

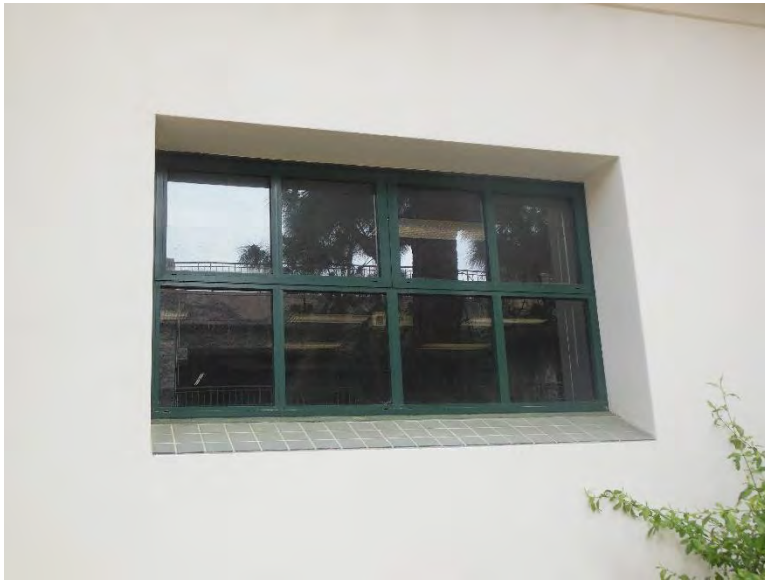
EW1. Aluminum framed lower floor windows and sill in good condition.

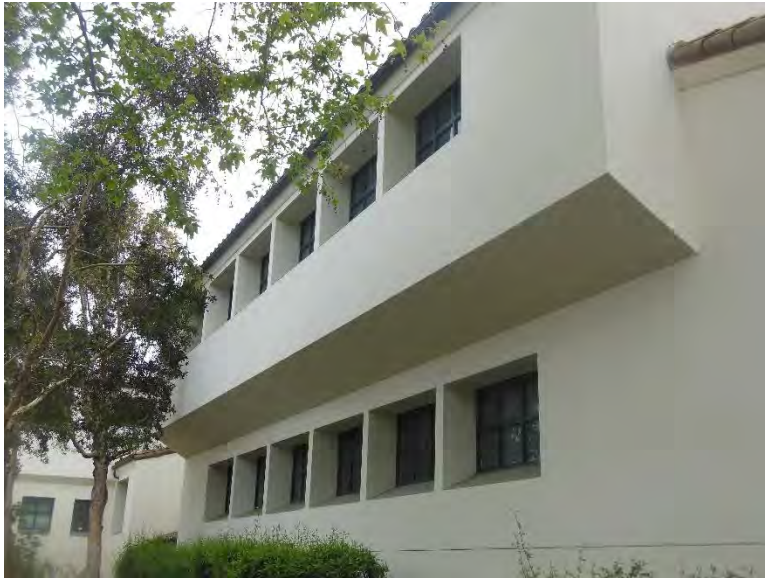
EW2. Aluminum framed lower and upper floor windows in good condition.

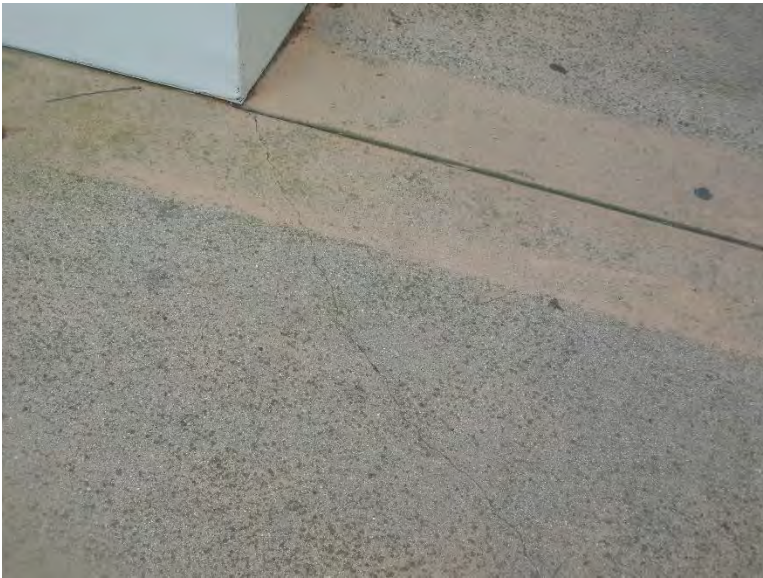
EF1. Colored concrete walkway with cracks.

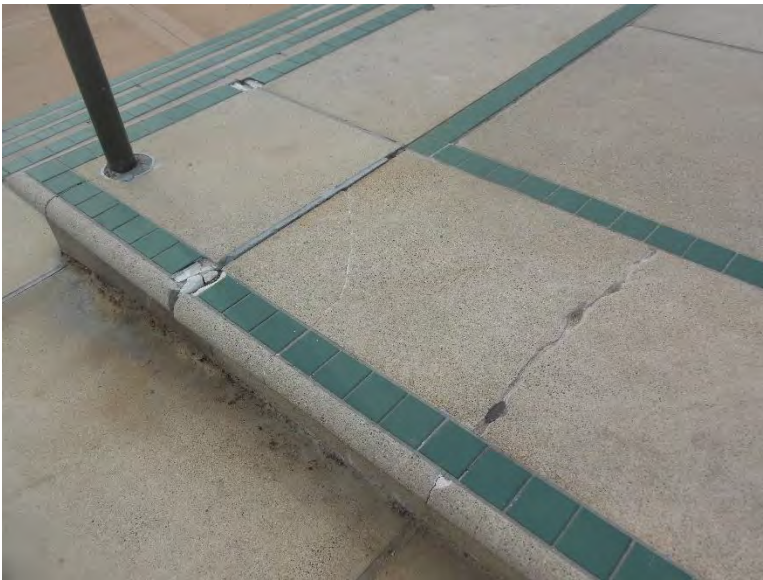
EF2. Front entry plaza stairs; concrete cracks and tile missing.

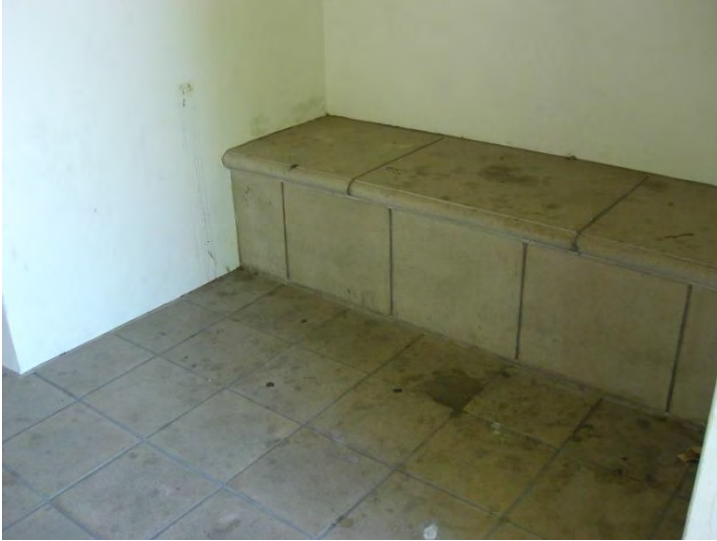
EF3. Third floor exterior concrete pavers and concrete stained finish.

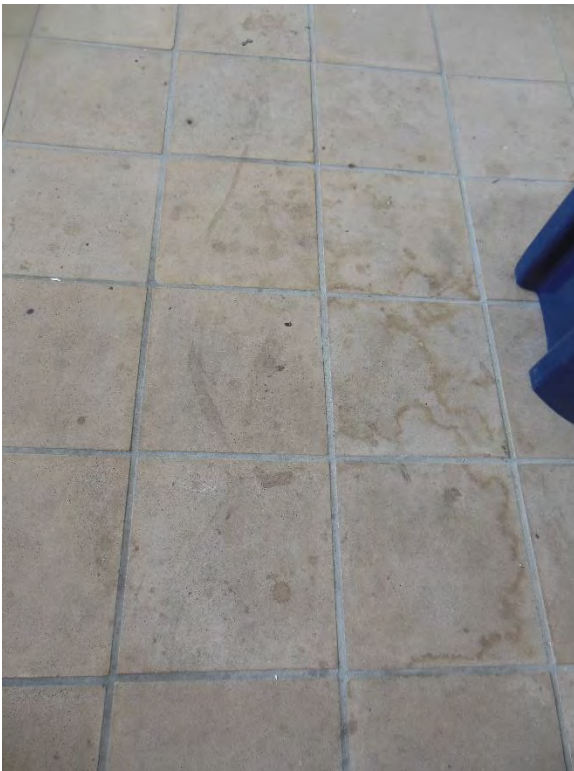
EF4. Third floor exterior walkway; concrete pavers stained.
