Appendices

Appendix A:
ADA Path of Travel Assessment Diagrams

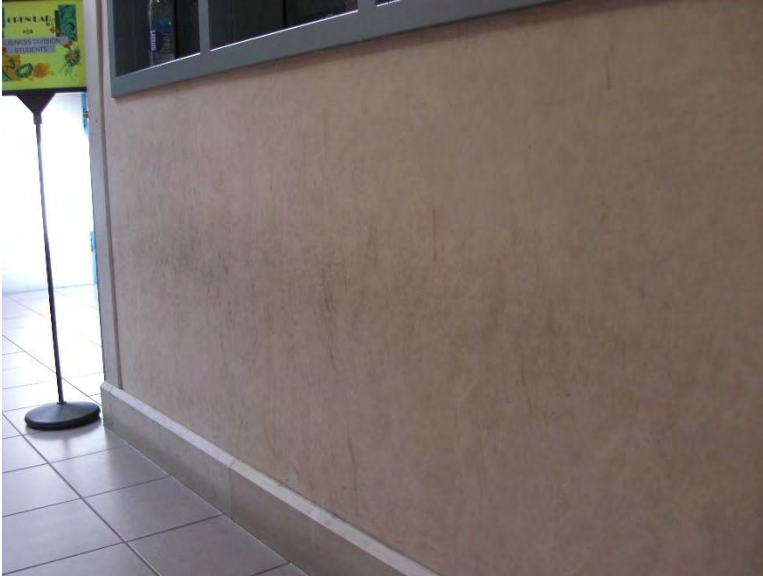
A1. Second floor corridor; veneer plaster wall stained and damaged.

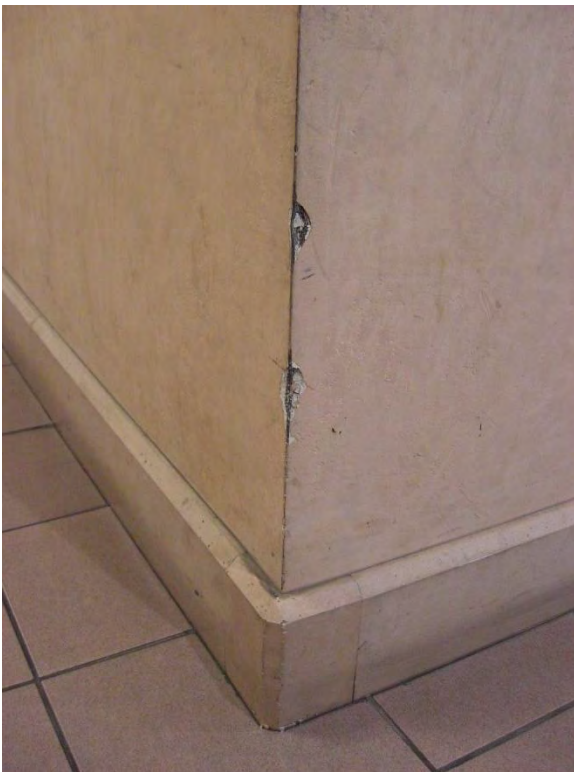
A2. Second floor corridor; veneer plaster corner damaged.

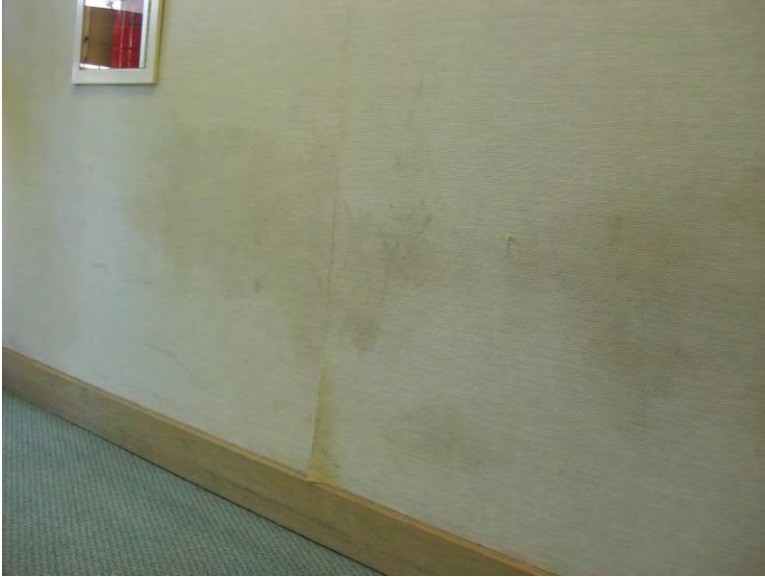
A3. Second floor Corridor 205; fabric covered wainscot stained and damaged.

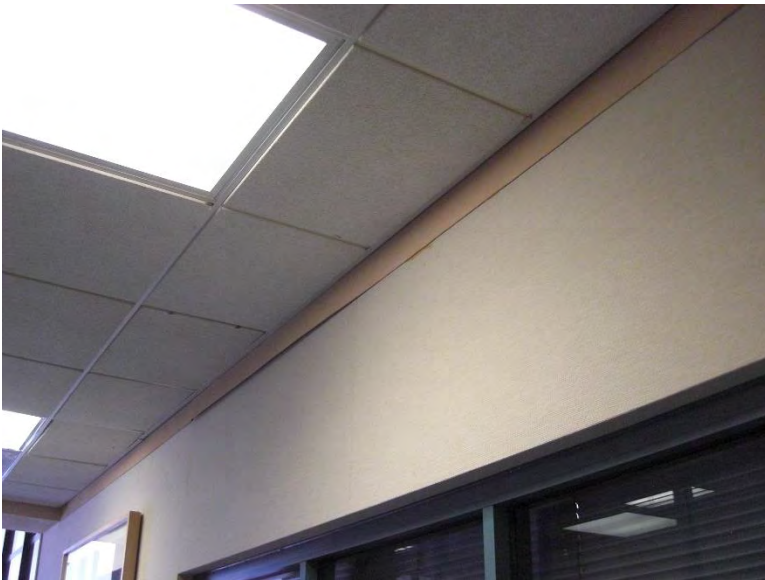
A4. Second floor Corridor 205; head trim piece delaminating from wall.

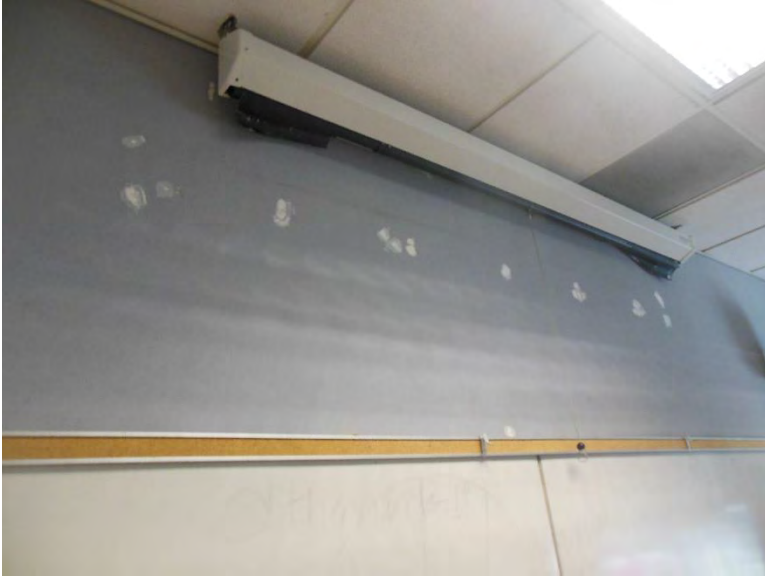
A5. Second floor classroom; wall repair damage.

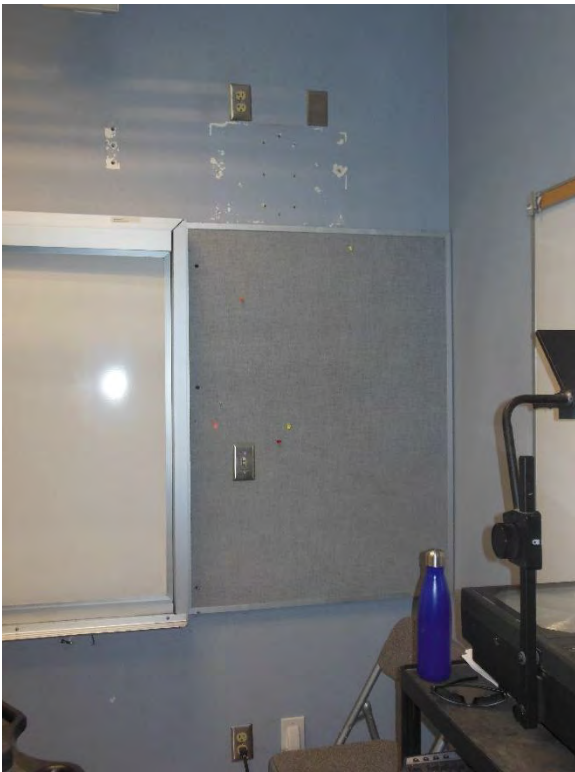
A6. Second floor classroom; wall repair damage.

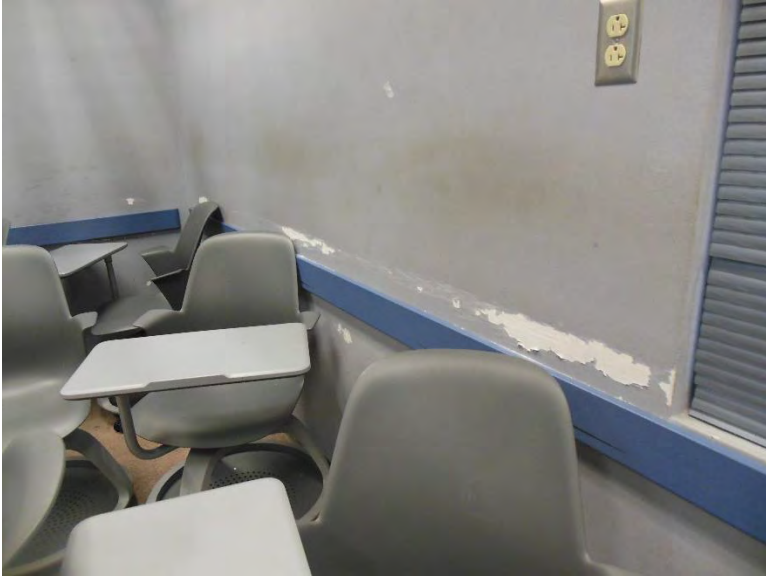
A6. Second floor classroom; paint finish damage from chair backs.

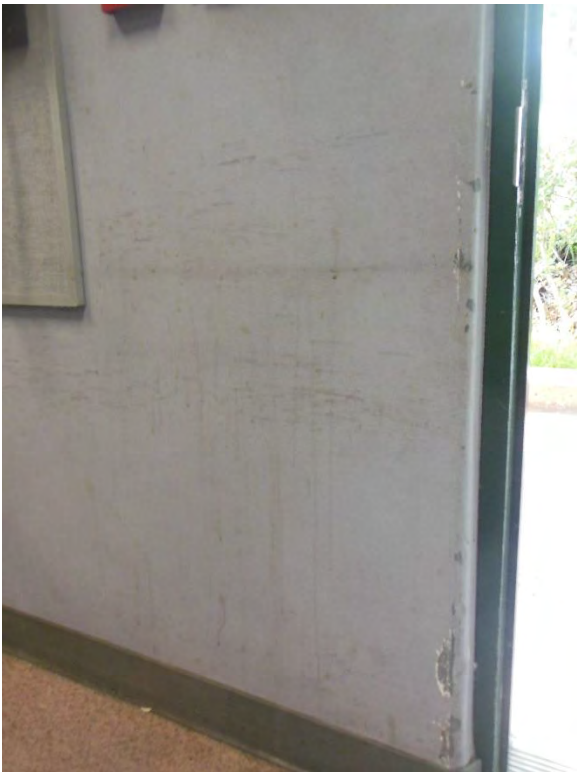
A7. Second floor classroom; wall and paint damage.

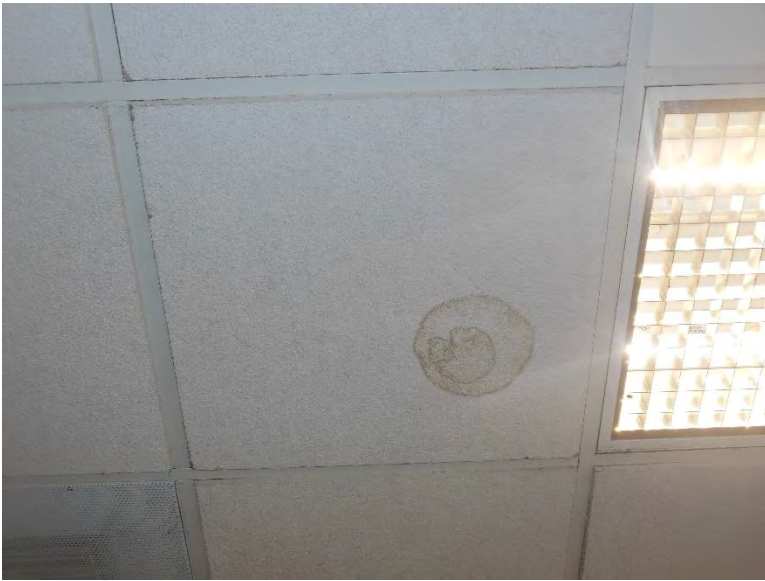
C1. Second floor classroom; stained ceiling tile.

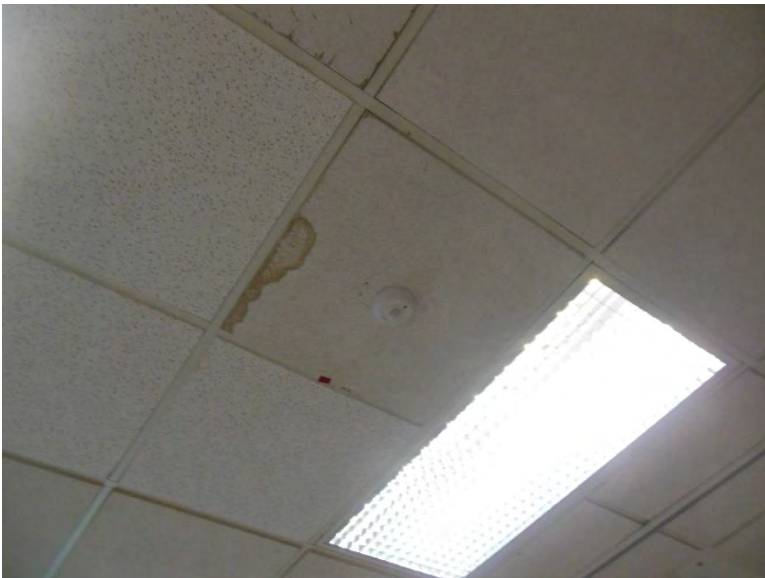
C2. Second floor classroom, stained and damaged ceiling tiles.

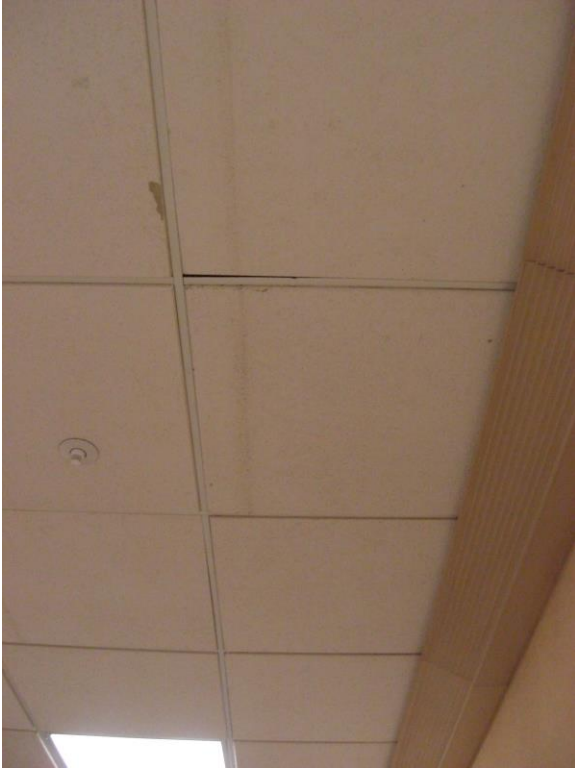
C3. Second floor corridor; damaged ceiling tiles.

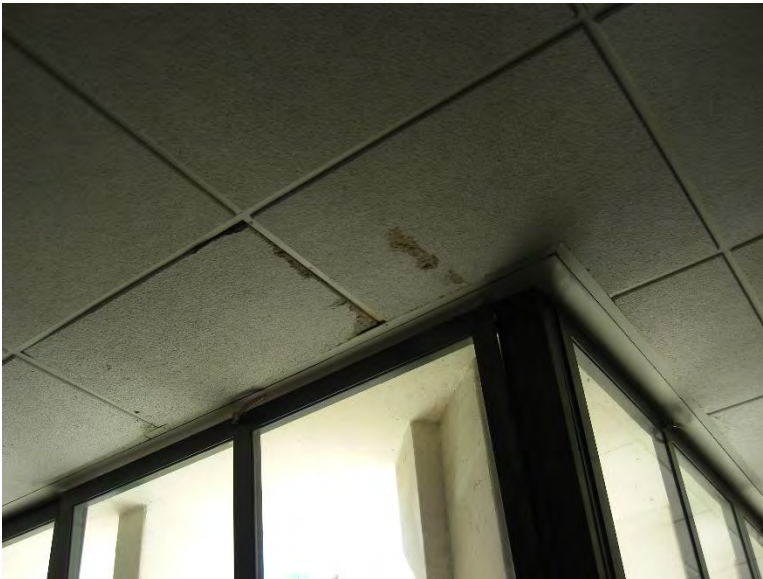
C4. Third floor corridor; damaged ceiling tiles.

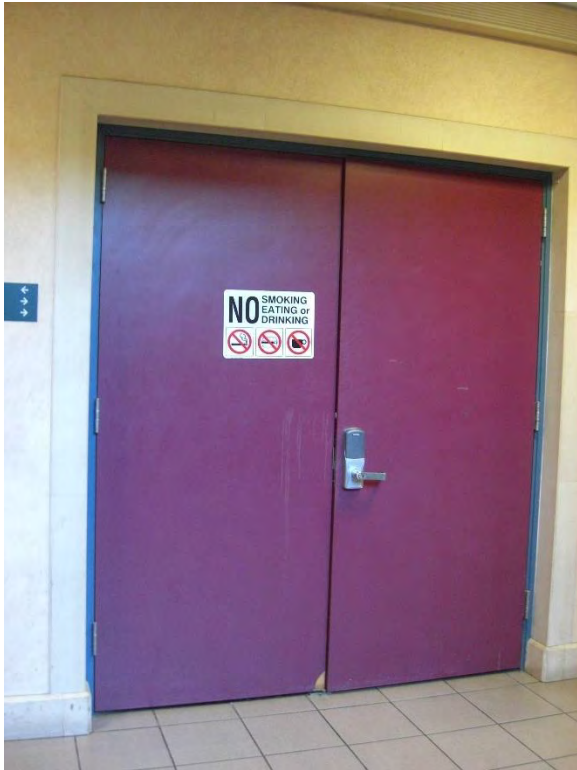
D1. Second floor; damaged and stained plastic laminate faced classroom doors.

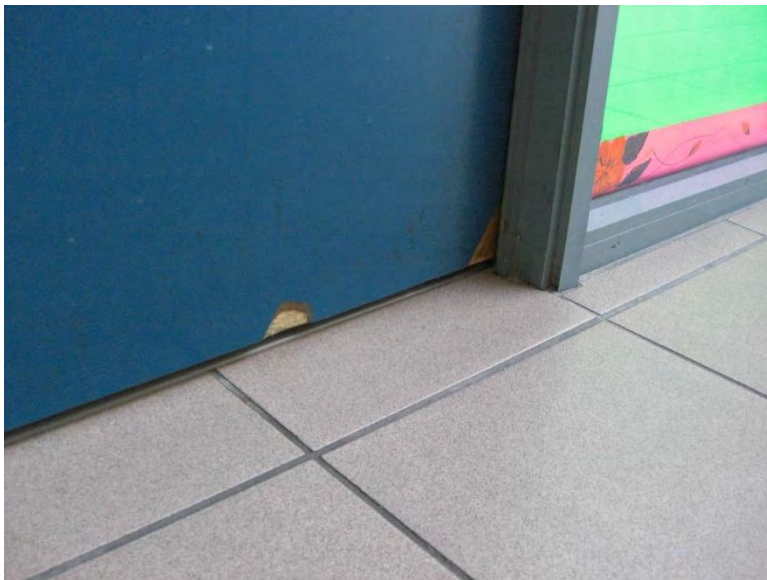
D3. Third floor; damaged and stained plastic laminate faced office door.

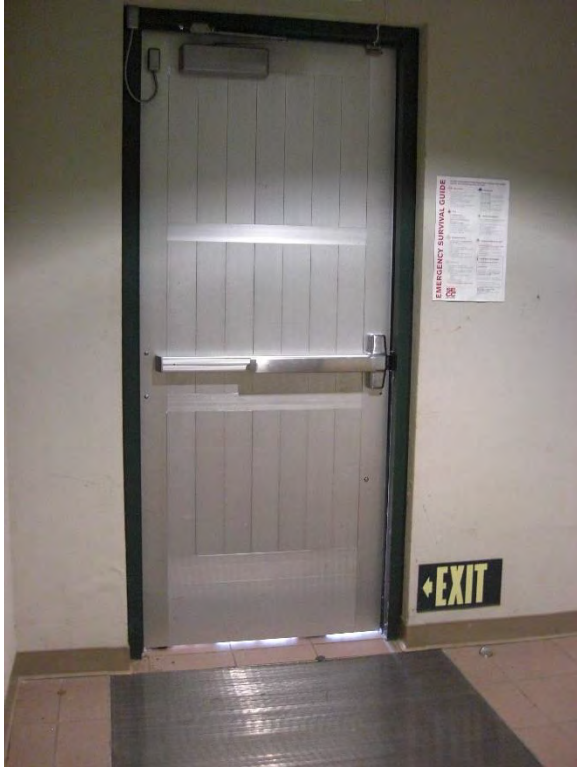
D4. Exit door from Forum lecture hall foyer. Tactile exit sign missing.

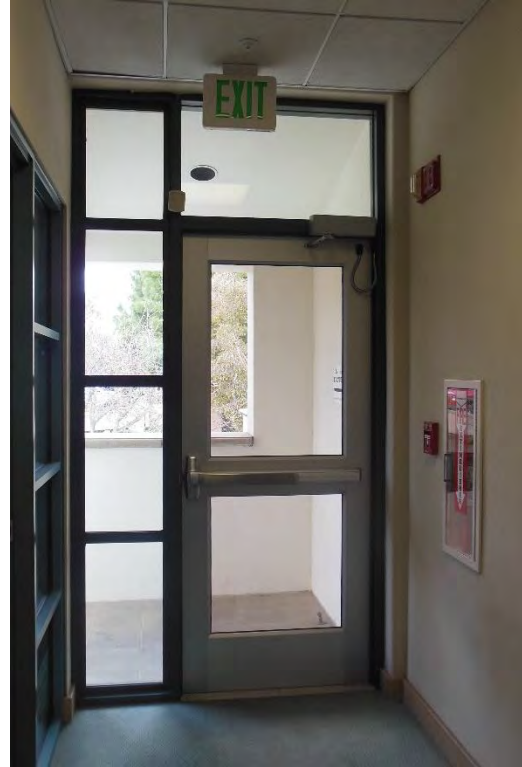
D5. Second floor corridor exit door. Tactile exit sign missing, and exit sign not illuminated.

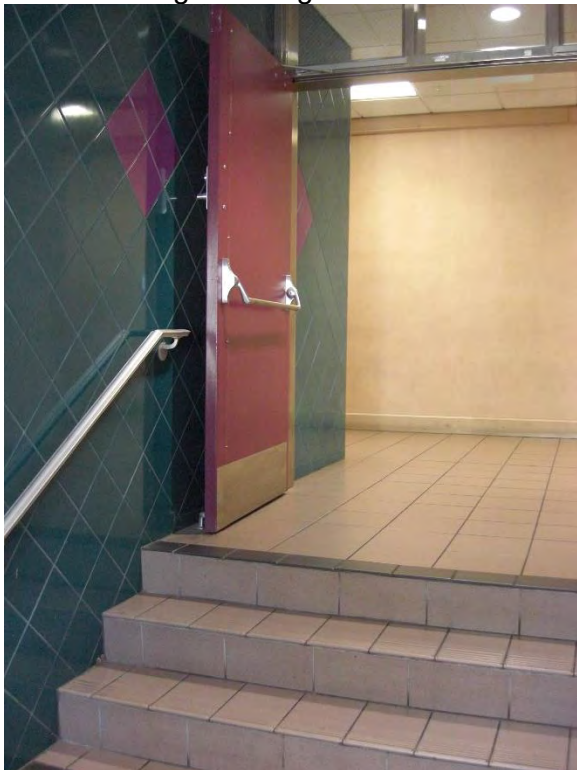
D6. Third floor, doors impede upper landing clearance.

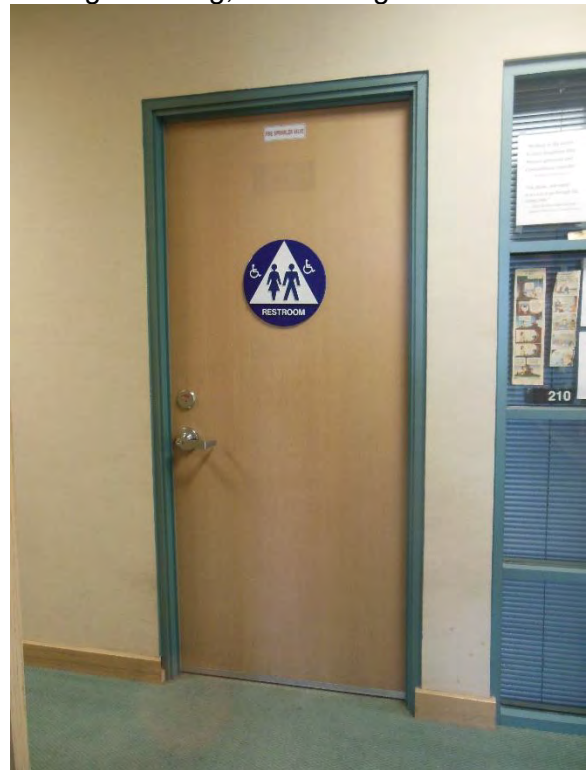
D7. Second floor staff unisex restroom. Missing wall mounted room ID signage.

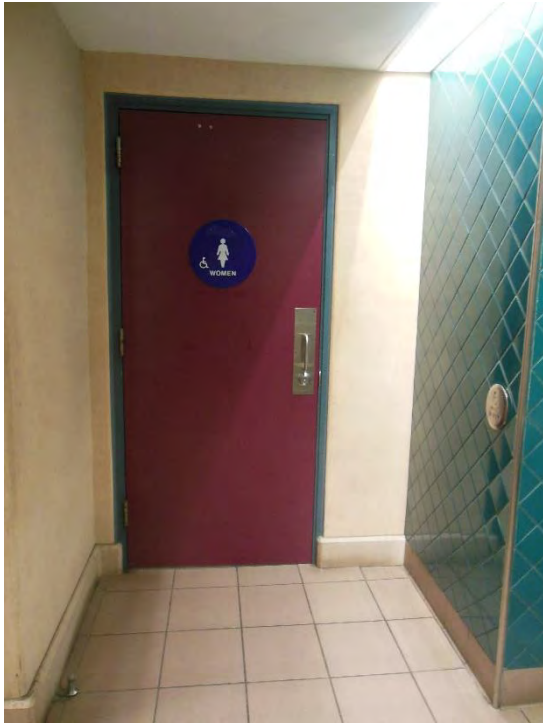
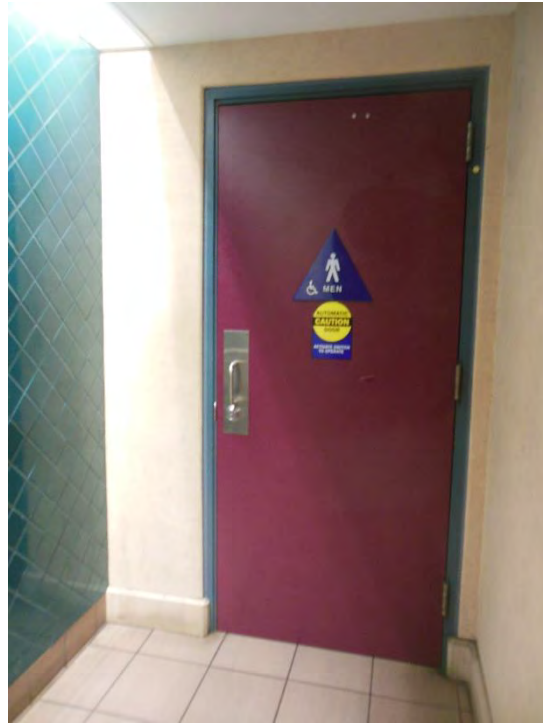
D7. Second floor restroom doors are missing wall mounted room ID signage. Low level access button for electronic door operator is required by code.

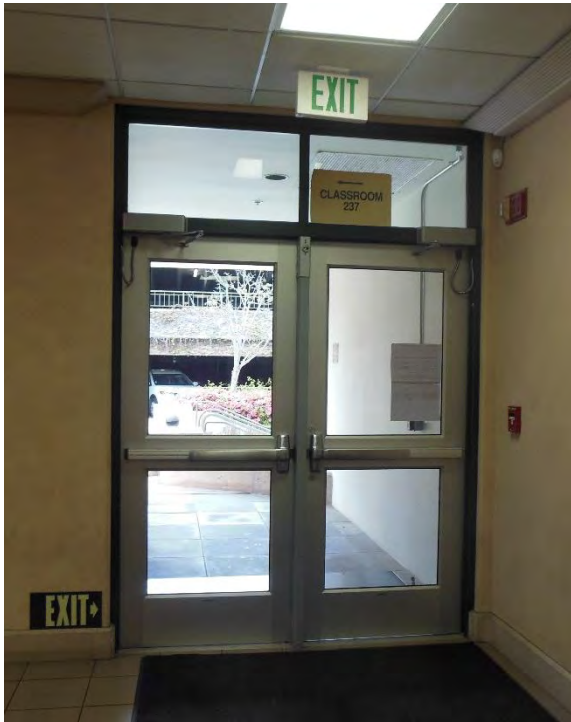
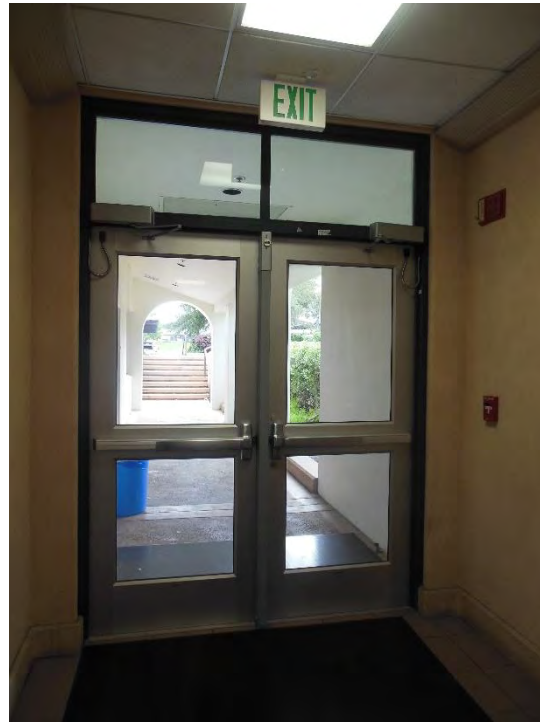
D8. Second floor corridor exit doors; missing wall mounted ADA exit signage and overhead exit signs are not illuminated.

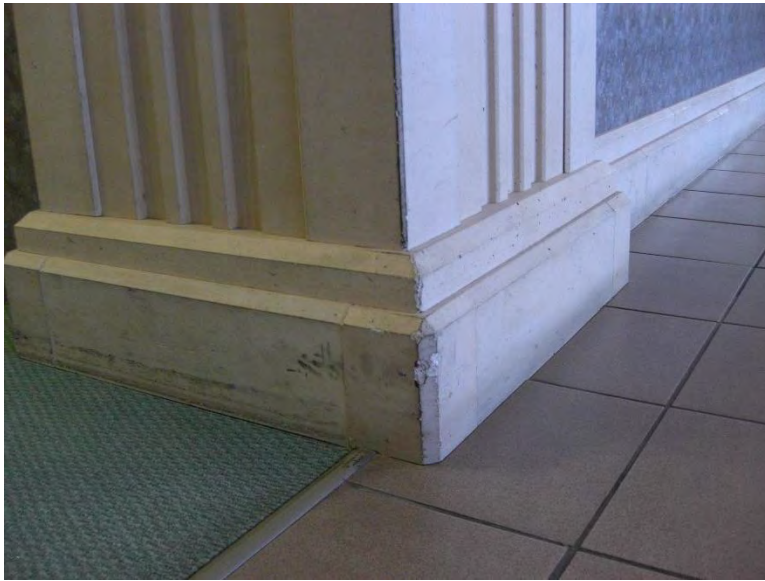
IF1. Second floor reception; wood base damage.

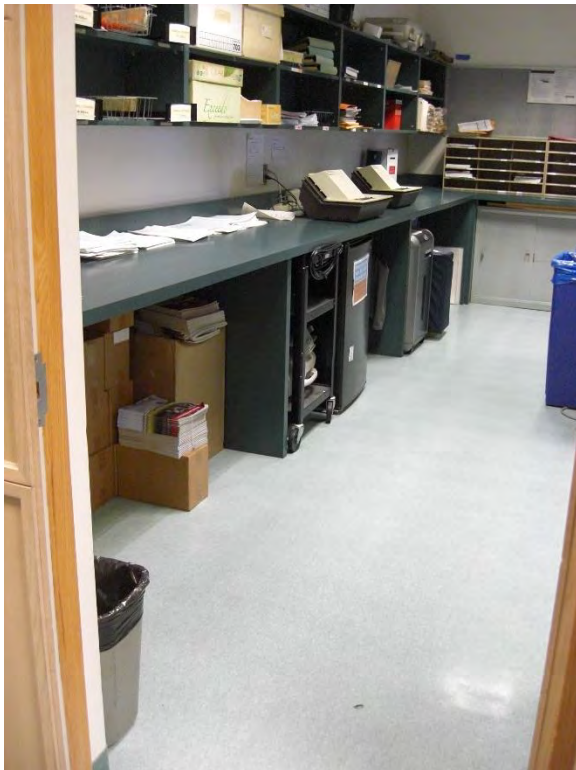
IF2. Second floor Workroom, damaged resilient floor.

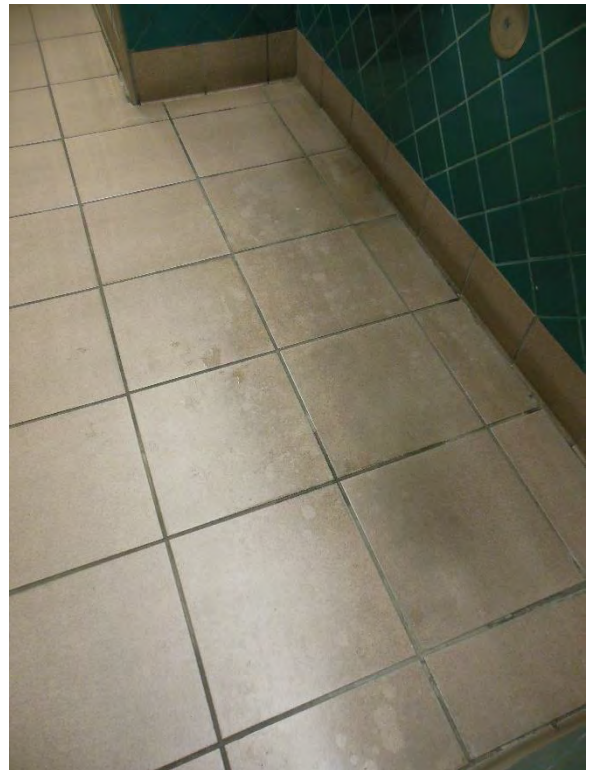
IF3. Second floor corridor, stained quarry tile under drinking fountains.

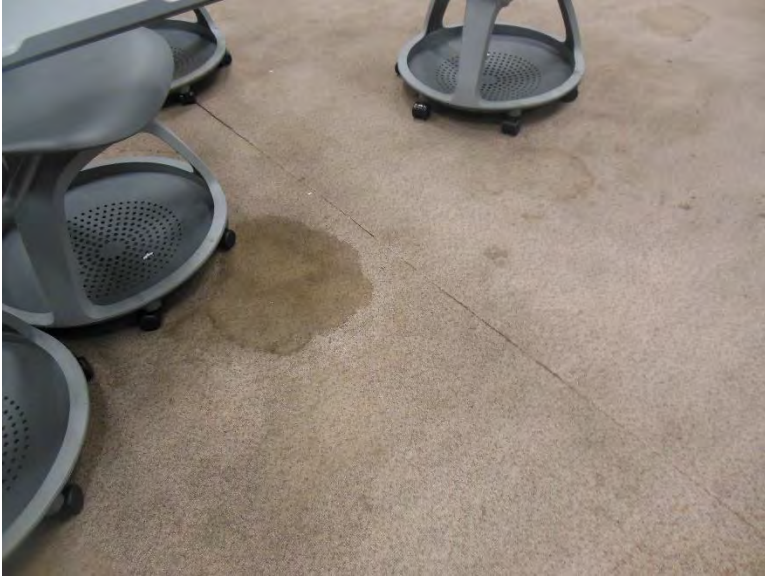
IF4. Second floor classroom, worn and stained carpet, typical.

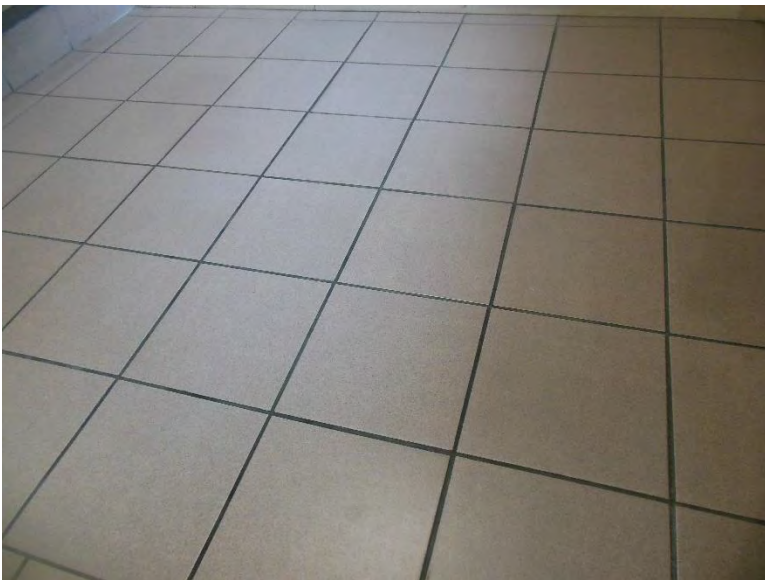
IF5. Interior quarry tile, in good condition.

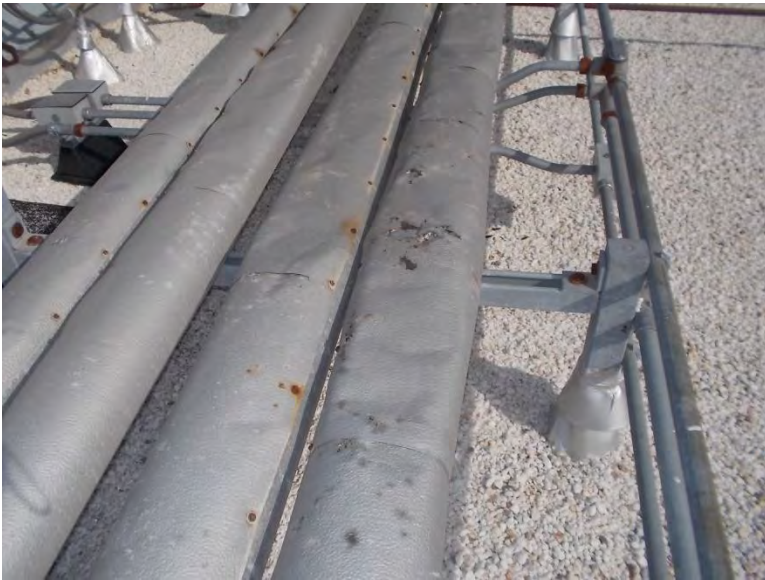
M2. Rooftop mechanical piping damaged.

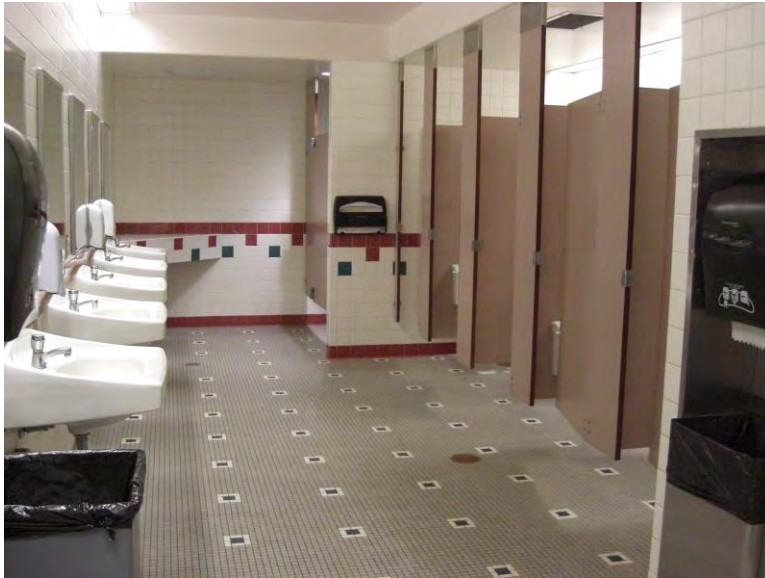
RR1. Second floor restrooms; improper placement of seat cover dispenser.

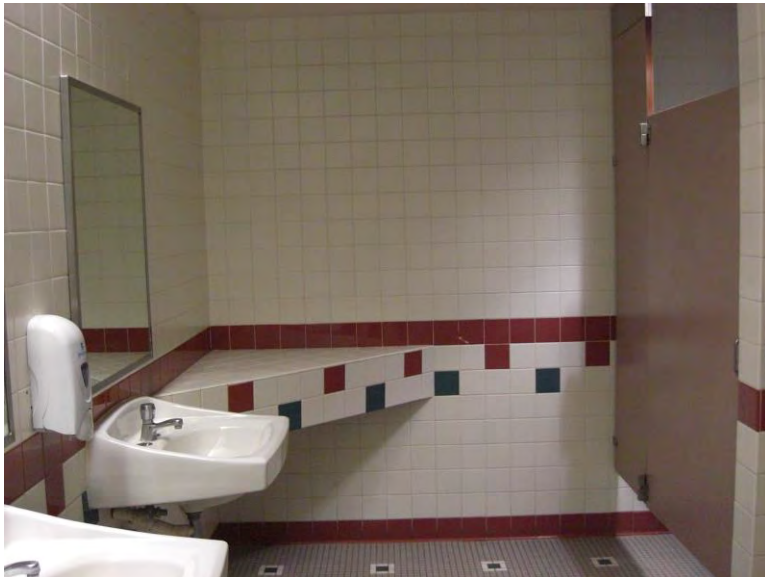
RR2. Second floor restrooms; corner shelf prohibits ADA required door clearances.

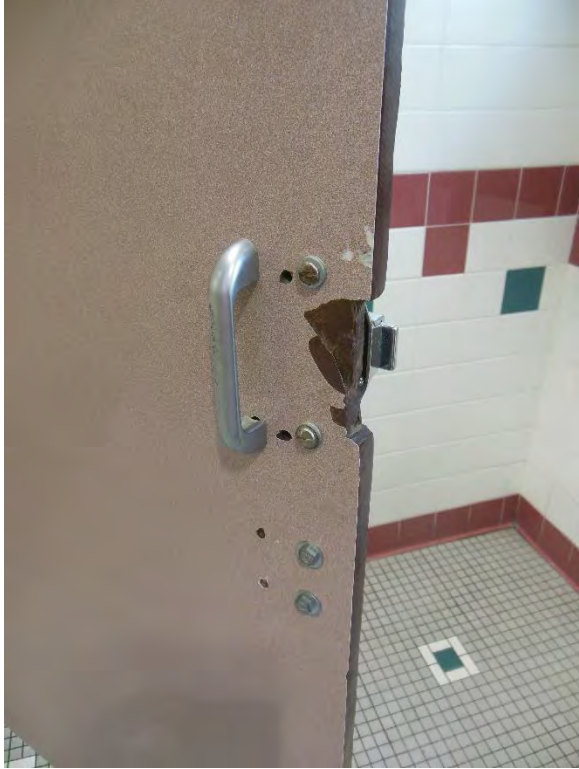
RR5. Café restrooms; damaged accessible stall hardware.

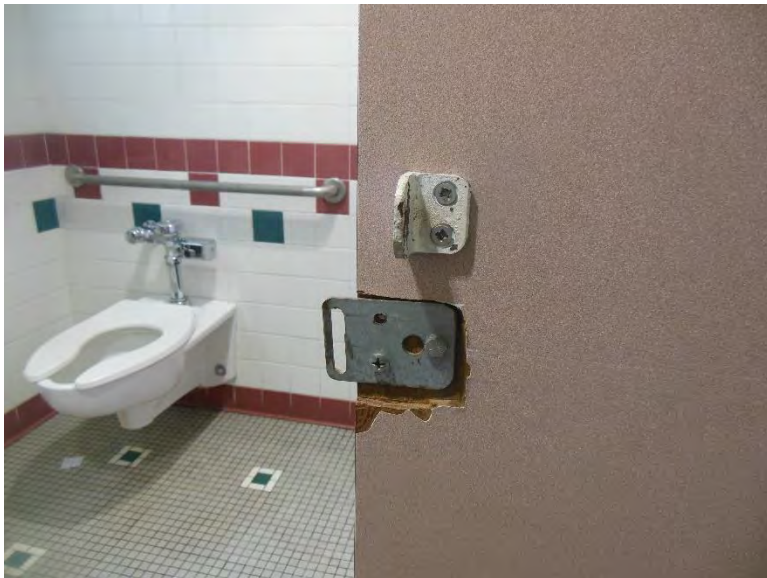
RR6. Café restrooms; damaged accessible stall hardware.

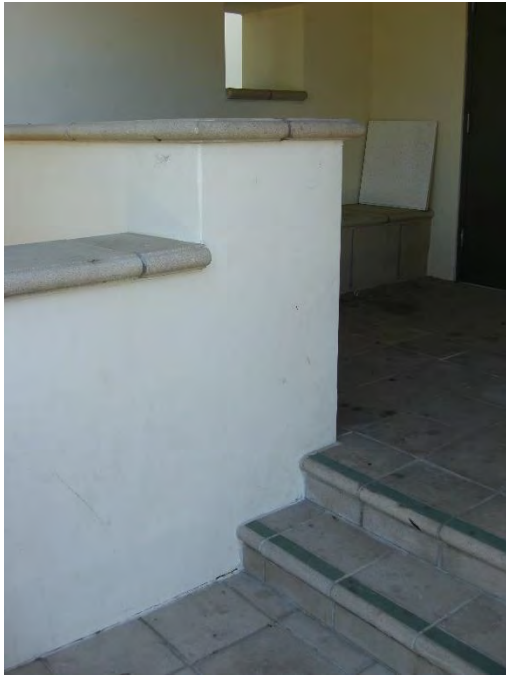
ST1. Exterior north stairs; missing required handrails.

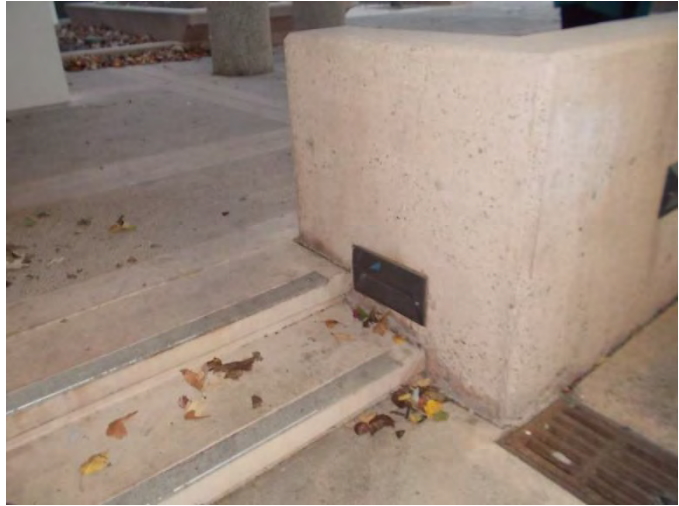
ST2. Exterior south stairs; missing required handrails.

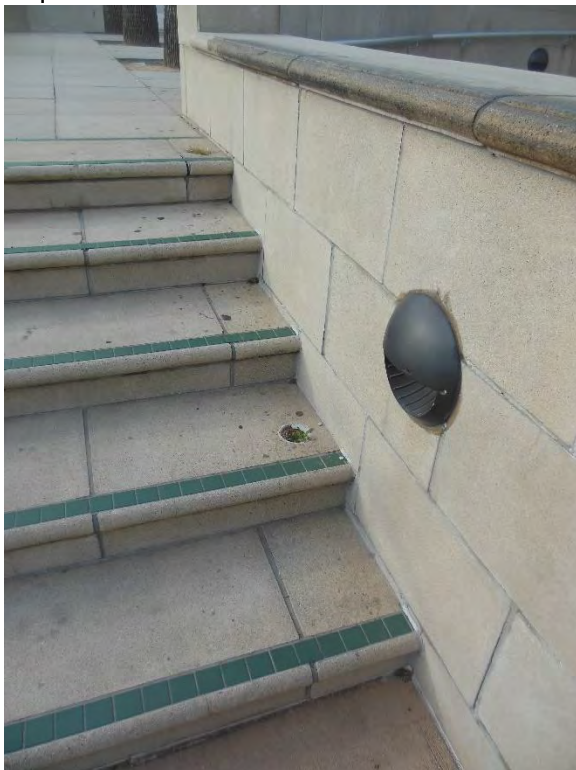
ST3. Front entry plaza stairs; handrail removed/missing.

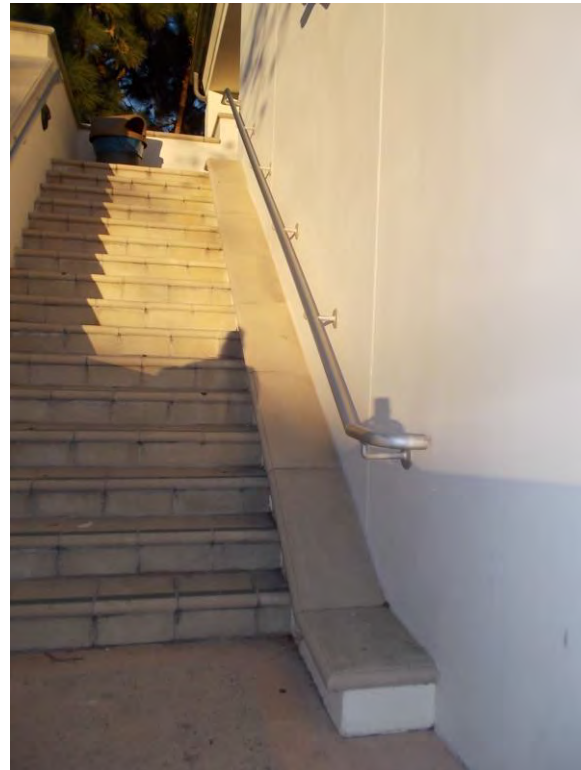
ST4. Exterior north stair exceeds distance to handrail from edge of stairs.

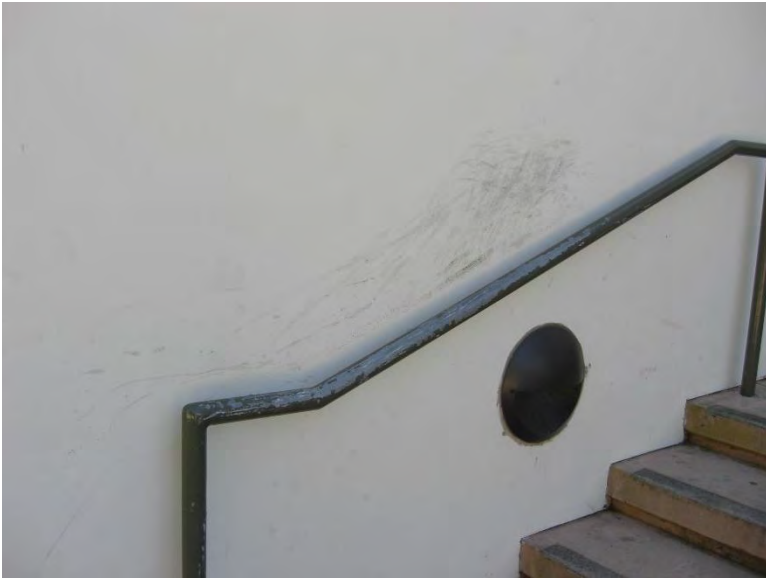
ST6. East side of building; exterior stair handrail finish degraded, and non-compliant height.

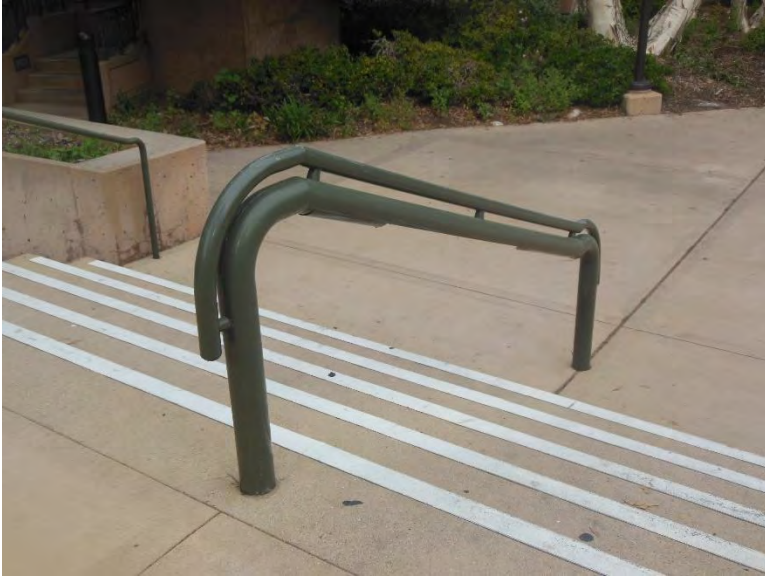
ST7. North side of building; exterior stair with non-compliant handrail heights and returns.

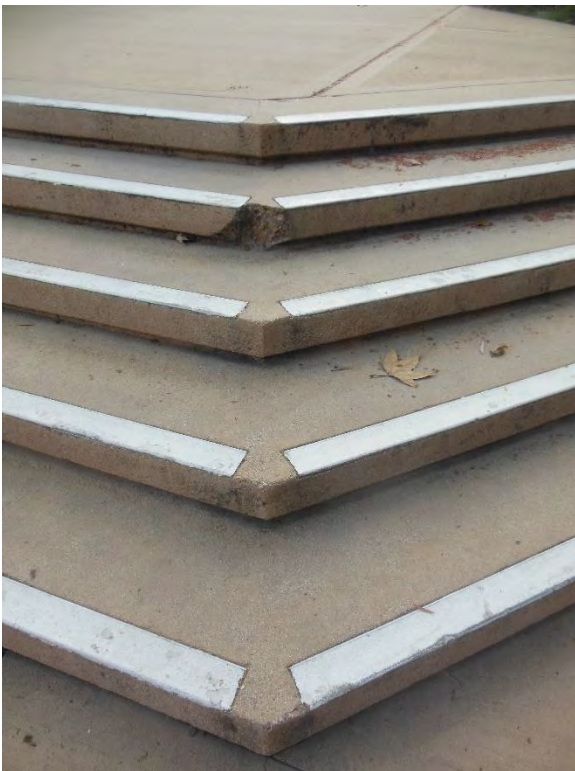
ST8. North side of building; exterior stair with damaged nosing, and missing handrail at change in stair direction.

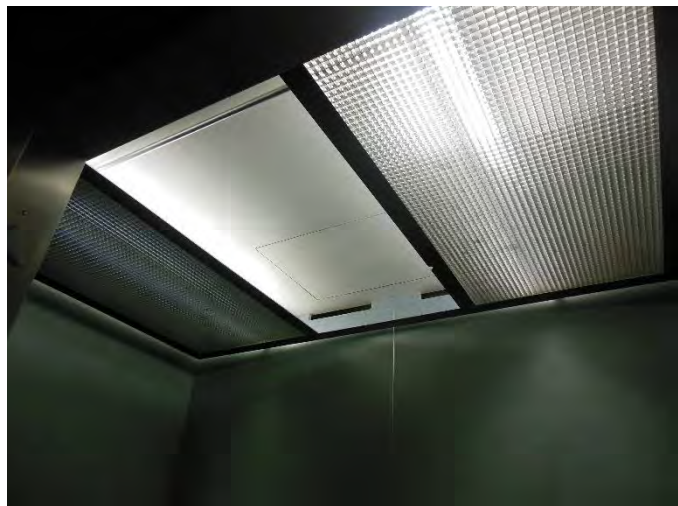
EV4. Elevator car ceiling; missing light lens.

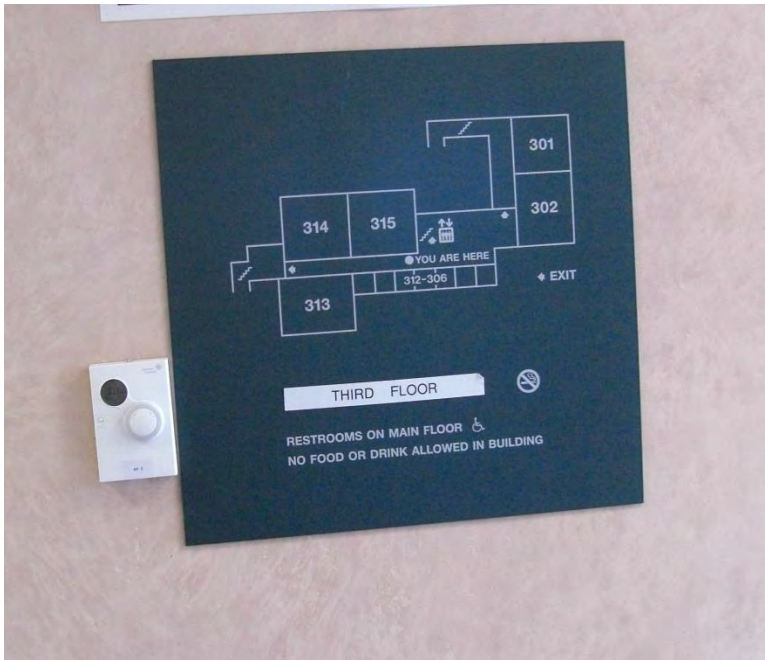
S3. Third floor, evacuation signage, missing extinguisher and fire alarm pull locations.

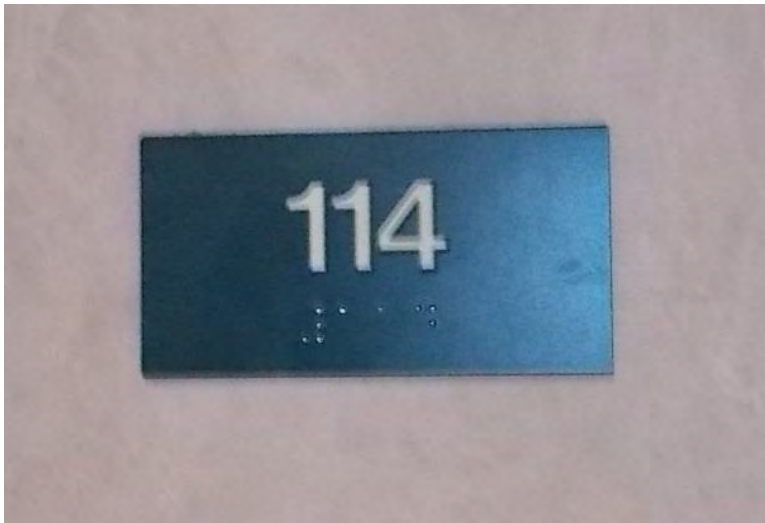
S4. First floor; typical room ID signage.

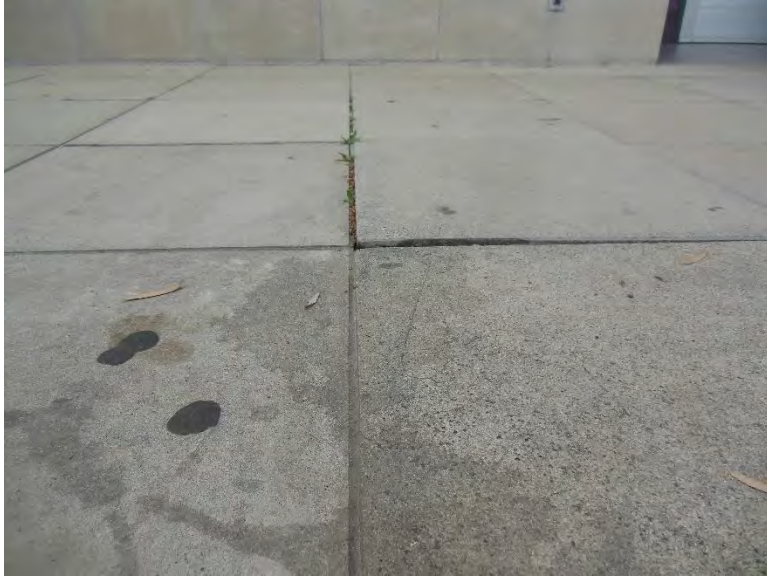
PT3. West entry plaza; abrupt change in level and hazardous surface features along path of travel.

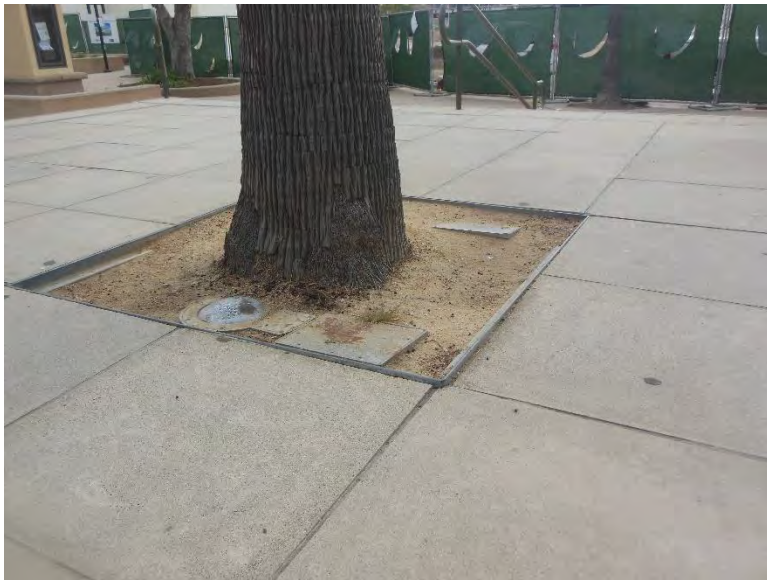
PT4. West entry plaza tree well; hazardous surface feature along path of travel.

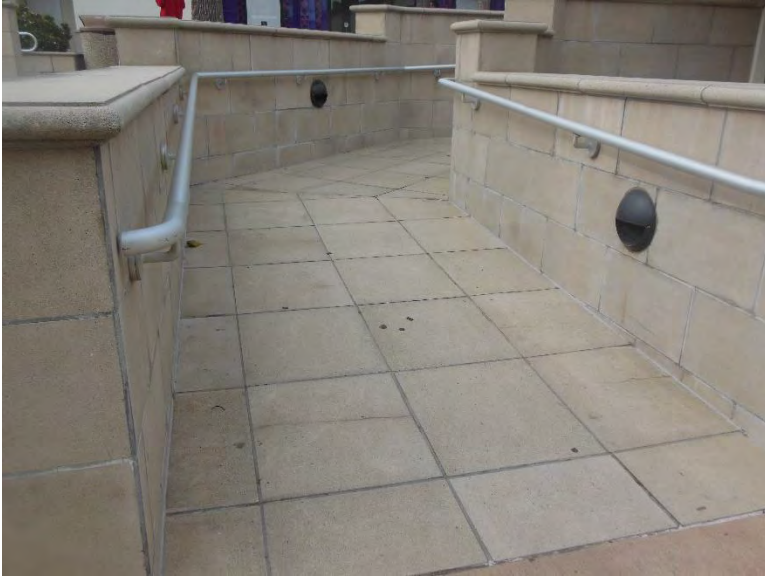
PT3. West side ramp to main building entry; intermediate landing exceeds the 2% allowed maximum cross slope.

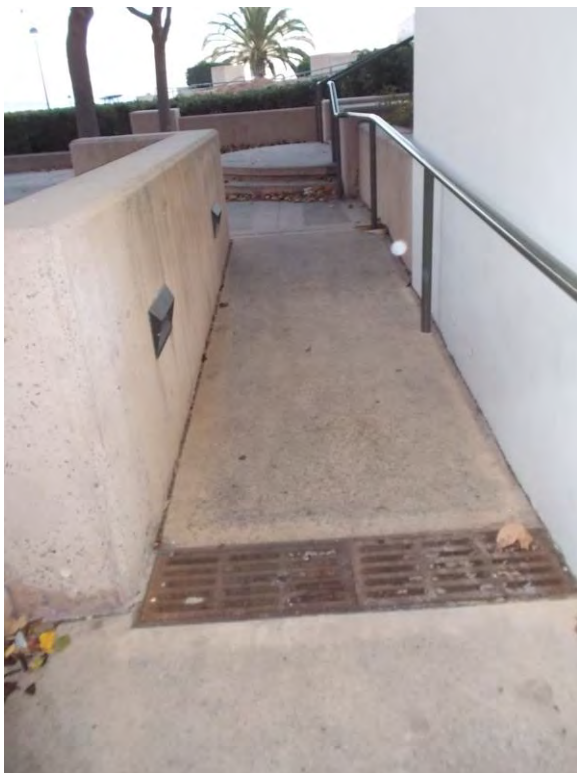
PT7. South side of building, ramp leading to Room 101; One handrail missing, non-compliant height at existing handrail, and drain grate creates abrupt and non-level lower landing.

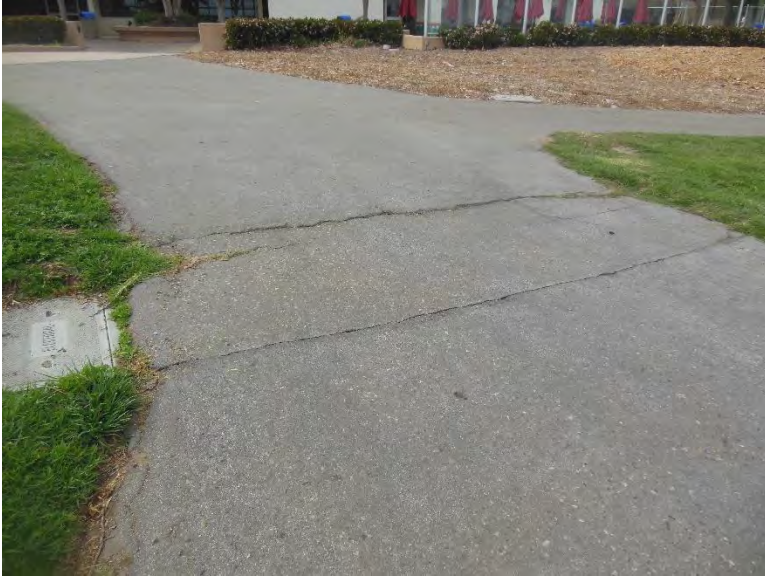
PT8. South side of building; excessive cross and longitudinal slopes, and abrupt change in level and hazardous surface features along path of travel.

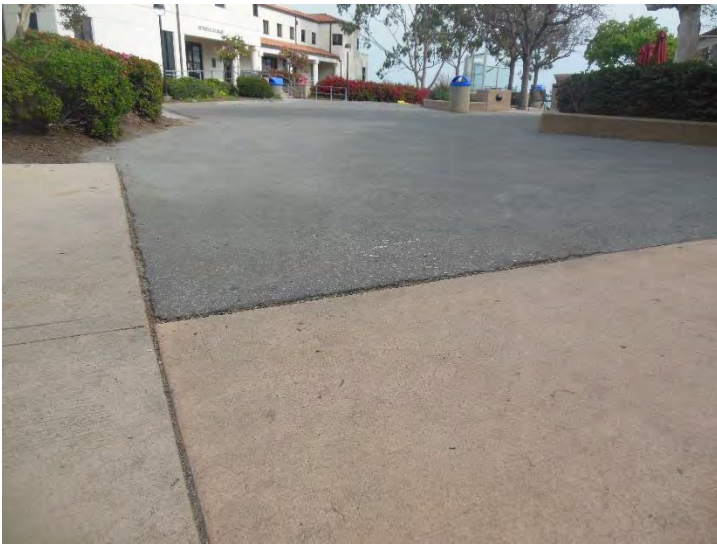
PT9. Northeast exterior walkway; uneven asphalt to concrete transitions. Abrupt change in level and hazardous surface features along path of travel.

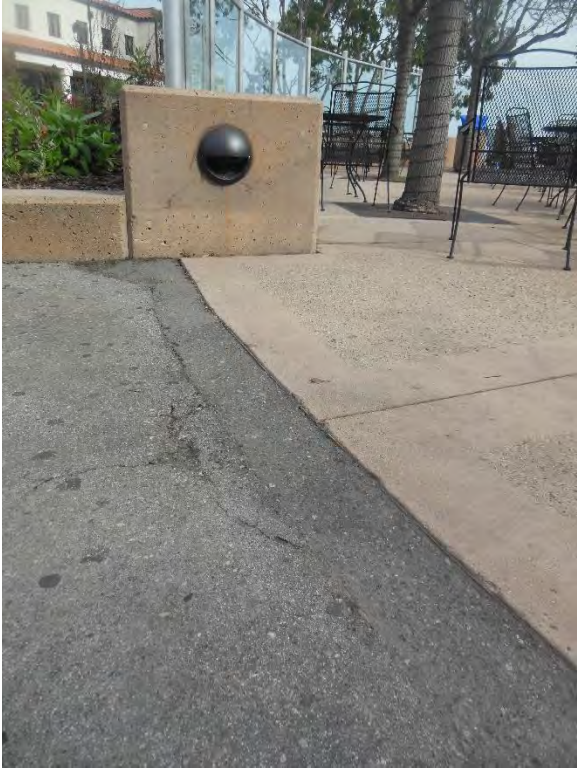
PT10. Outdoor Café pathway material transition; abrupt change in level and hazardous surface features at path of travel.

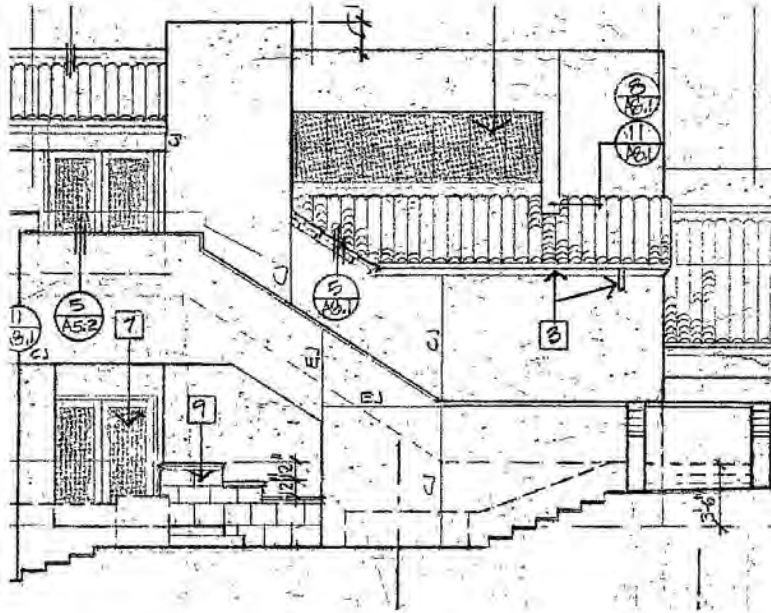
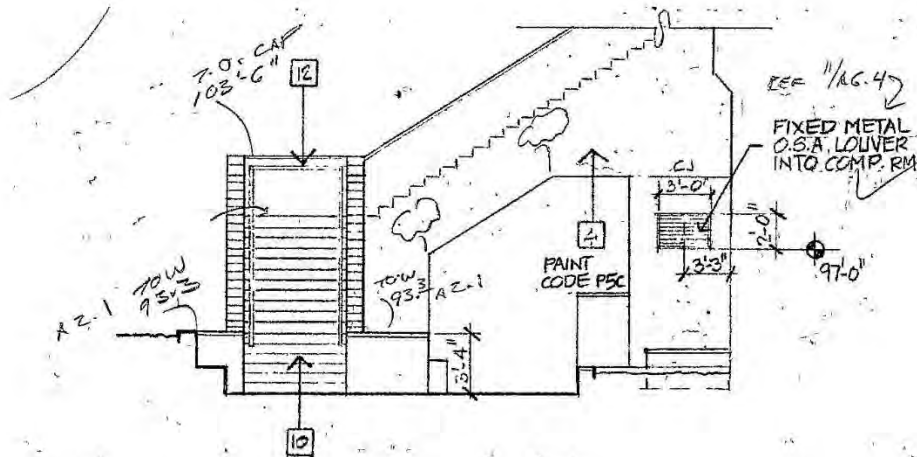
4 PARTIAL WEST ELEV.
