Appendices

Appendix A:
ADA Path of Travel Assessment Diagrams

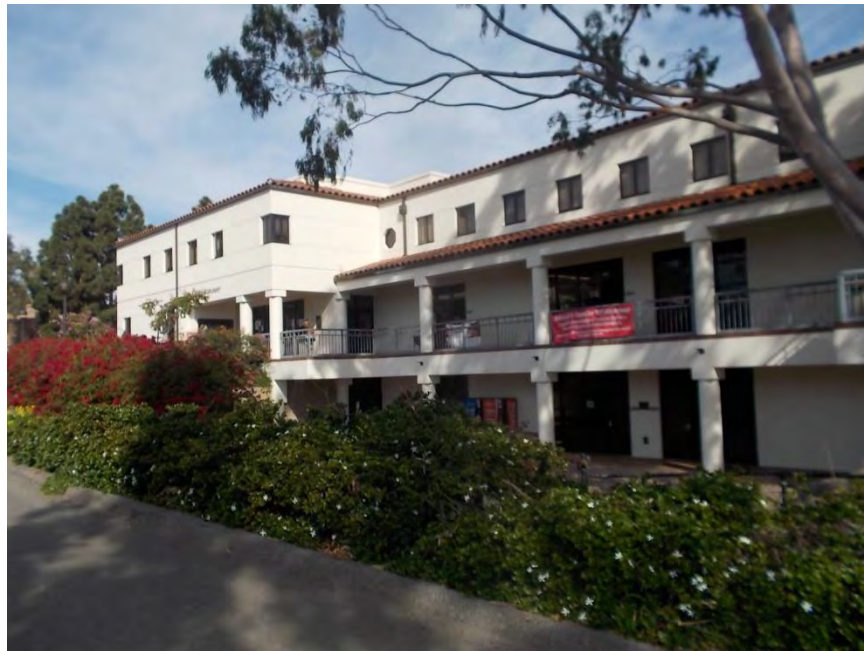
Prepared by
RJC Inc.

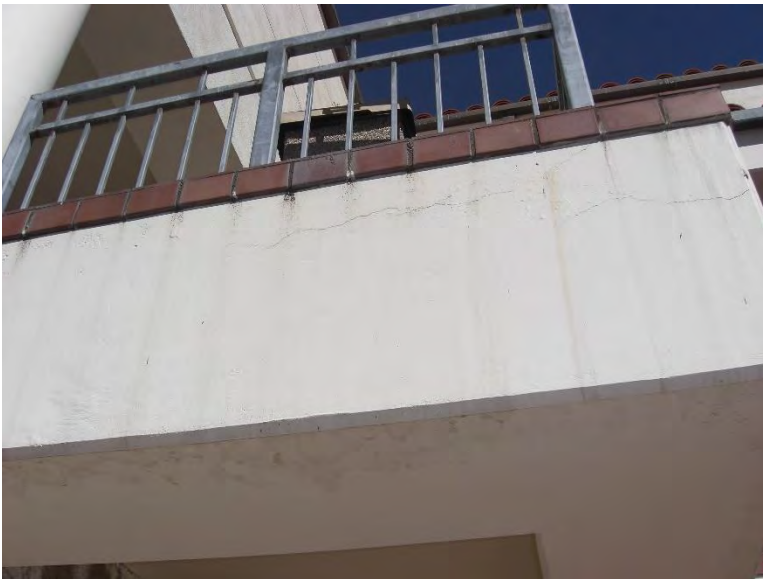
AE2. West facing entrance overhang cracked plaster finish with water damage.

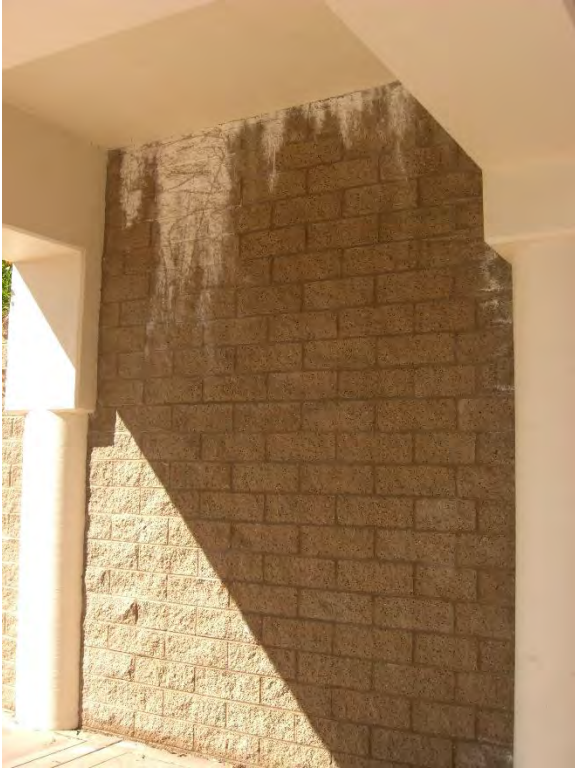
AE3. First floor CMU wall under overhang with efflorescence (white mineral deposits) from water intrusion above.

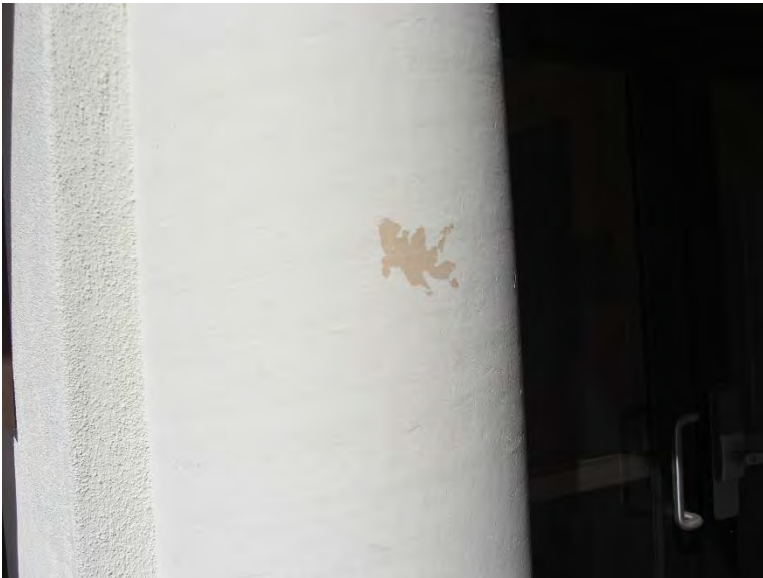
AE4. First floor CMU column under overhang with paint finish damage.

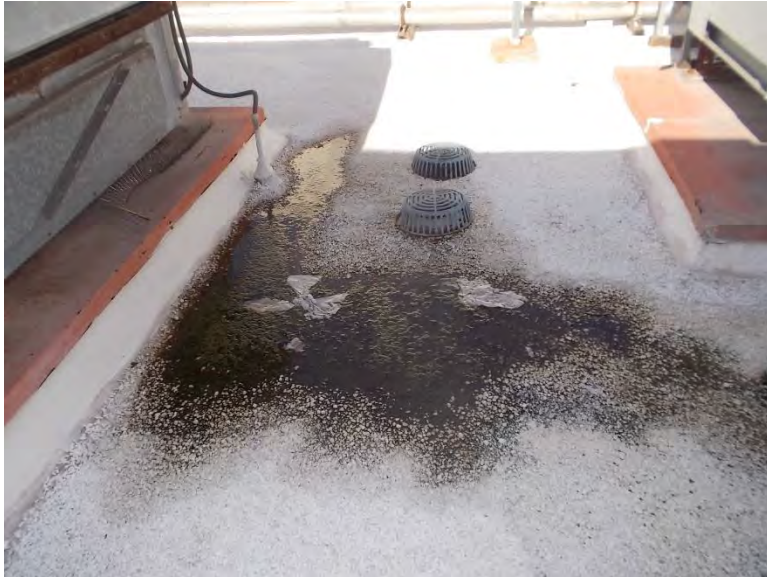
R1. Mechanical roof well with water damage at built up roofing system.

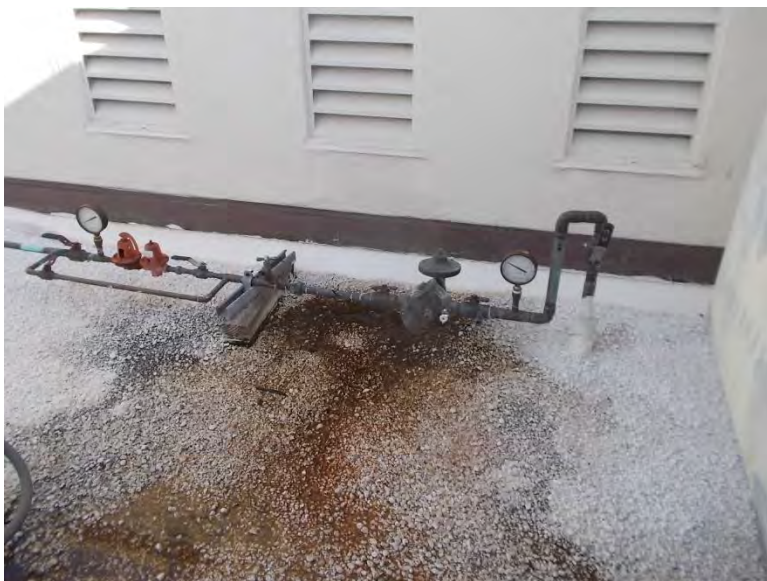
R2. Mechanical roof well with water damage at built up roofing system.

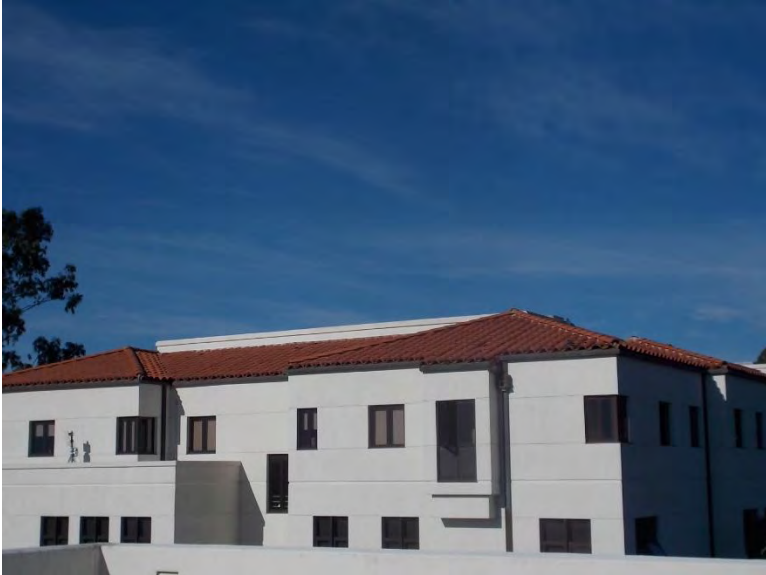
R3. Clay tile roof system, in good condition.

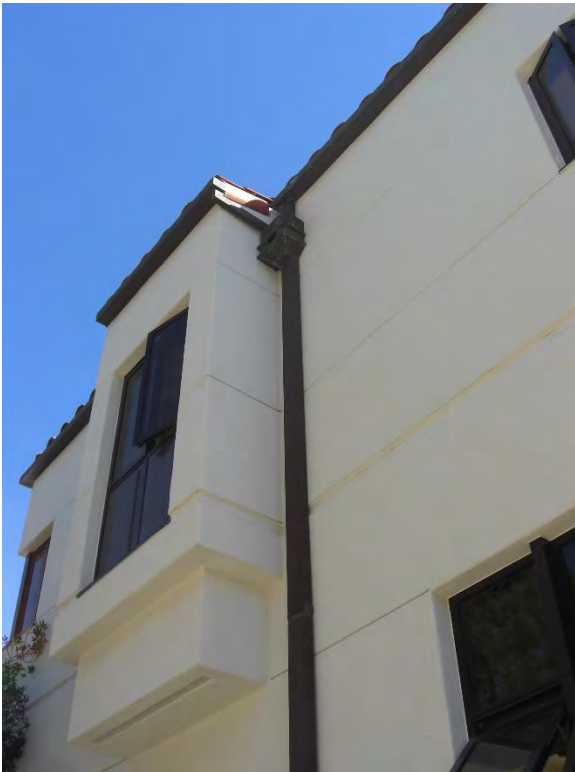
R4. Clay tile roof system with metal downspouts, in good condition.

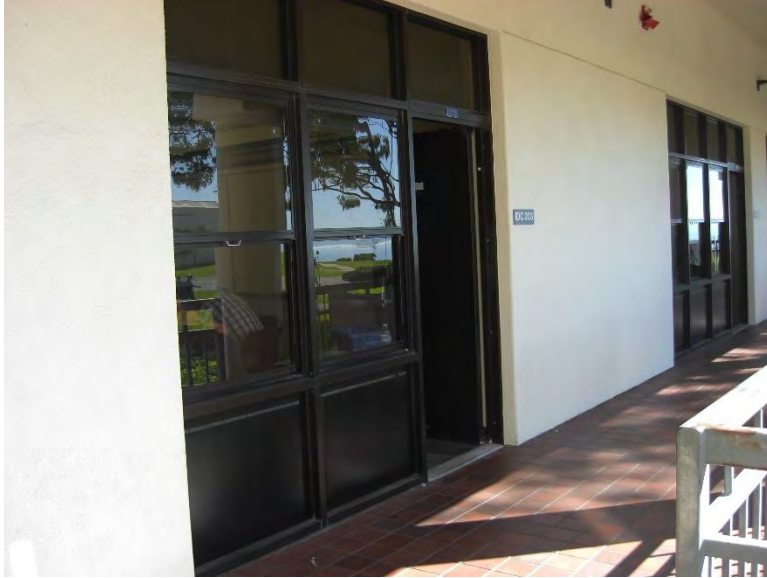
EW1. West wall, second floor storefront window system in good condition.

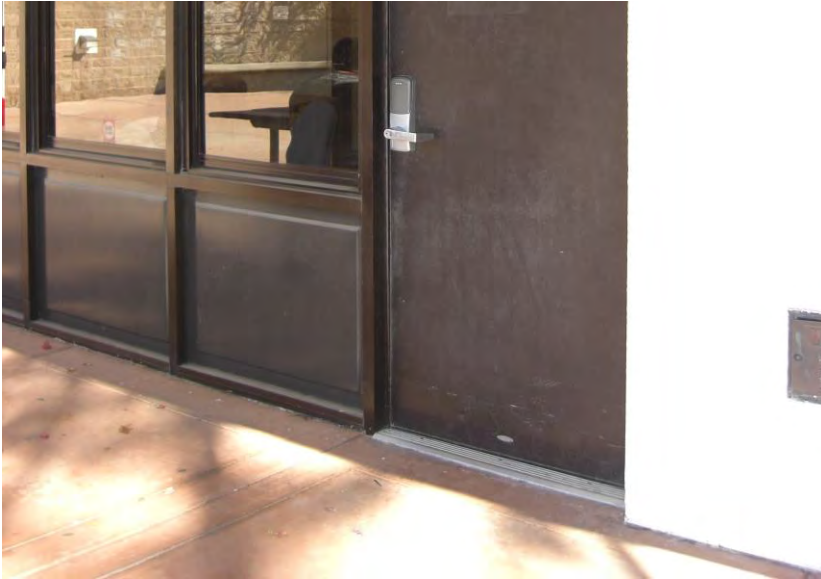
EF1. Second floor exterior colored, scored concrete walkway; good condition.

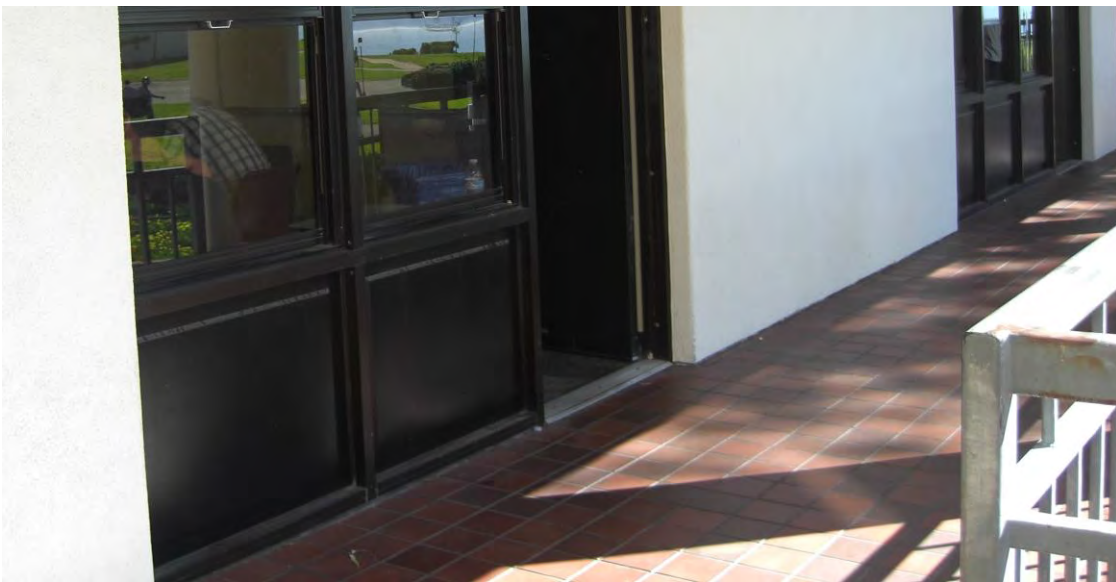
EF2. Second floor exterior ceramic tile walkway; good condition.

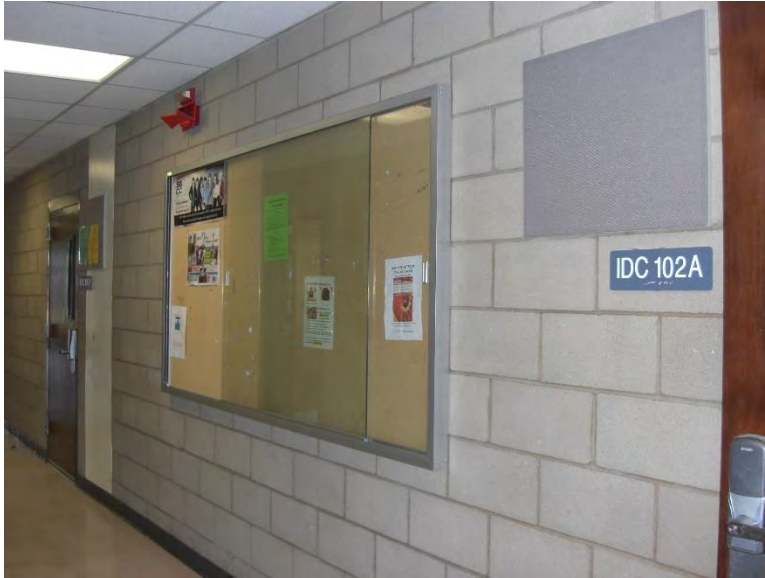
AI1. First floor interior corridor CMU walls; good condition.

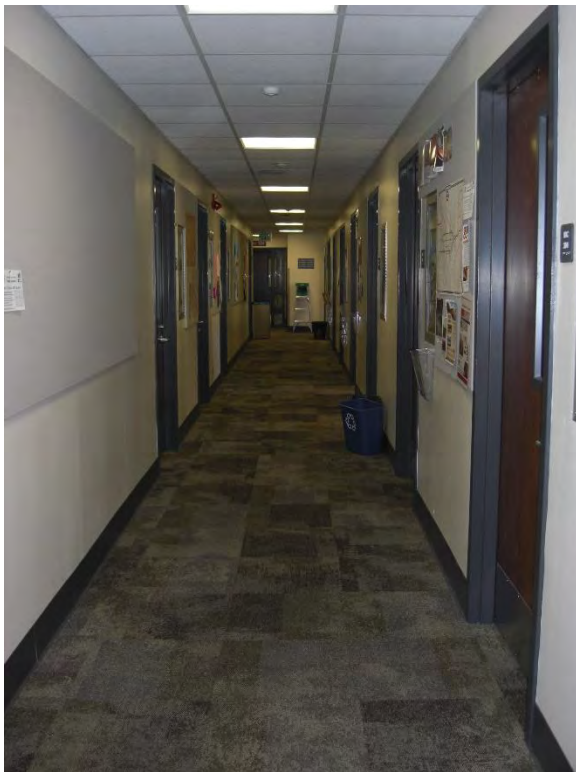
AI2. Third floor interior corridor walls; good condition.

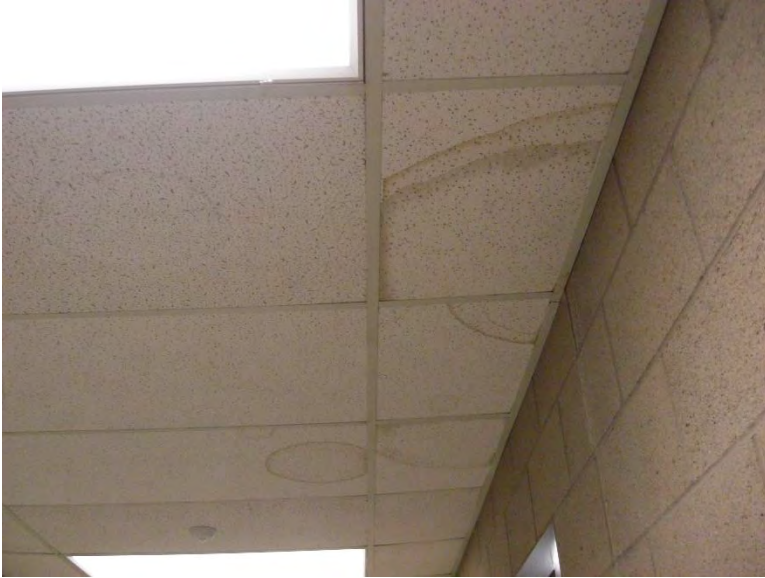
C1. First floor corridor ceiling system; water damaged.

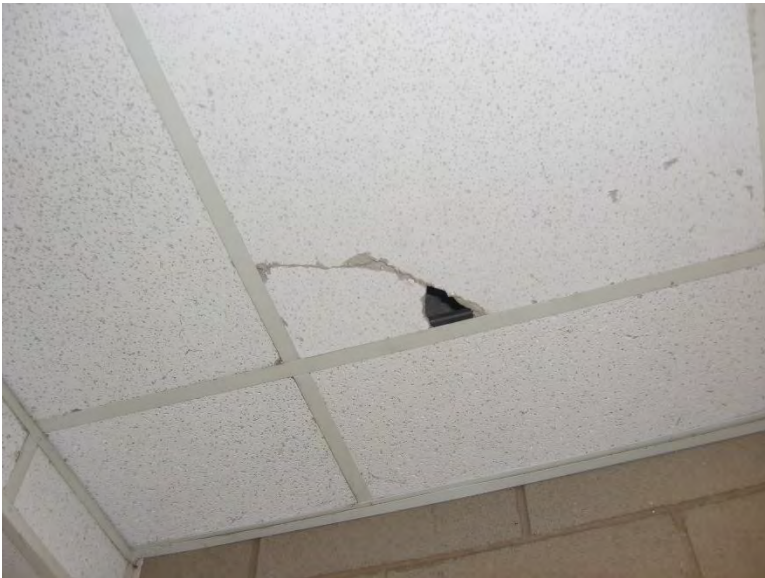
C2. First floor corridor ceiling tile; damaged.

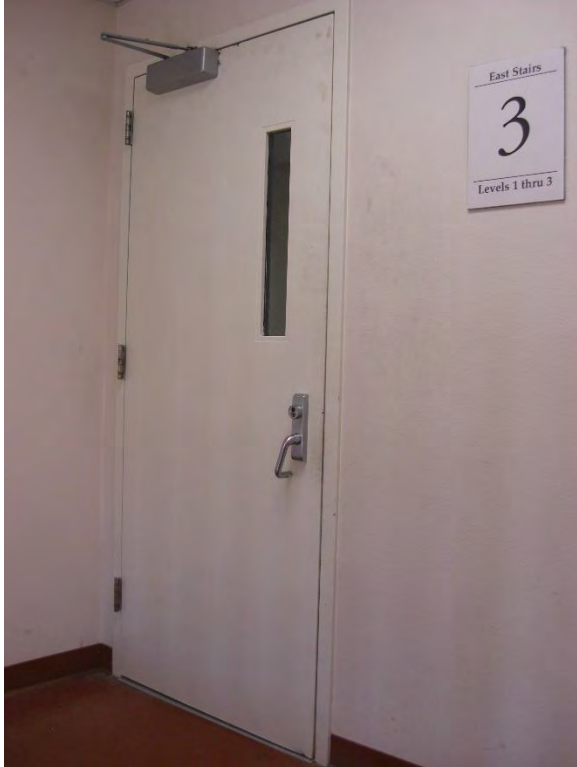
D3. Third floor stairwell door with damaged lever hardware.

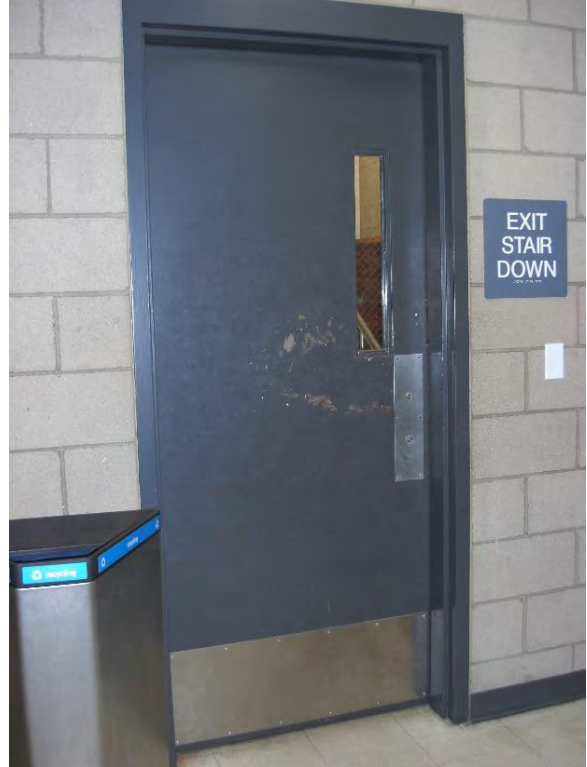
D4. Second floor stairwell door with damaged paint, and no panic hardware.

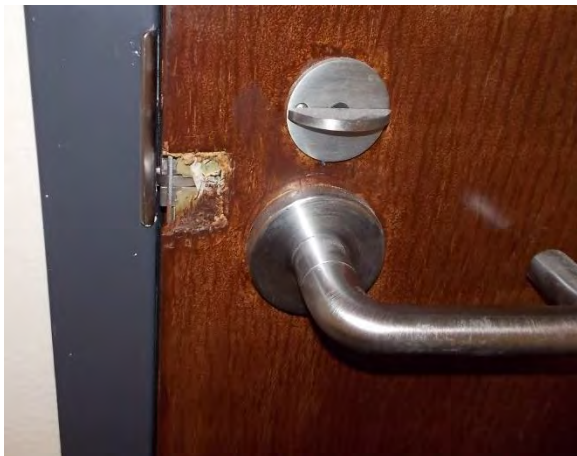
D5. Third floor office door with damage edge at latch.

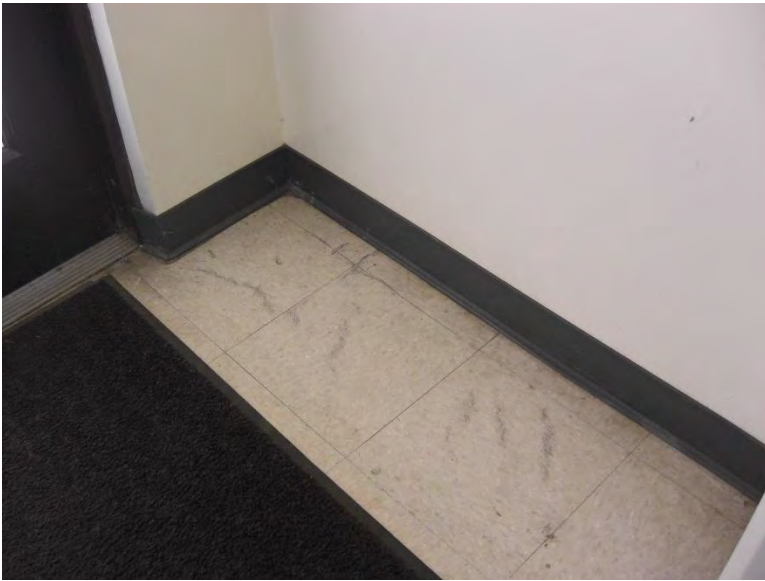
IF1. Second floor entry corridor; cracked and damaged VCT flooring.

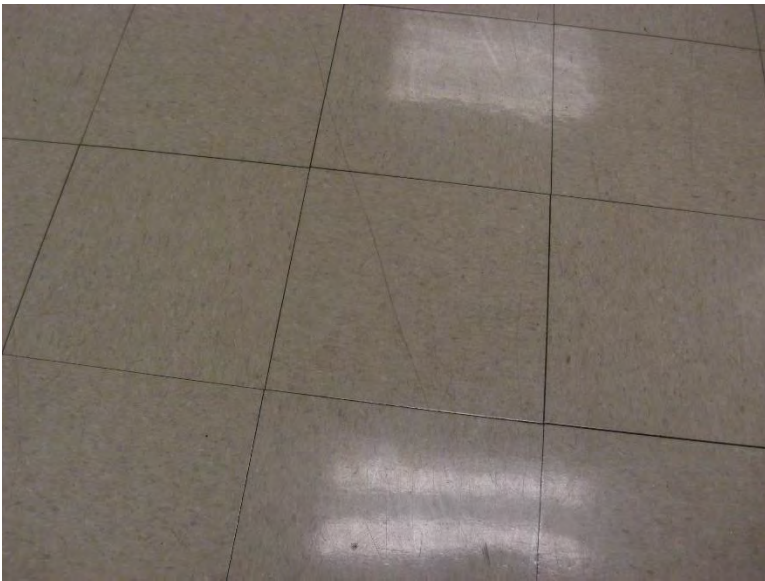
IF2. Second floor corridor; scratched/damaged VCT flooring.

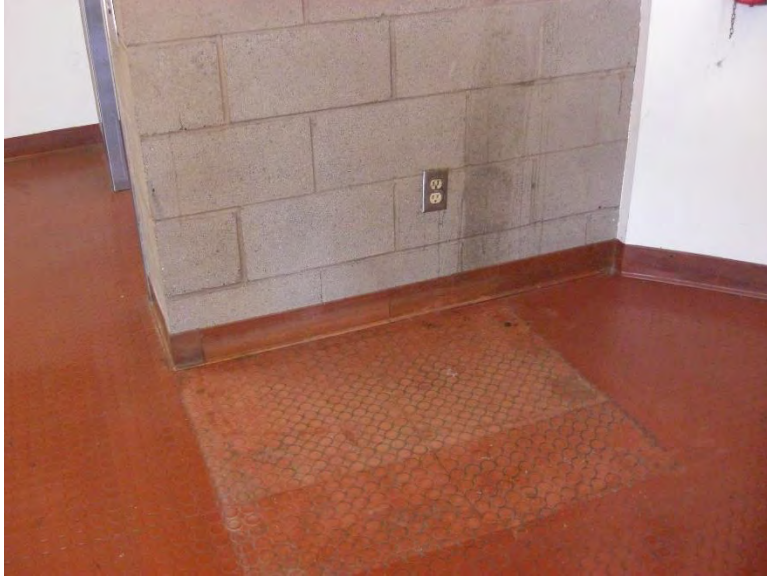
IF3. First floor exit passageway at stairwell enclosure by elevator. Damaged rubber flooring and resilient base.

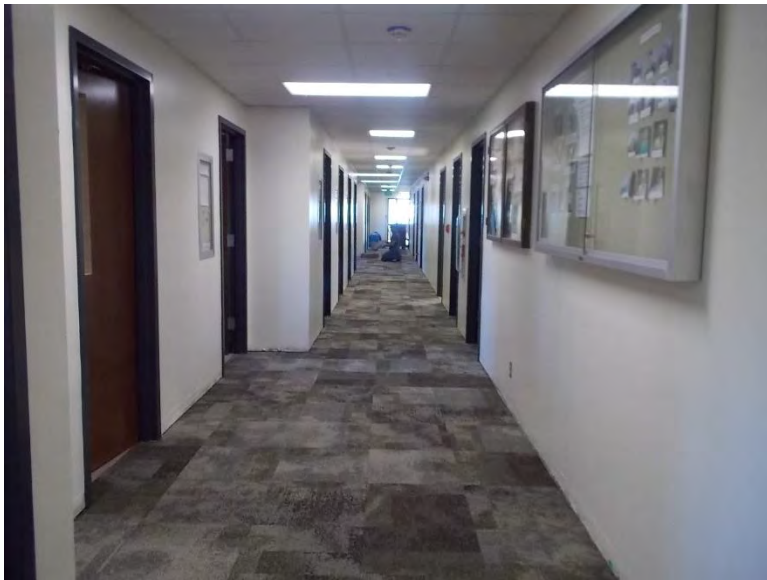
IF4. Third floor corridor carpet tile in excellent condition; installed in 2015.

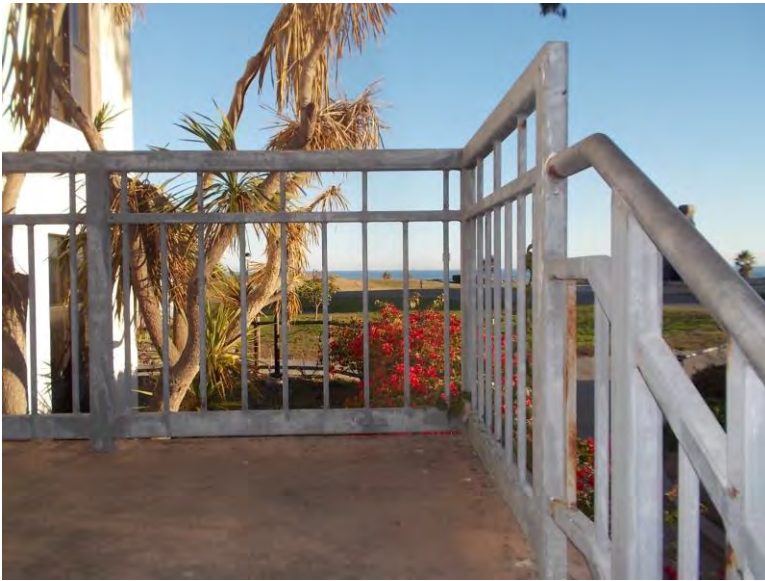
ST1. South exterior stairs with non-compliant and corroded handrails.

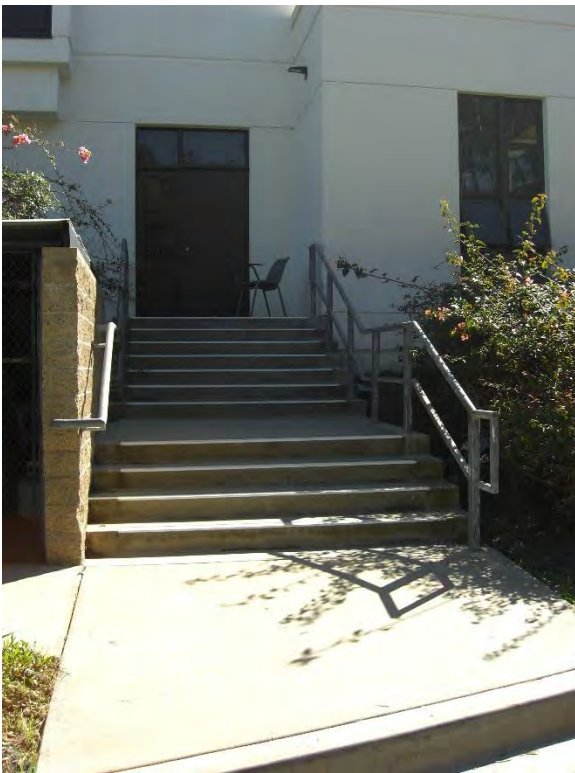
ST2. North exterior stairs with non-compliant and corroded handrails.

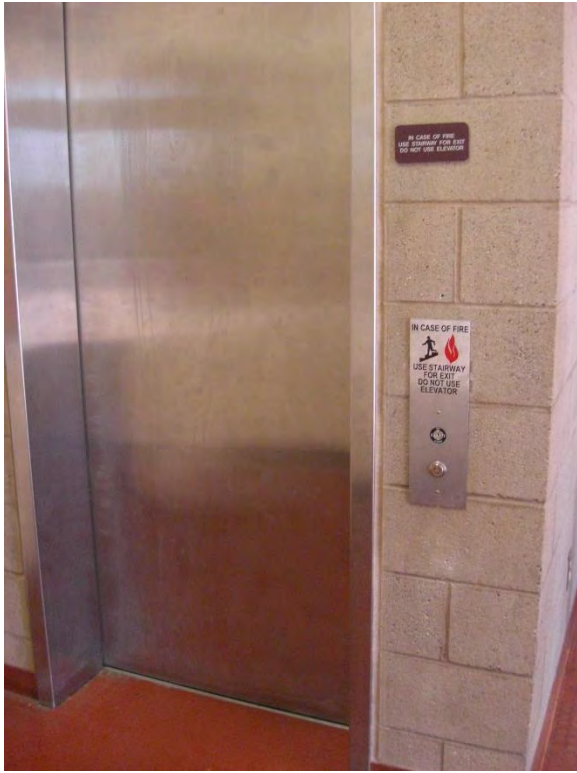
EV1. First floor elevator doors; missing proper signage.

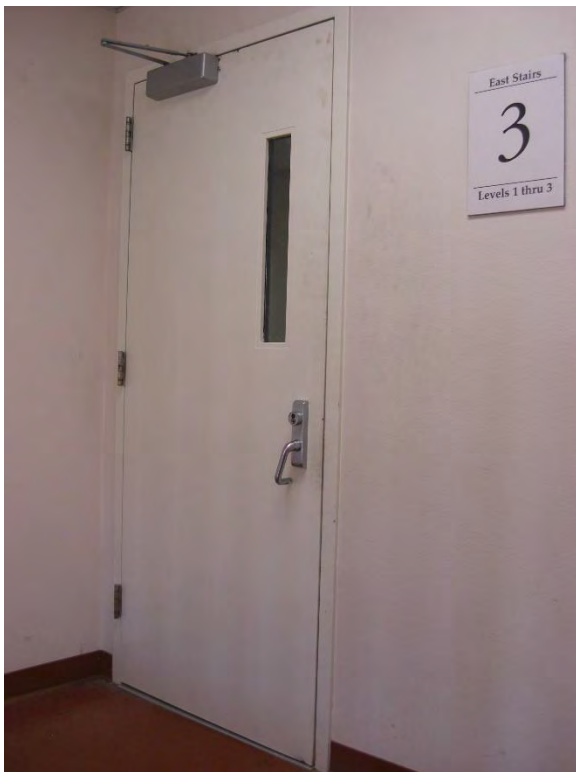
S2. Stairwell exiting signage is inadequate; second floor.

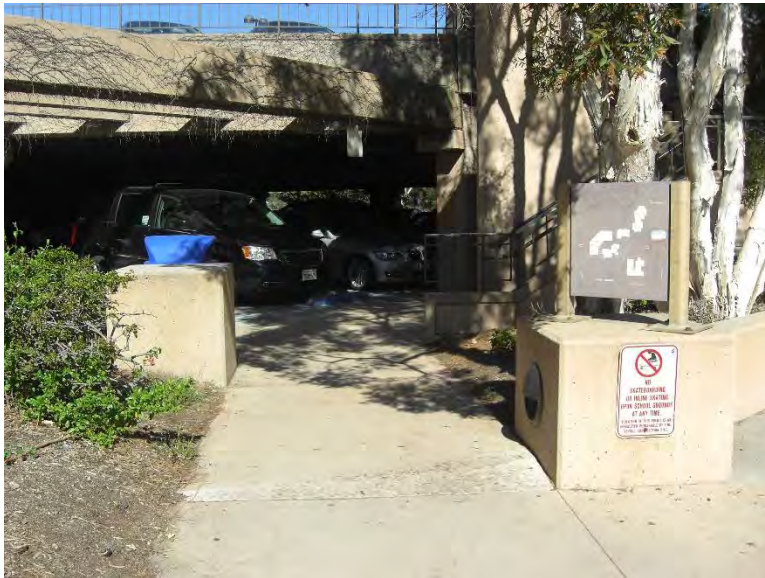
PT1. Paved surface from the IDC building to the accessible parking stalls is uneven and degraded. Path of travel sign is missing.

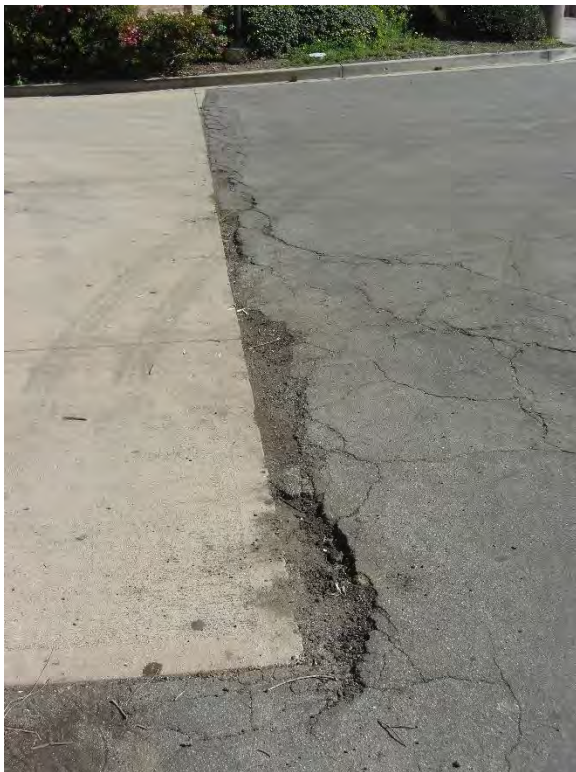
PT2. Asphalt to concrete transition along path of travel from the IDC building to the parking lot is crumbled, uneven and degraded.

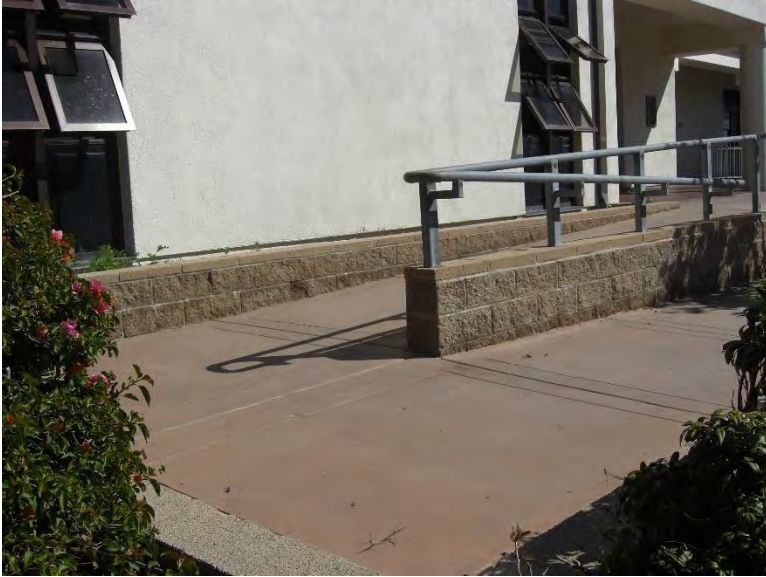
PT3. Non-compliant ramp at west main entry.

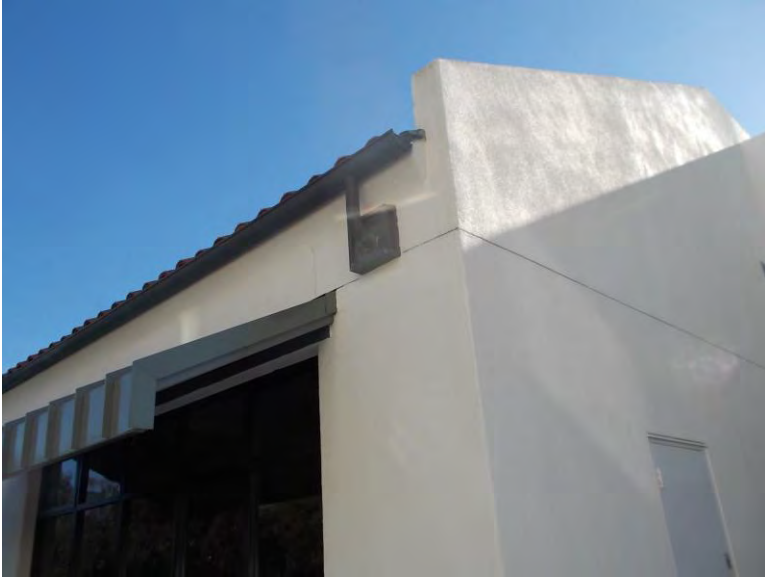
AE1. Exterior walls, minor plaster cracking.

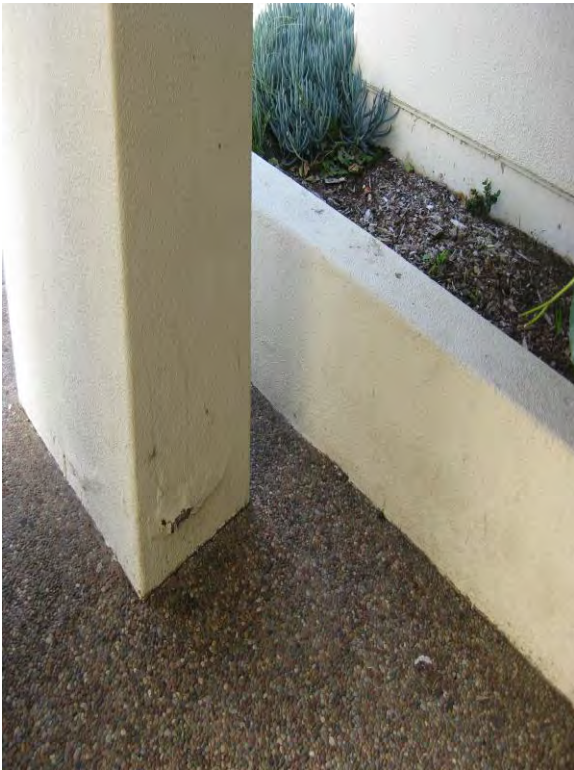
AE2. Cracked and bubbling plaster at south entry column.

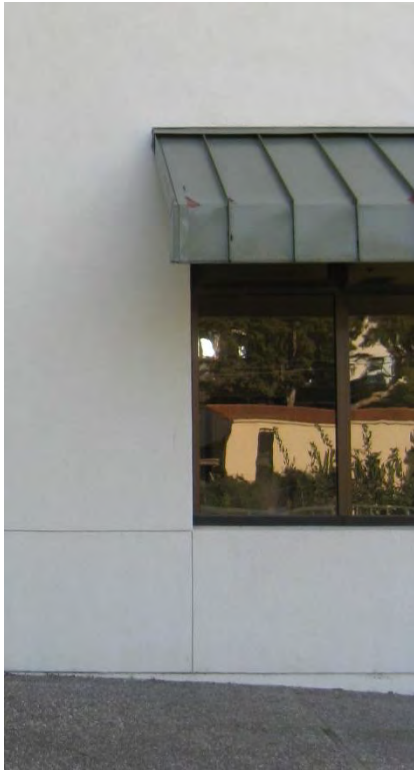
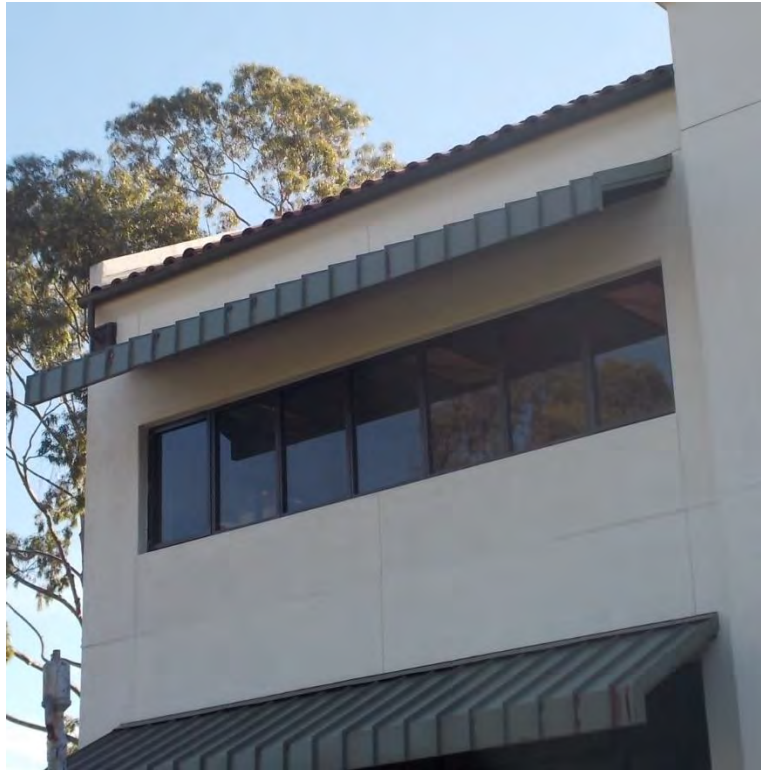
R1. Metal awning damage, northeast side of building.

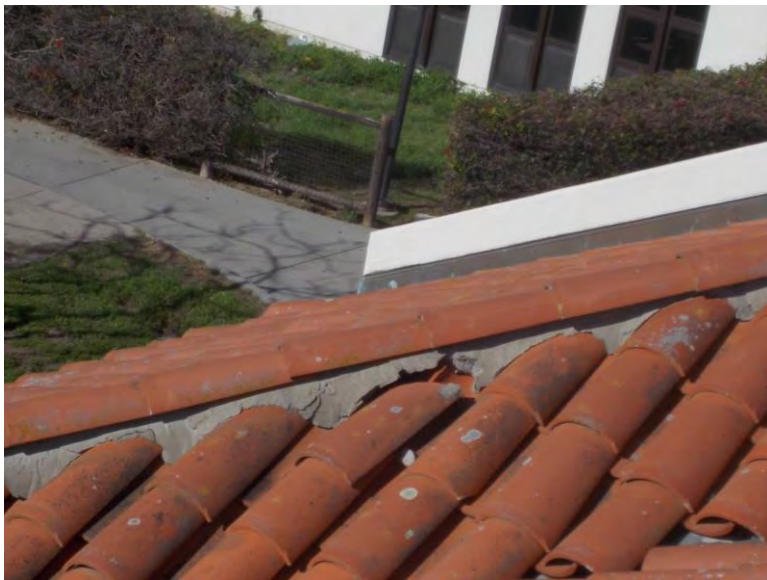
R2. Roof tile mortar damage at ridge, northeast side of roof.

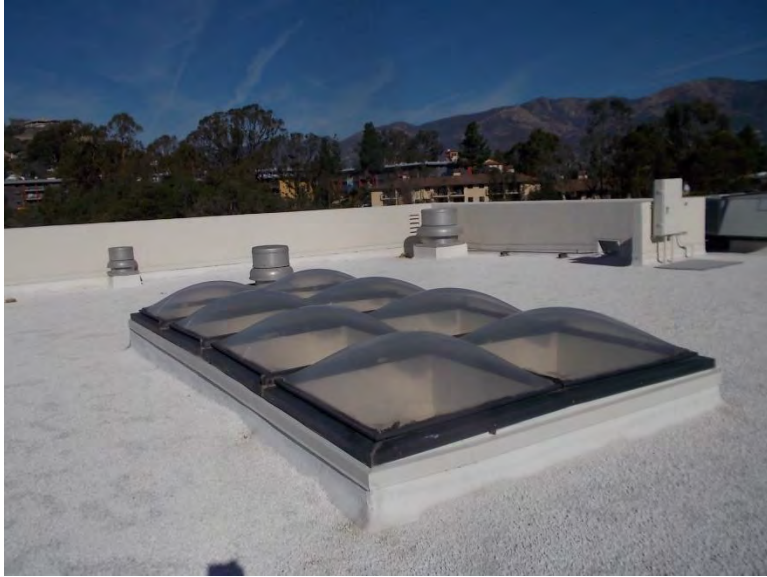
R3. Skylights over Library east side.

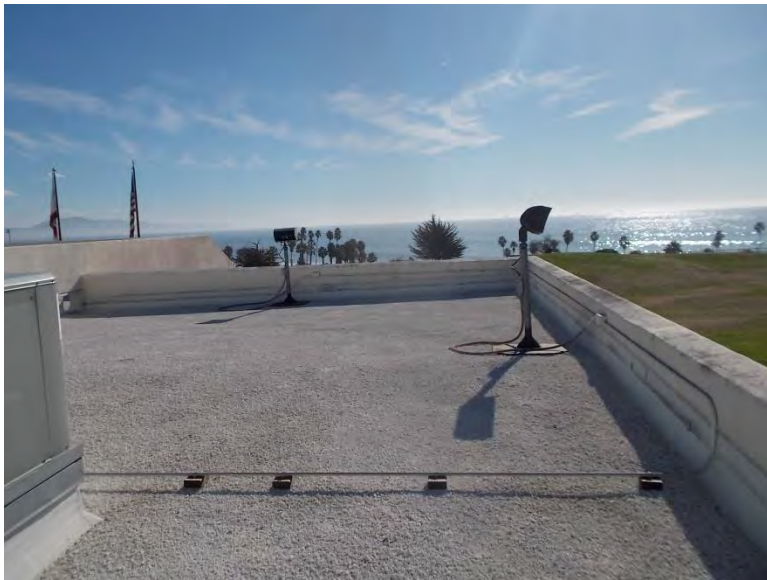
R4. Built-up roof system in good to excellent condition. Flood lights serve to light the walkways and plazas below.

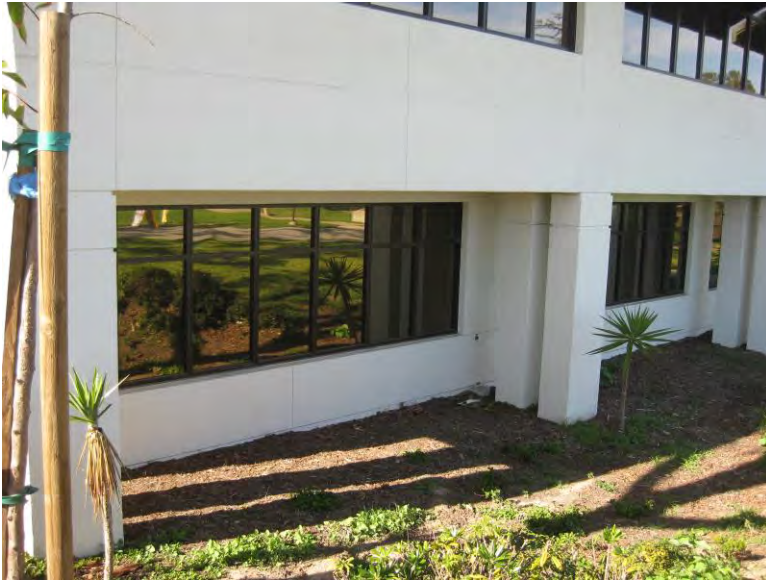
EW1. Exterior windows first level, in good condition.

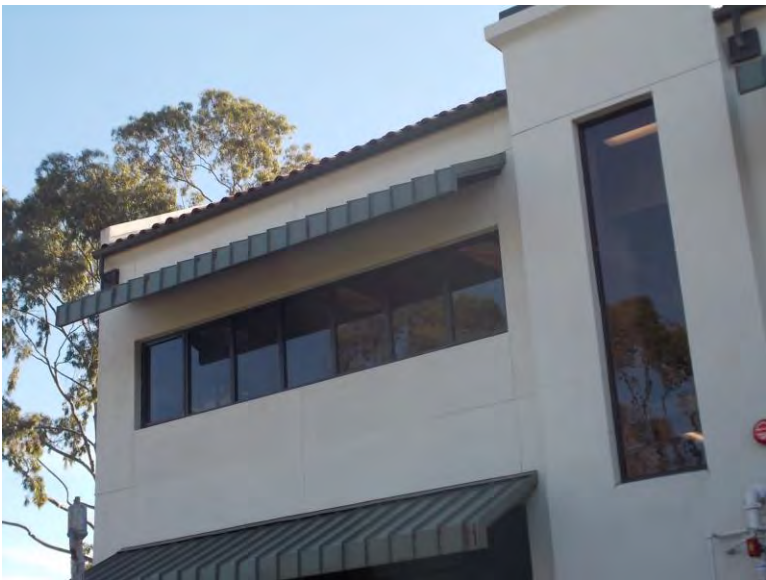
EW2. Exterior upper level windows, in good condition.

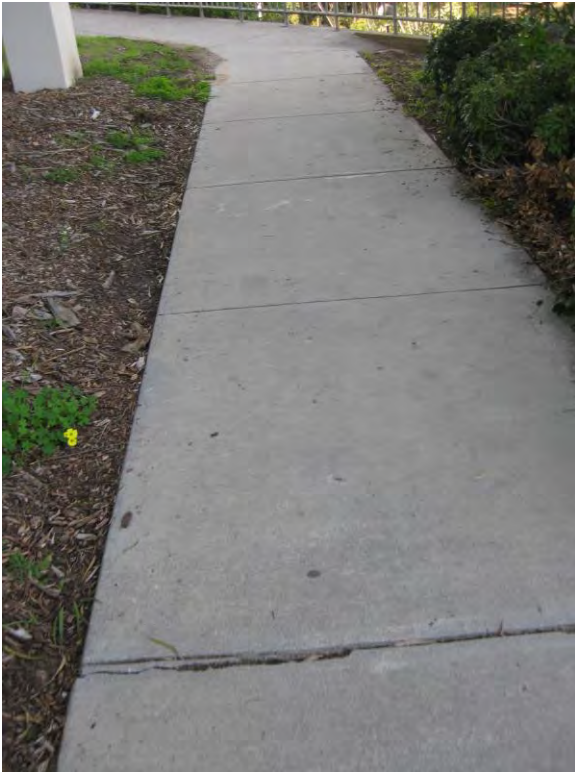
EF1. East side concrete walkway, with large cracks, tripping hazards and excessive cross slope.

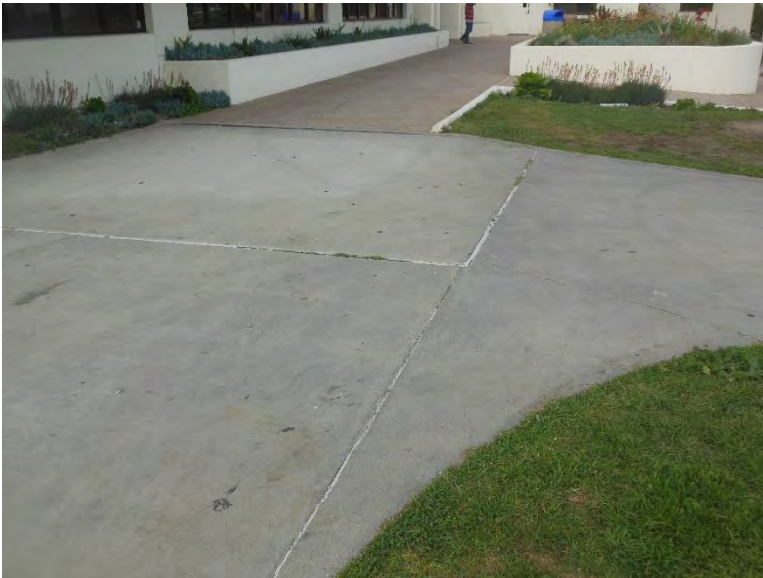
EF2. South side concrete walkway, with excessive longitudinal slope and deteriorated expansion joints.

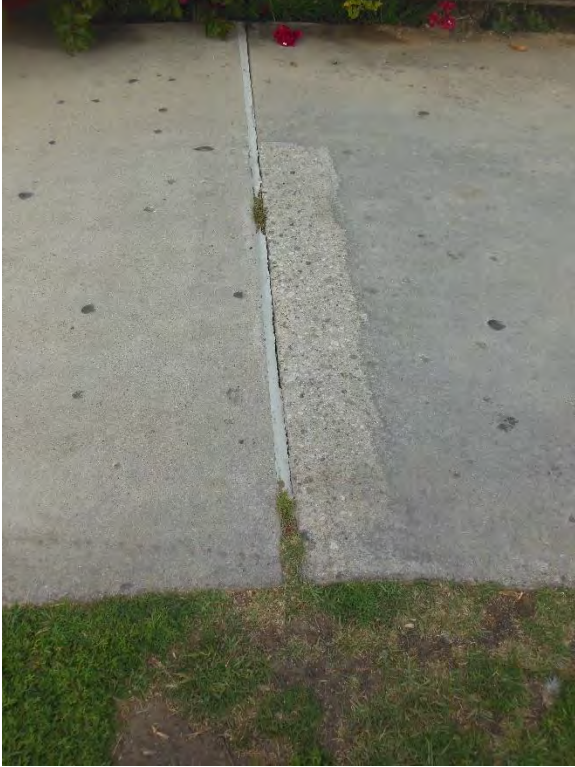
EF3. Concrete walkway, with tripping hazard ground down.

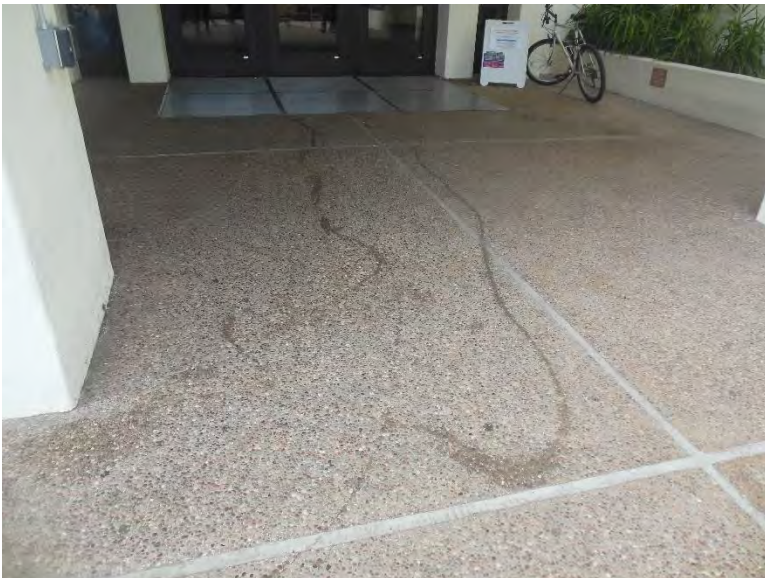
EF4. Main south entrance walkway; stained pebbled finish surface.

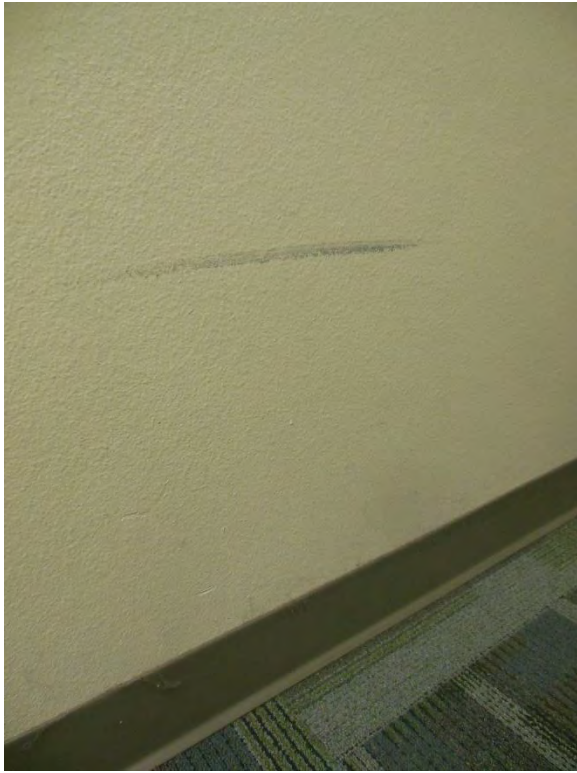
A1. Learning Center interior wall with minor damage.

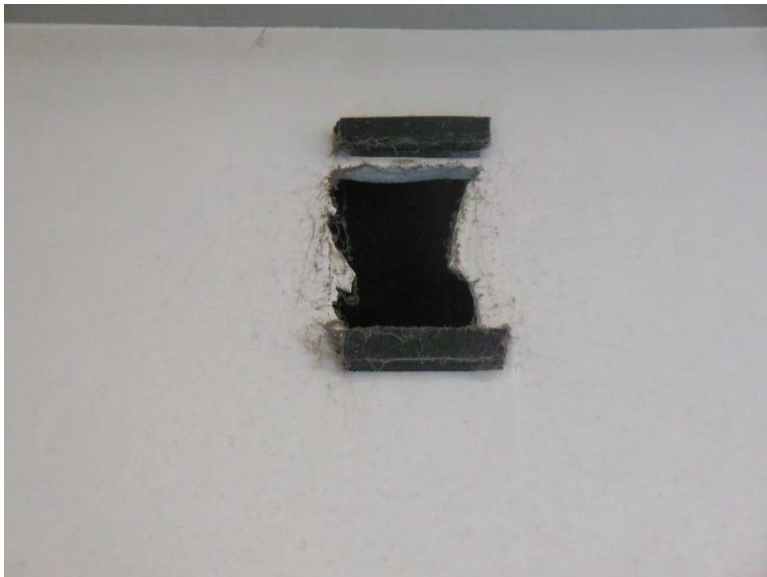
A2. Lobby interior wall with hole.

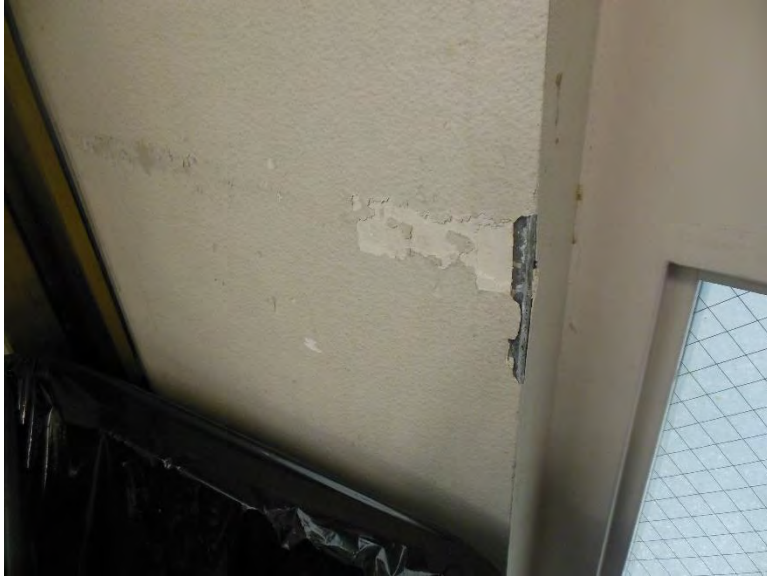
A3. Library vestibule; wall damage.

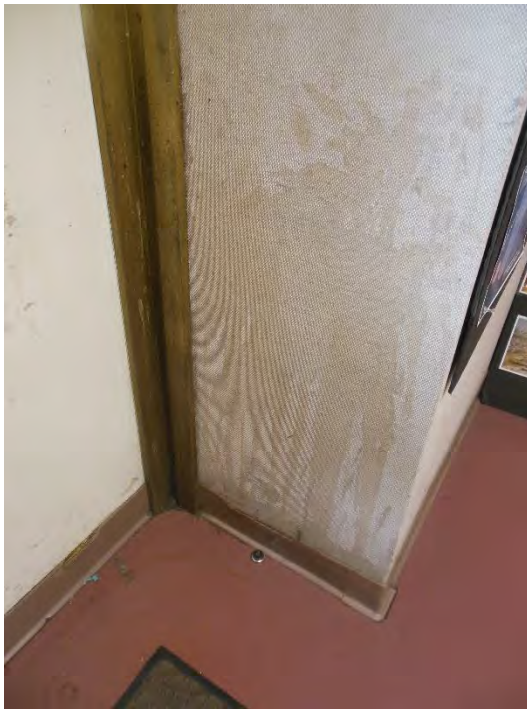
A4. Library vestibule;
fabric wallcovering stained.

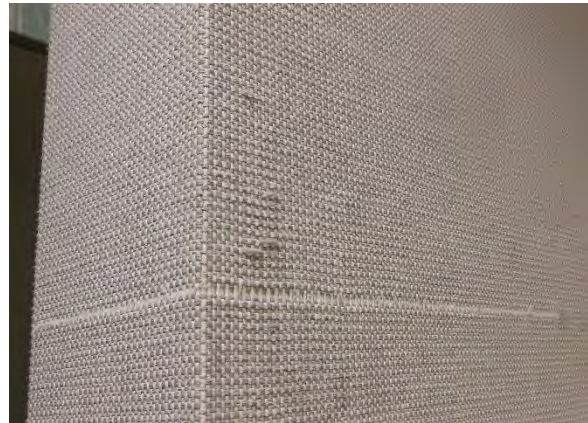
A5. Library upper floor;
fabric wallcovering damaged.

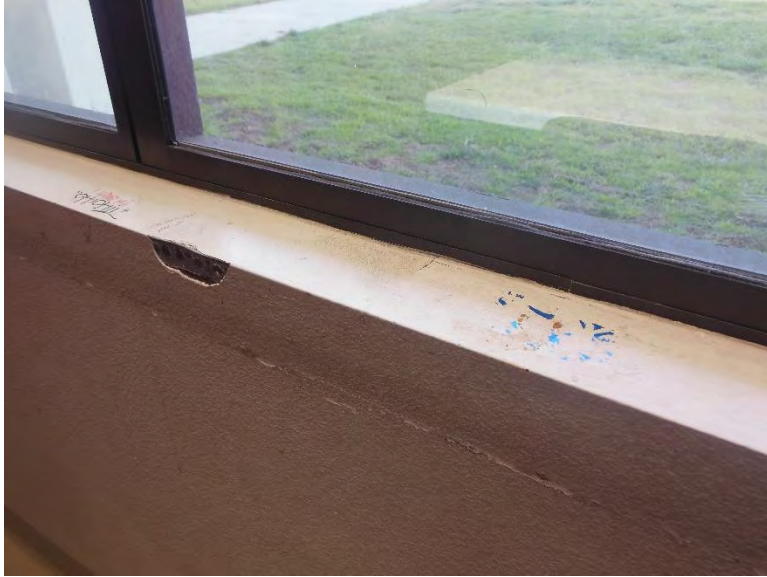
A6. Library south side; lower level window sill vandalism and damage.

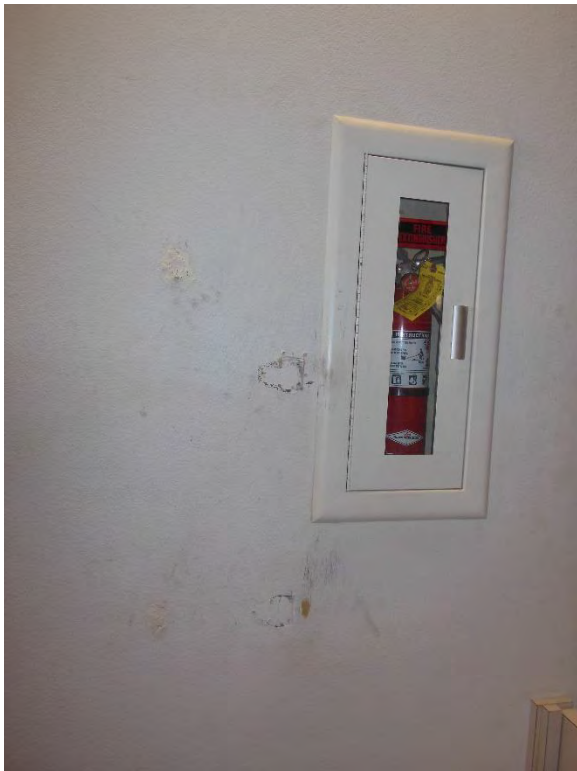
A7. Library lower level; wall damage.

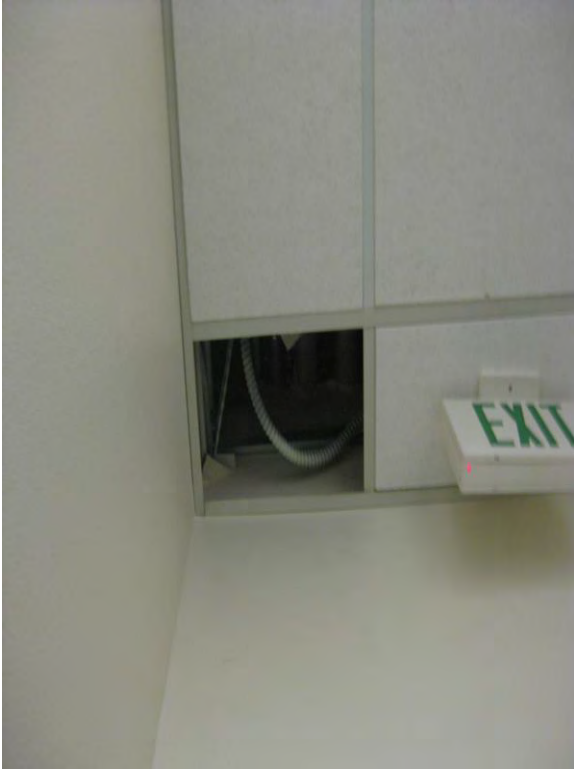
C1. Corridor 112B; missing ceiling tile.
