Appendices

Appendix A:
ADA Path of Travel Assessment Diagrams

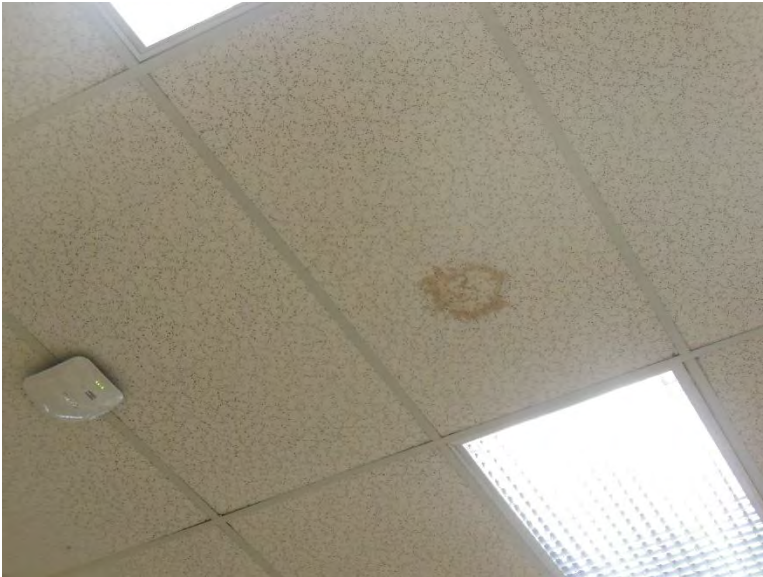
C2. Library second floor; stained ceiling tile.

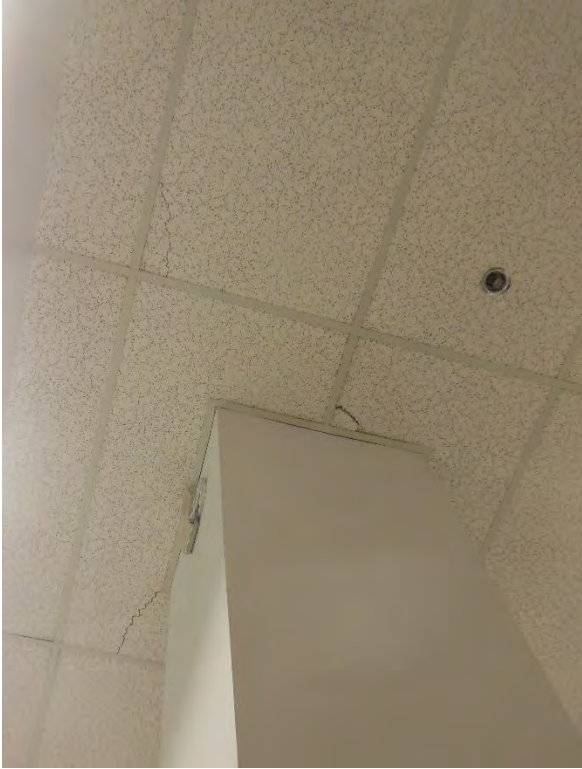
C3. Library upper floor; broken/damaged ceiling tiles.

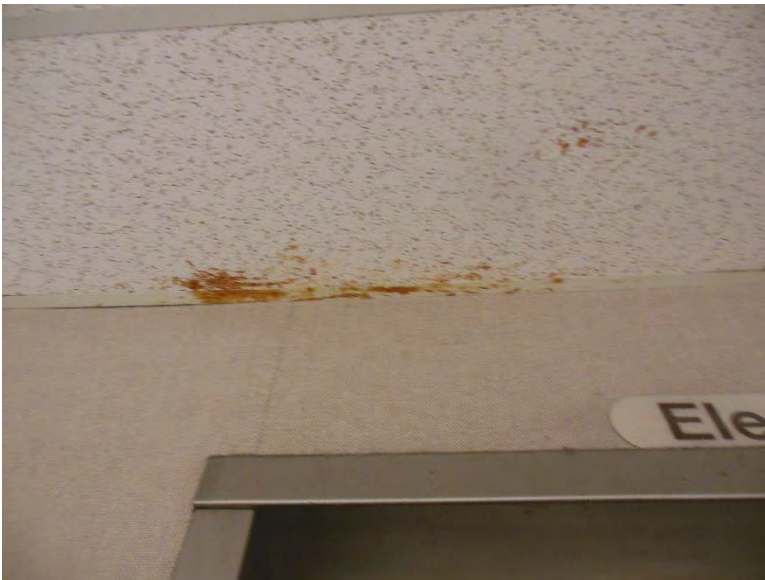
C4. Library upper floor; stained ceiling tiles at elevator.

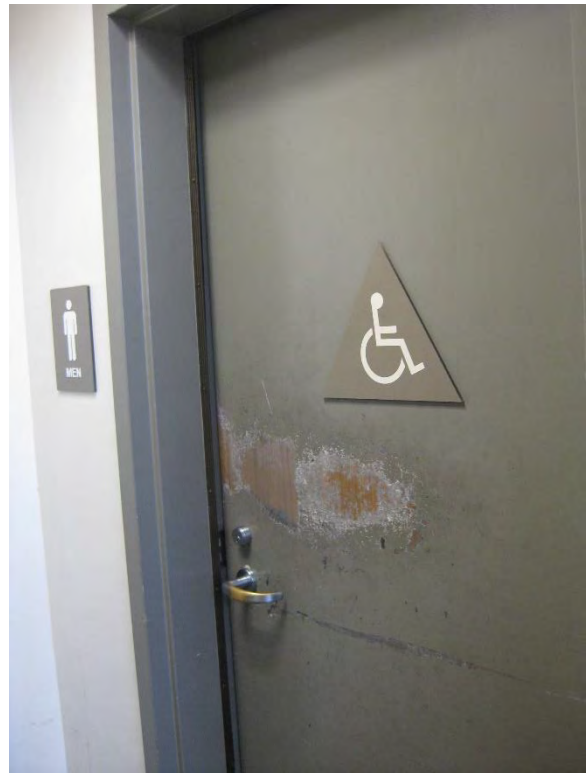
D2. Lobby Men's Restroom; damaged paint, and non-compliant door signage.

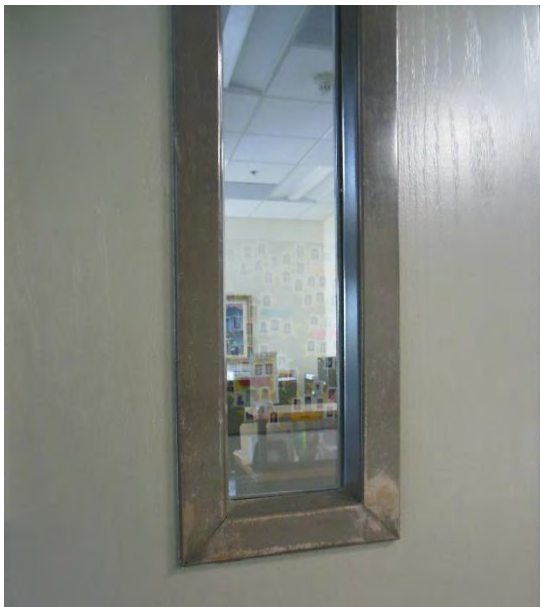
D3. Office 121; damaged frame at door lite.

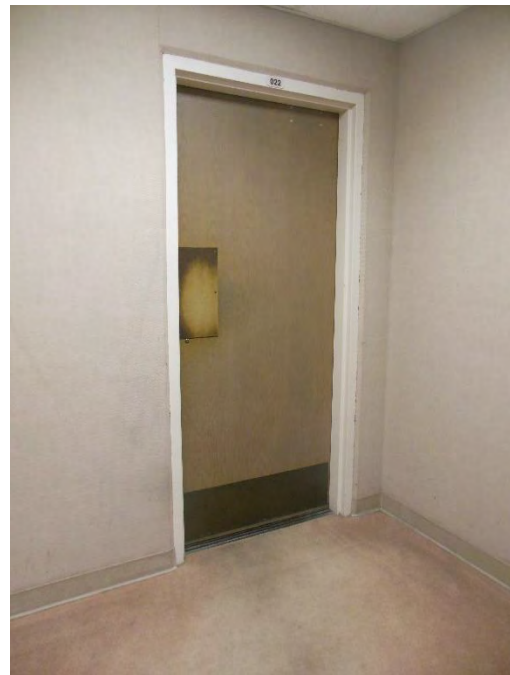
D4. Men's Restroom, 2nd floor; door and wall ADA signage not provided.

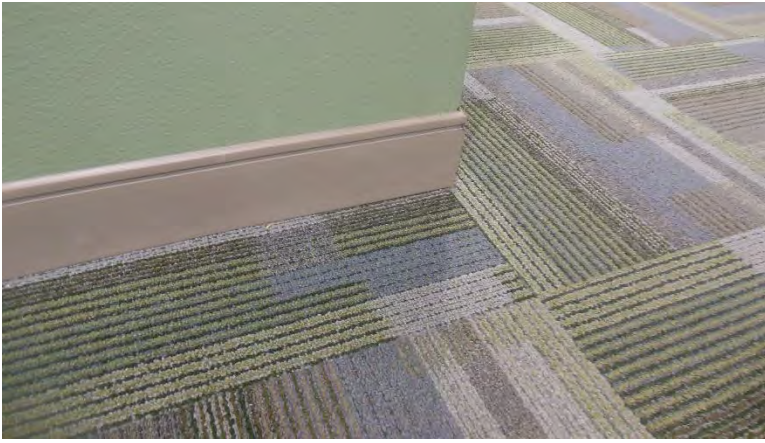
IF1. Learning Center carpet tile and wood base in excellent condition.

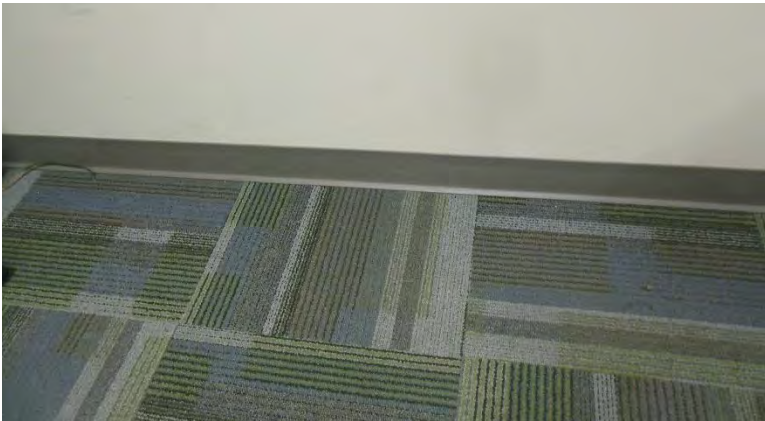
IF2. Learning Center carpet tile and rubber base in excellent condition.

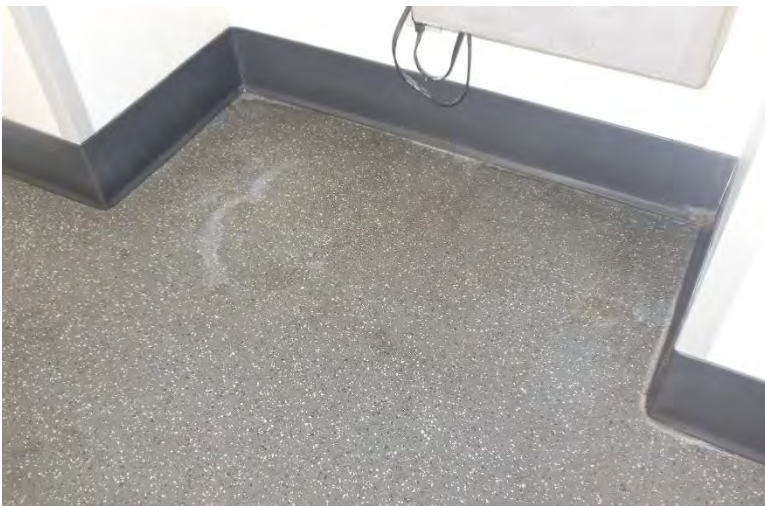
IF3. Lobby rubber tile and rubber base with water damage at drinking fountains.

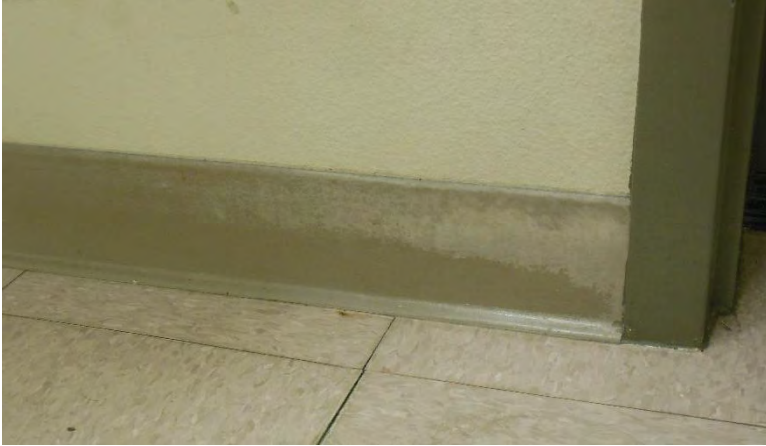
IF4. Corridor 112; original VCT and rubber base in poor condition.

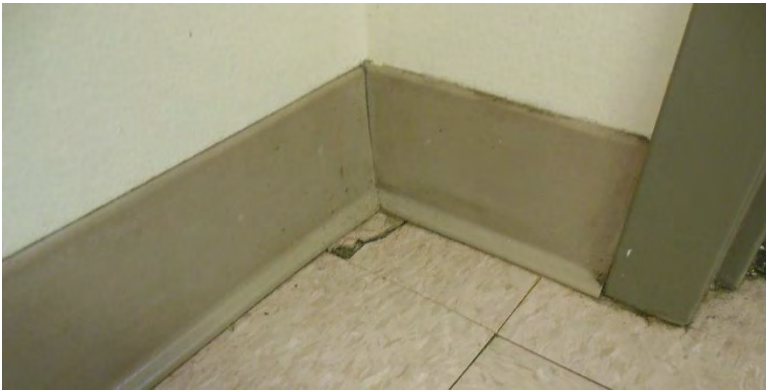
IF5. Corridor 112; original VCT and rubber base in poor condition.

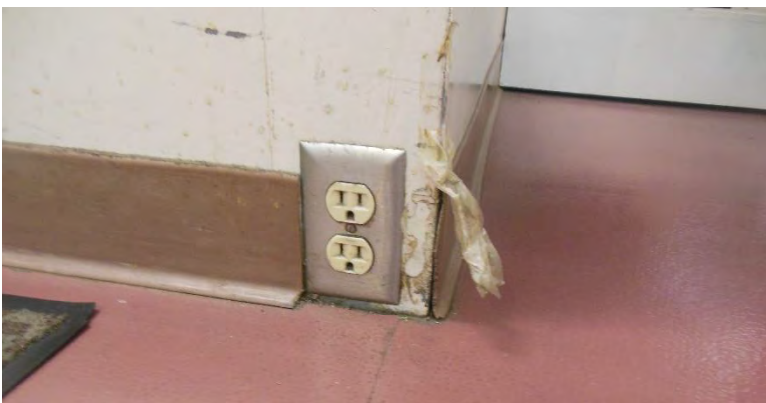
IF6. Library vestibule; resilient base in very poor condition.

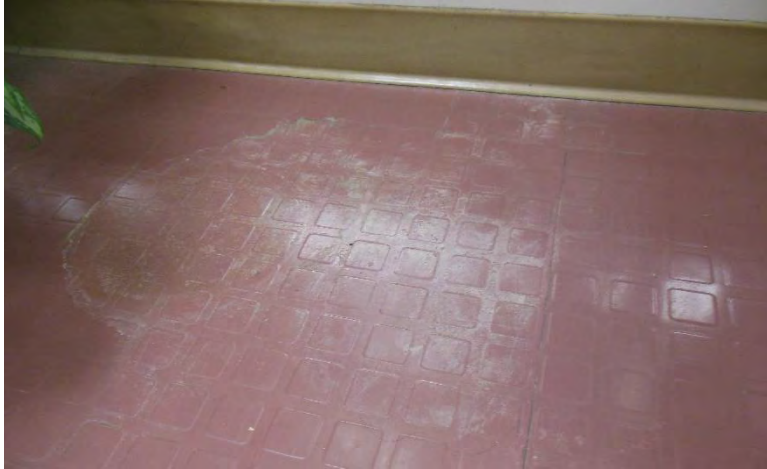
IF7. Library vestibule; rubber floor in very poor condition.

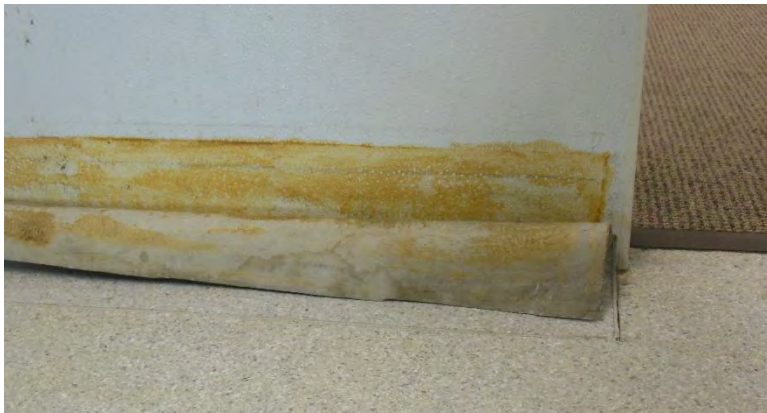
IF8. Library Café, upper floor; resilient cove base in very poor and unsanitary condition.

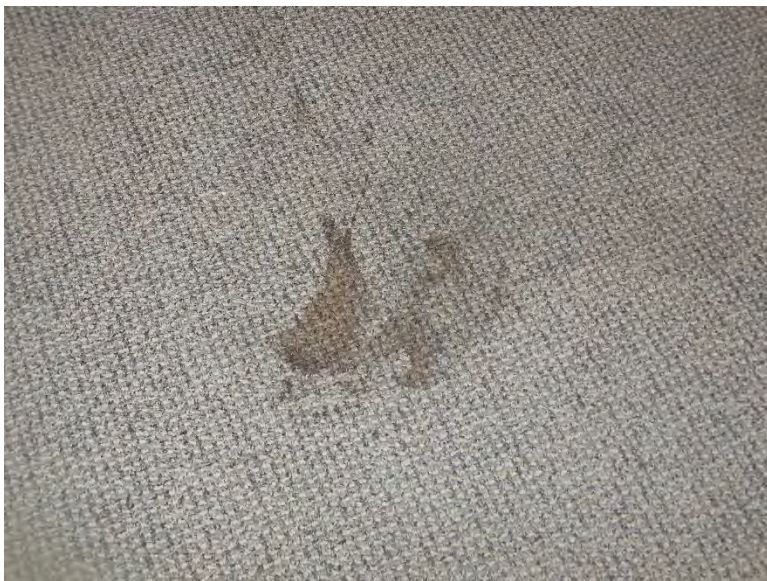
IF8. Library; broadloom carpet with stains throughout, typical.

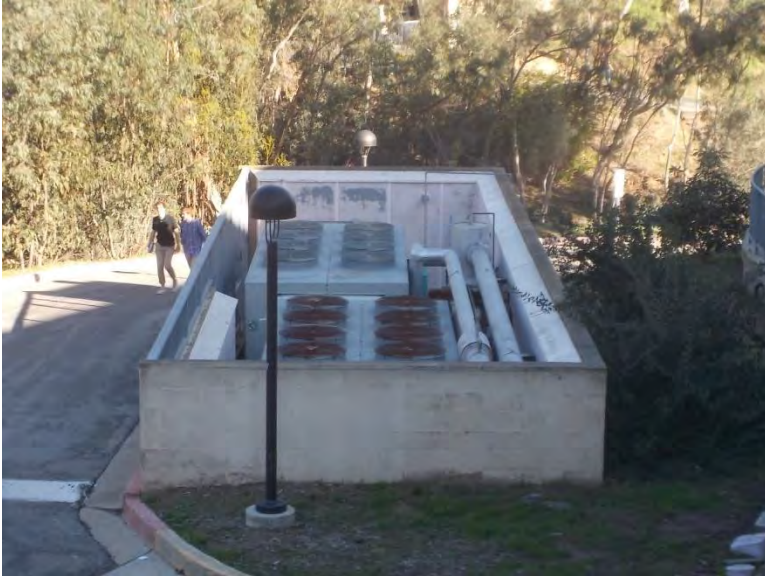
M1. Chiller enclosure. One unit is in use and in good condition.

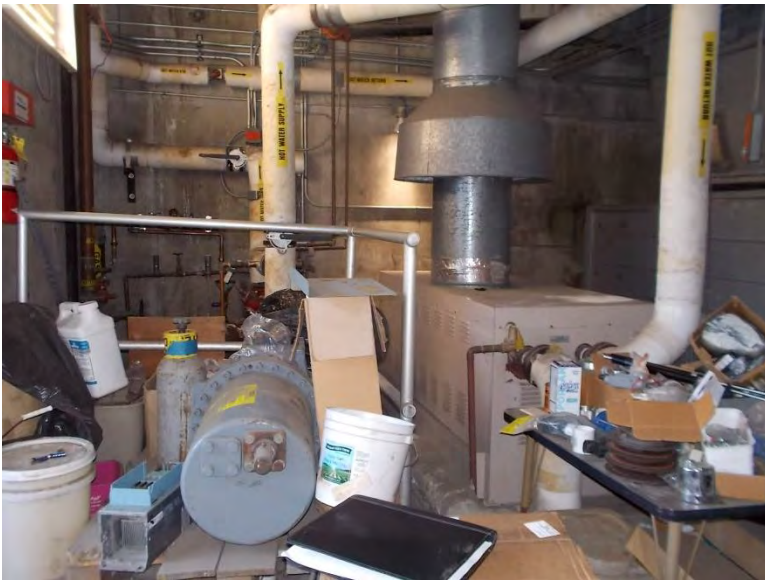
M2. Mechanical equipment blocked by debris.

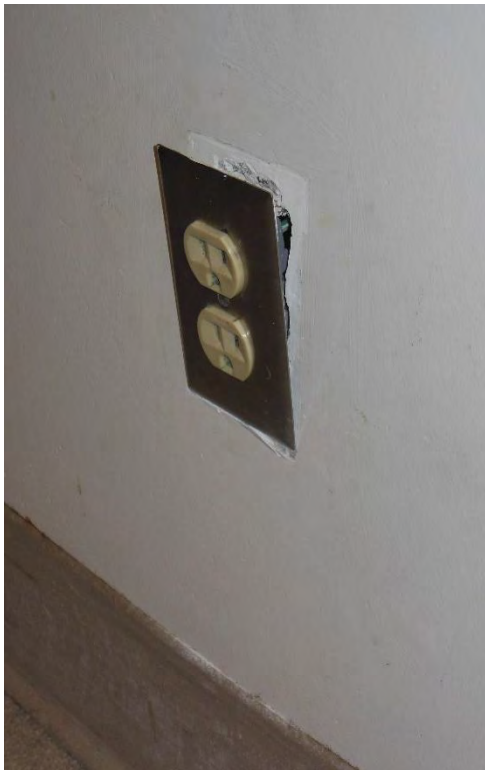
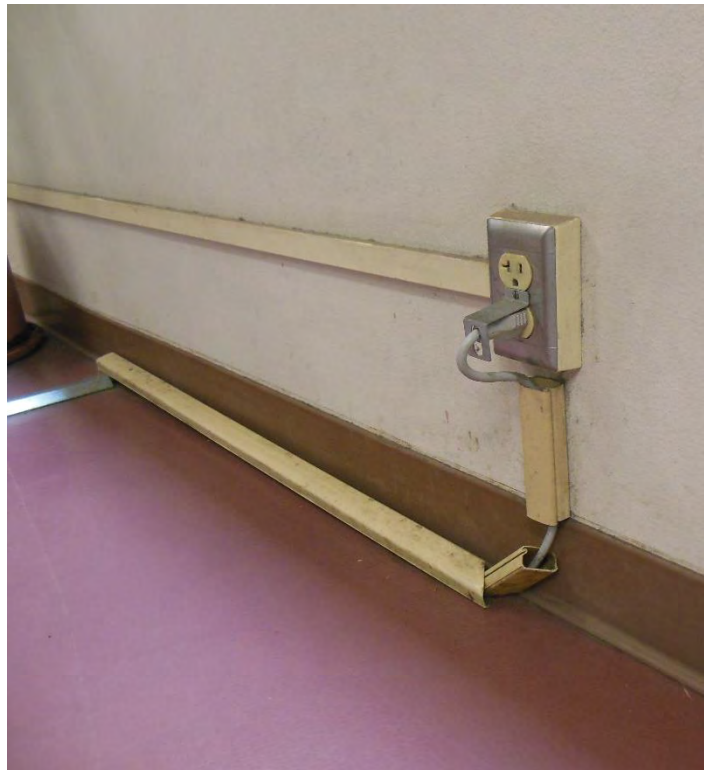
E5. Library, first floor; electrical duplex outlets, poor condition/installation.

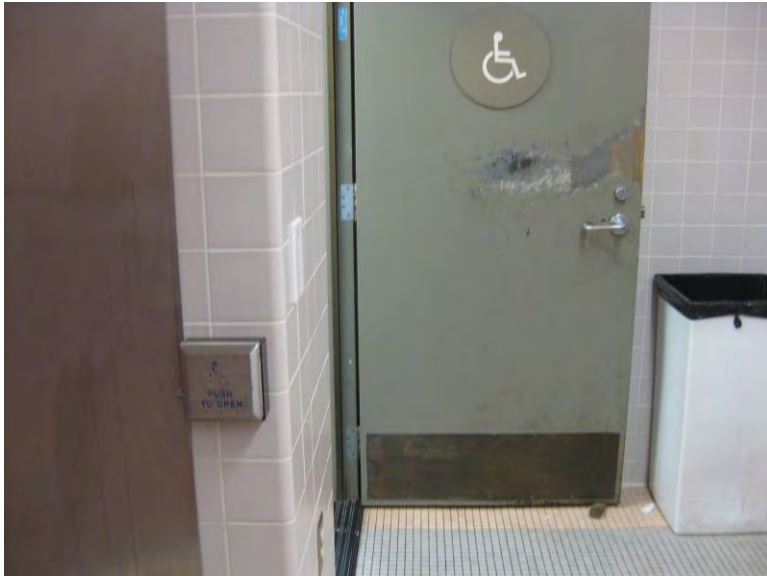
RR1. Women's Lobby restroom. Door finish repair required. Low level access button for electronic door operator is required by code, and ADA door signage is non-compliant.

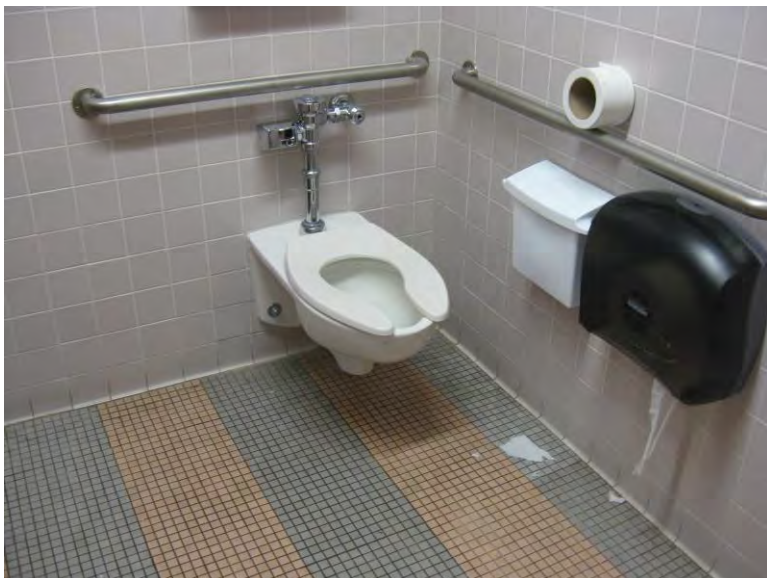
RR2. Women's Lobby Restroom. Dispenser and disposal units protrude into required clear space below handrail.

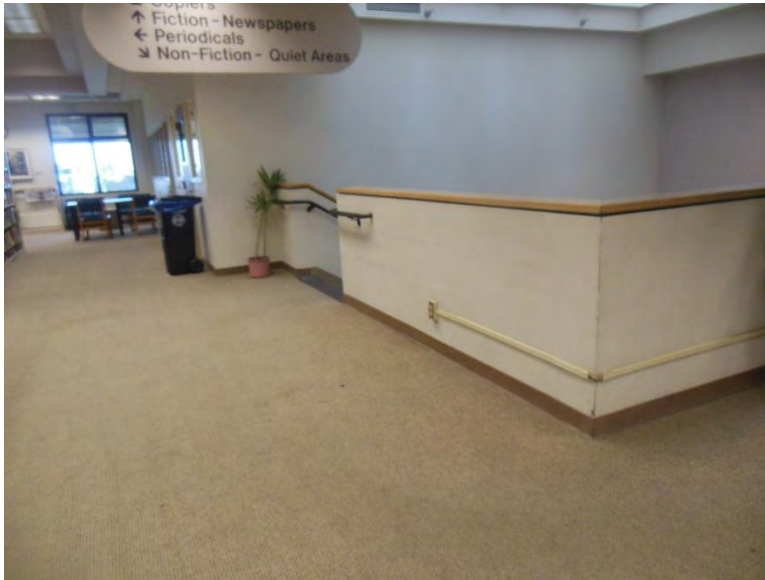
ST1. Library main interior staircase; ADA signage missing.

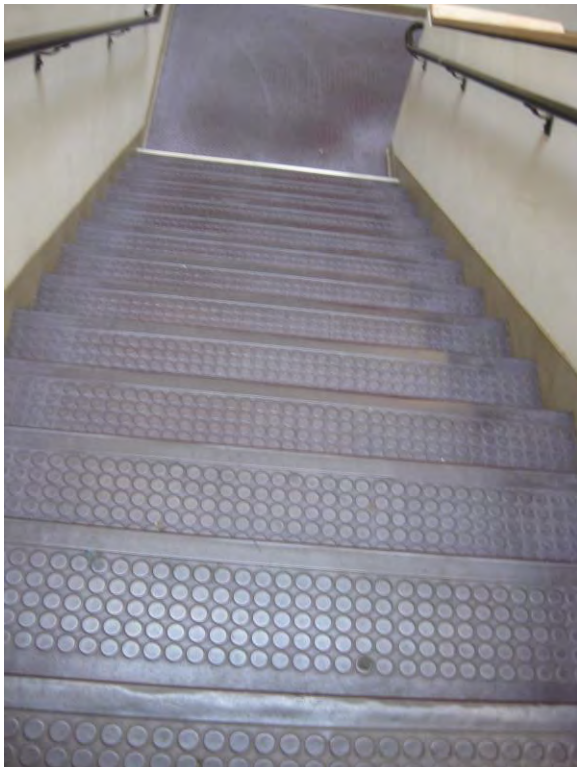
ST2. Library interior stairs; upper and lower visual warning stripes missing at stair nosings. Rubber treads worn and damaged.

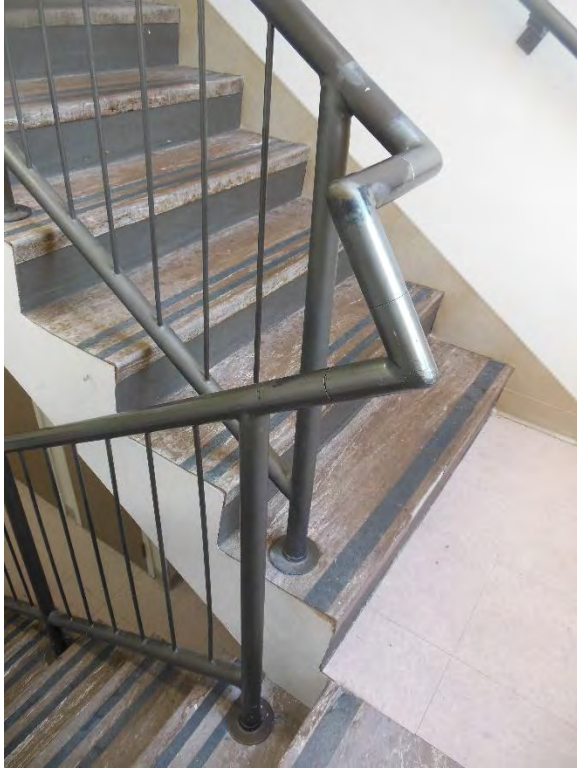
ST3. Stairwell 136; non-compliant handrail heights and returns.

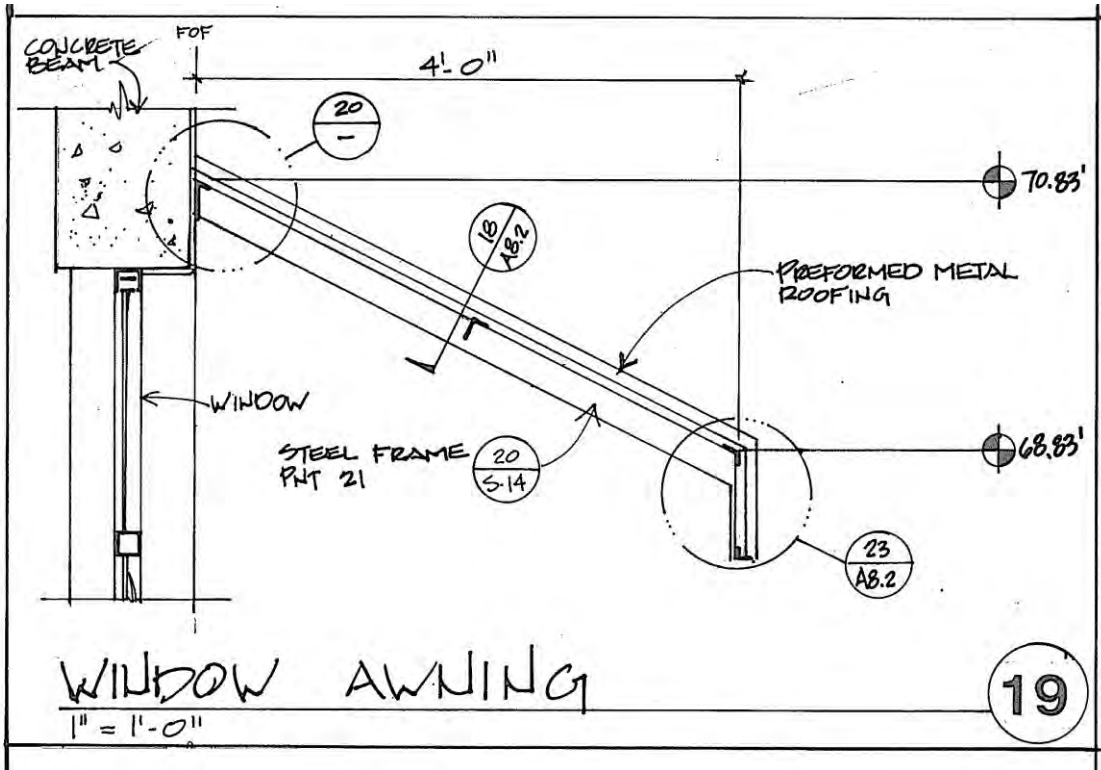
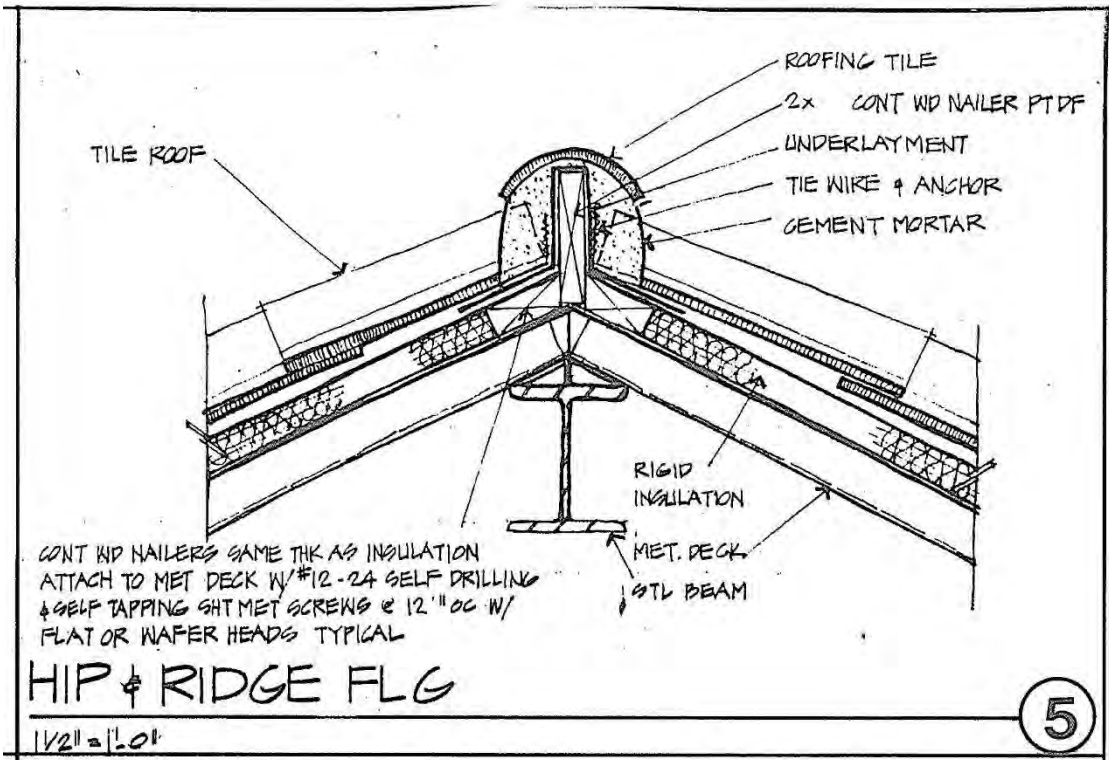
Facility Condition Assessment Report STUDENT SERVICES

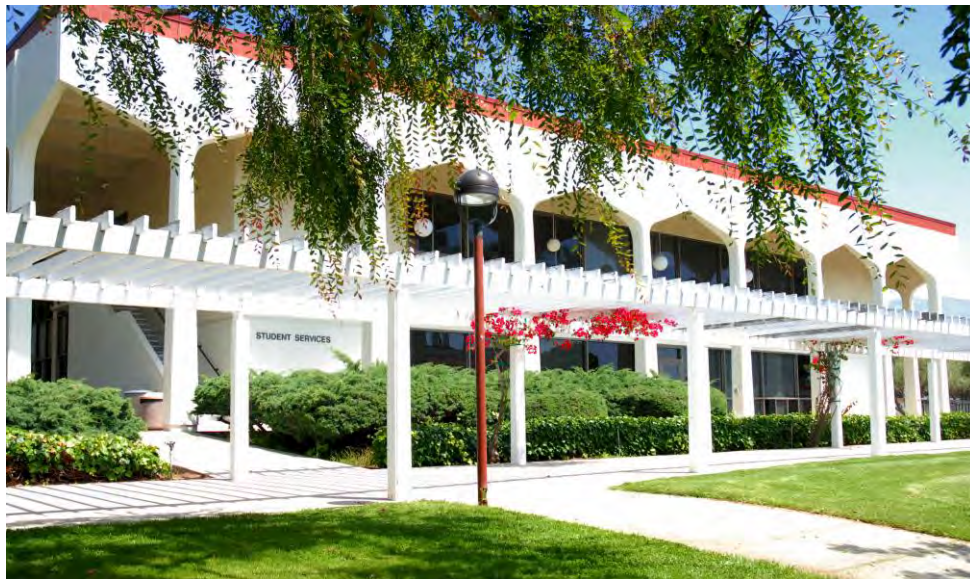
Prepared by
RJC Inc.

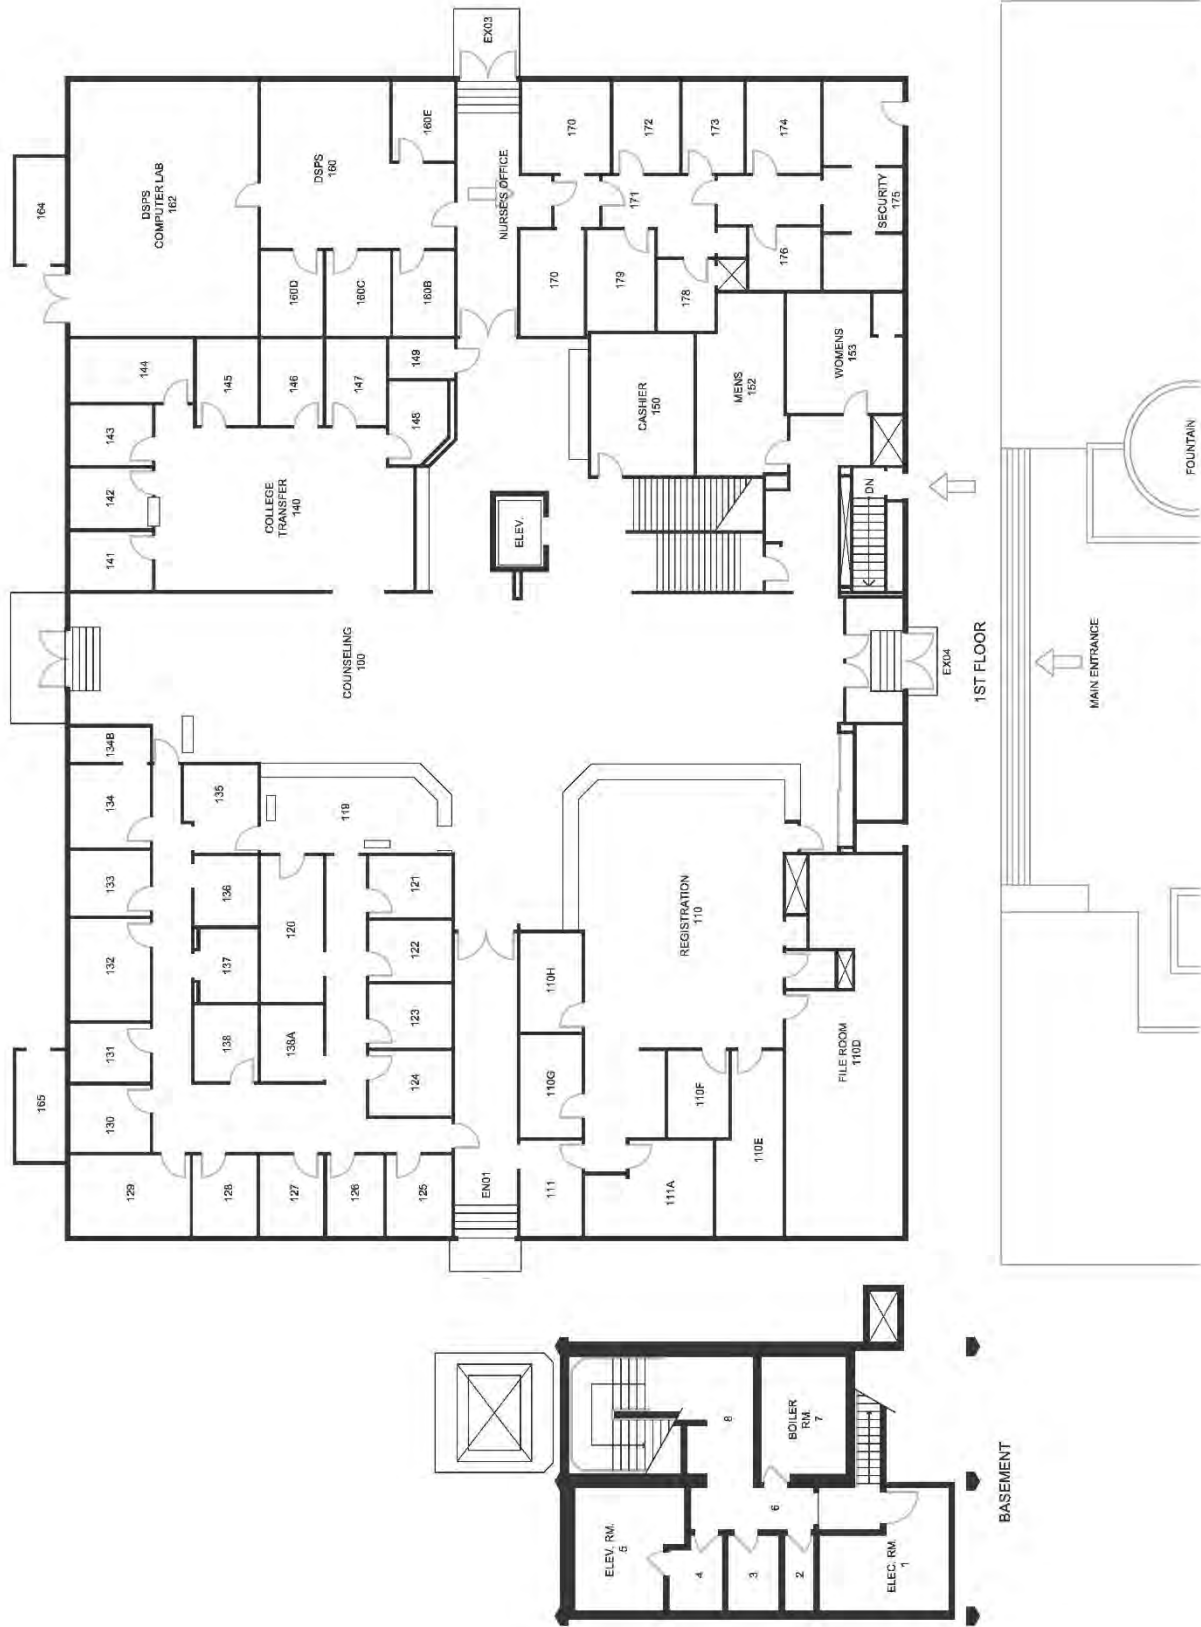
STUDENT SERVICES 1ST FLOOR PLAN / BASEMENT PLAN
NO SCALE

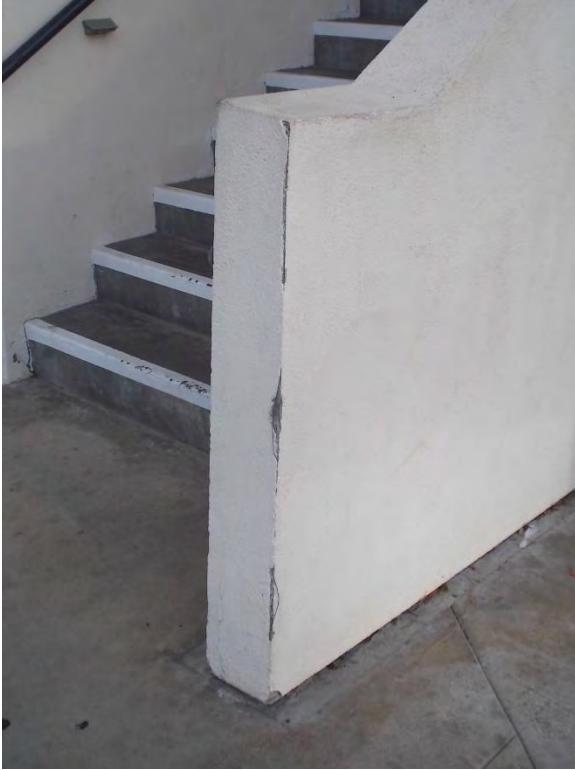
AE3. Exterior half wall; damaged plaster and paint.at corner condition.

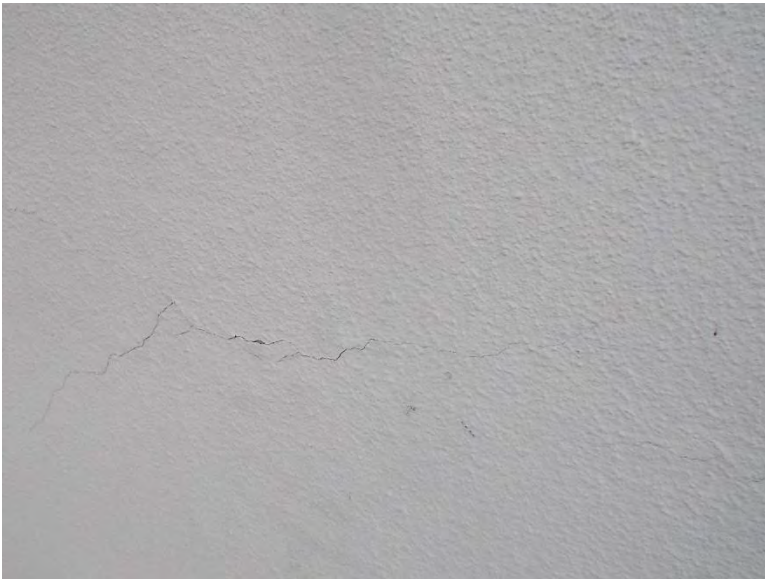
AE4. Exterior wall; cracked plaster finish.

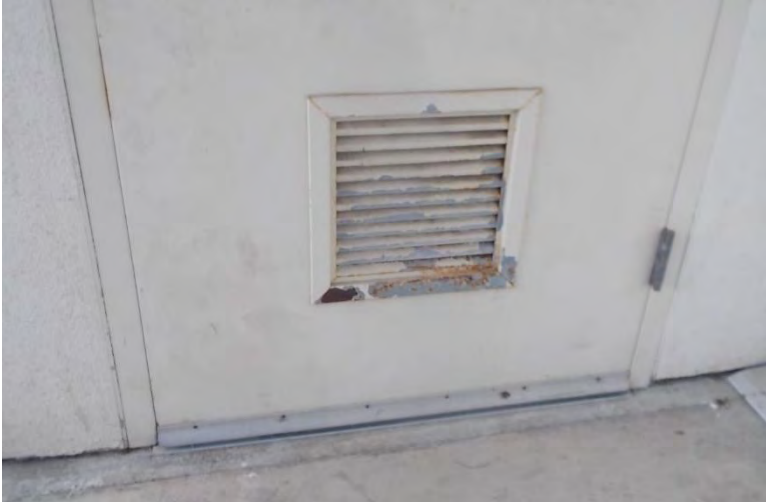
D5. Storage 164 door; damaged louver.

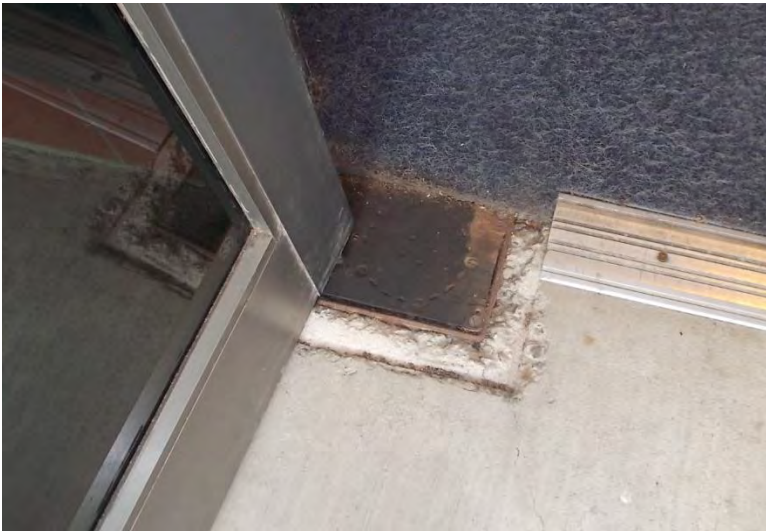
D6. West side entrance; door floor operator with exposed concrete.

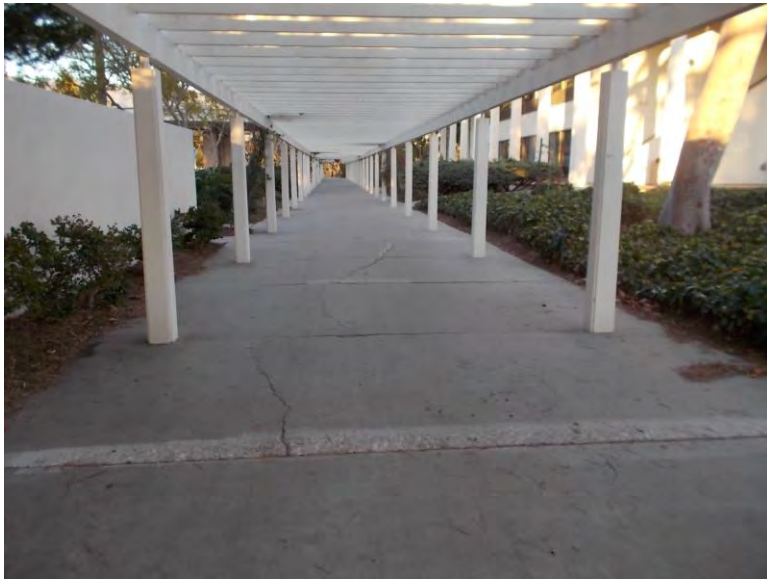
EF2. Exterior walkway; cracked concrete, excessive slopes, and abrupt changes in level. End of walkway terminates into fire truck lane.

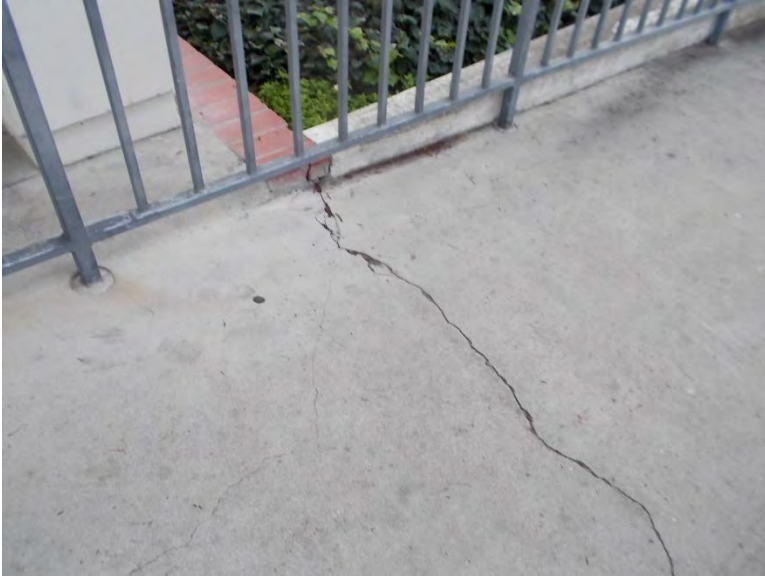
EF3. Northeast exterior walkway at top of ramp; cracked concrete.

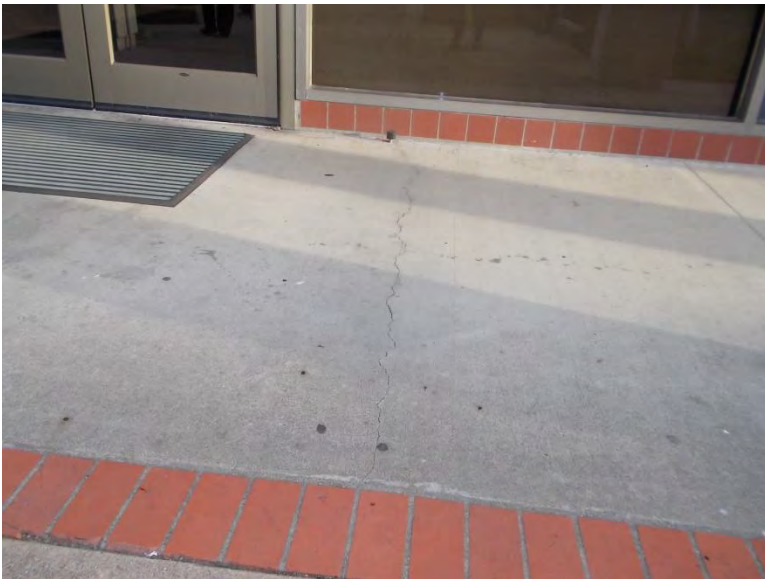
EF4. North side entrance; cracked concrete walkway.

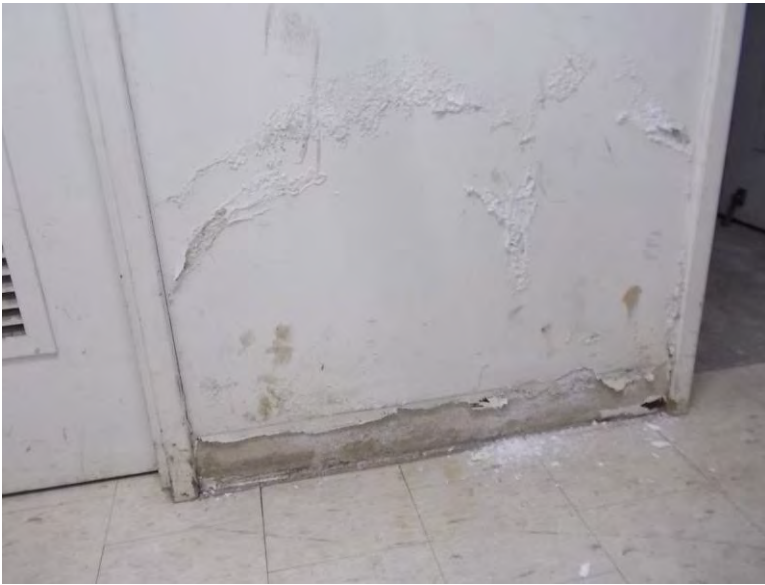
AI1. Basement; interior drywall and base damage.

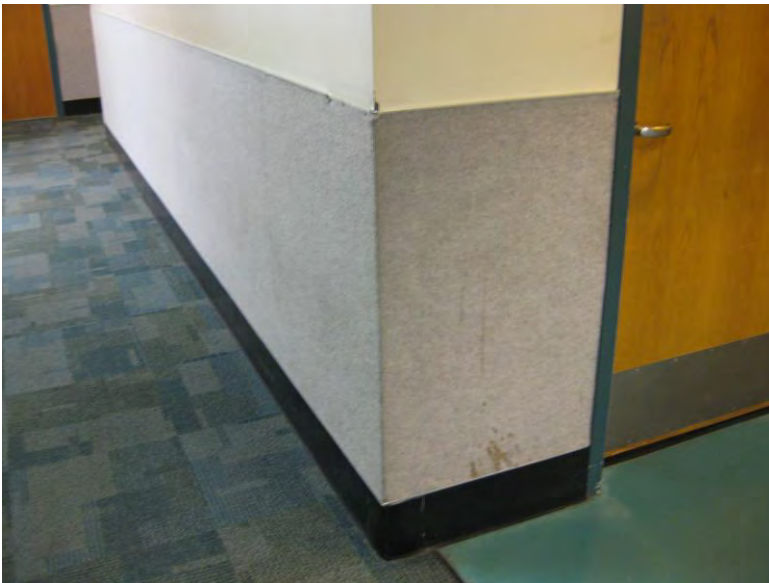
AI2. Second floor corridor; fabric covered wainscot stains and corner damage.

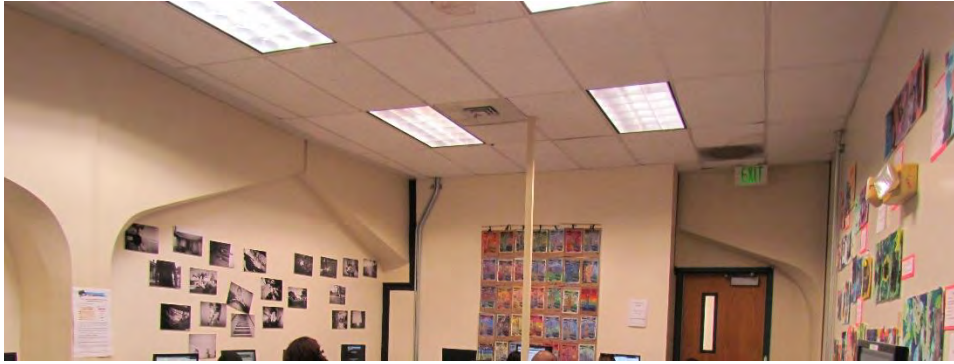
A13. Second floor Atrium infill space; awkward wall transitions.

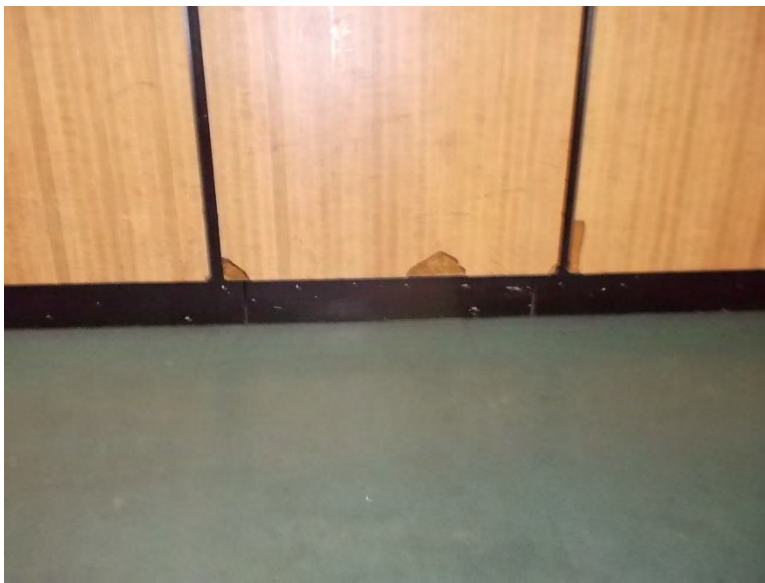
A14. Elevator cab interior; damaged wall panels.

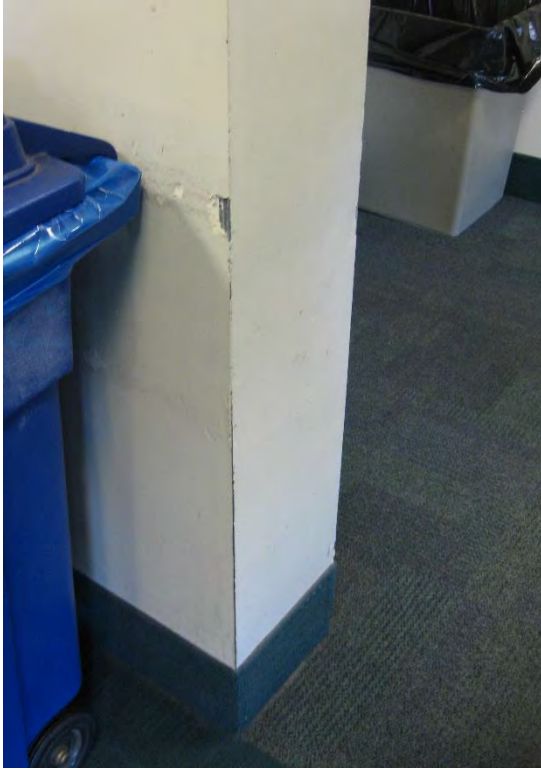
A15. Wing wall damaged corner.

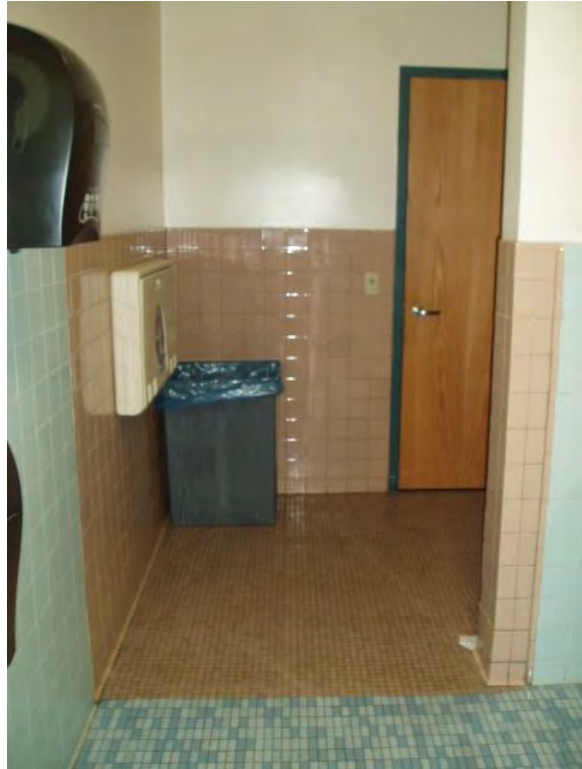
A16. Restroom wall tile mismatched.

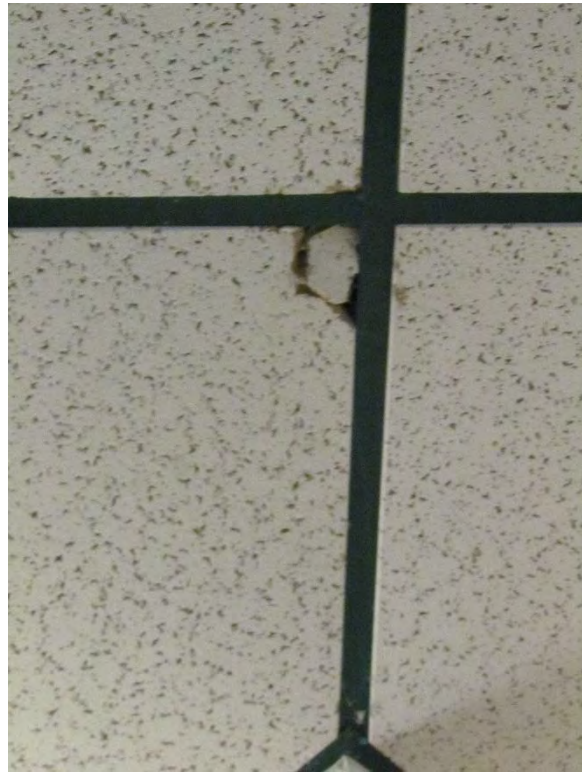
C2. Second floor; ceiling tile damaged.

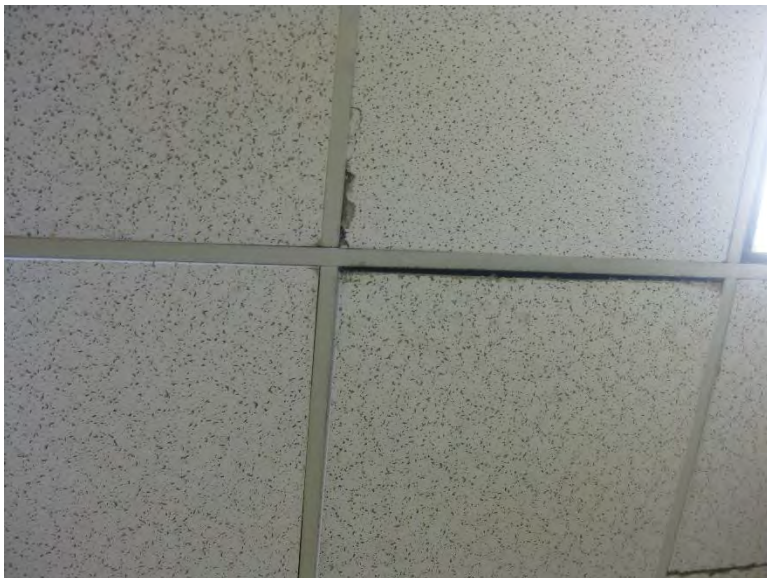
C3. Suspended ceiling tile; damaged.

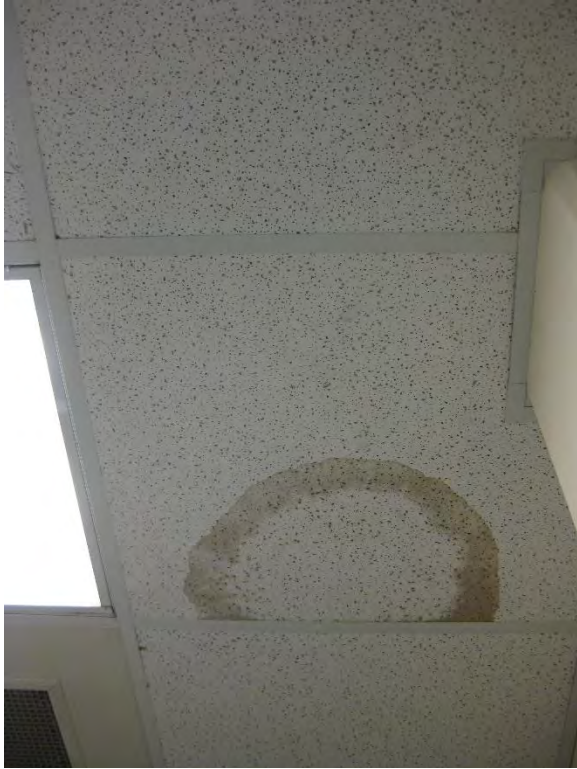
C4. Suspended ceiling tile; stained.

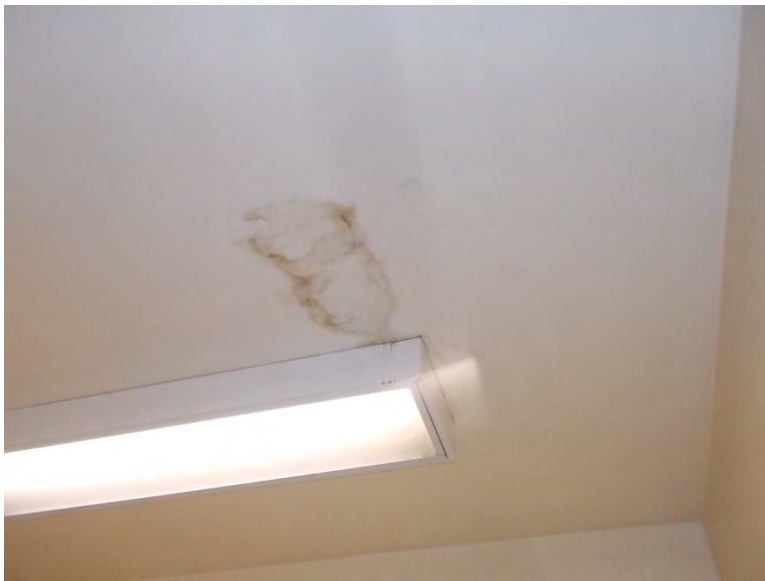
C5. Second floor Women's Restroom; gypsum board ceiling stained.

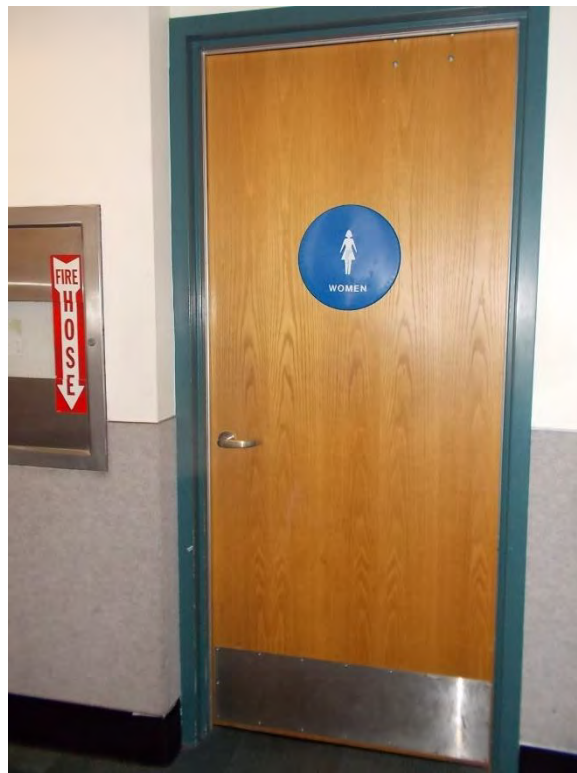
D5. Second floor restroom; push-side clearance not met, wall signage missing.

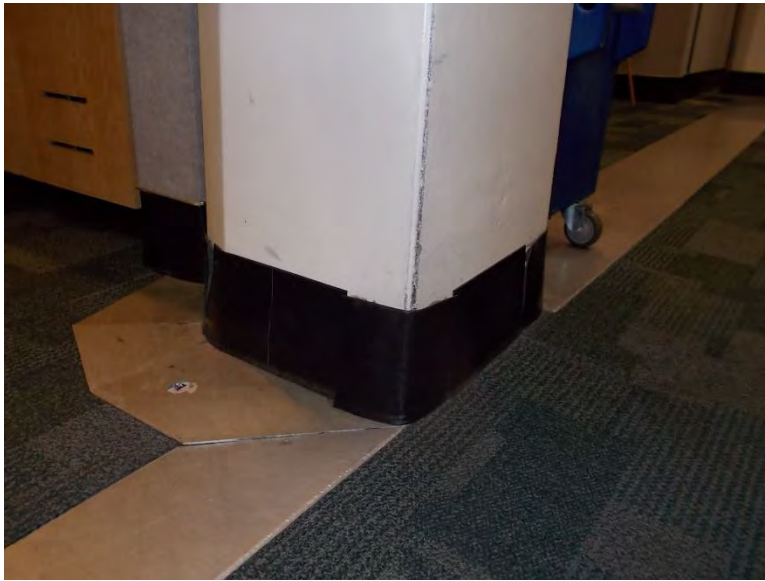
IF1. Second floor Atrium infill space; building expansion joint cover lifted, and rubber base damaged.

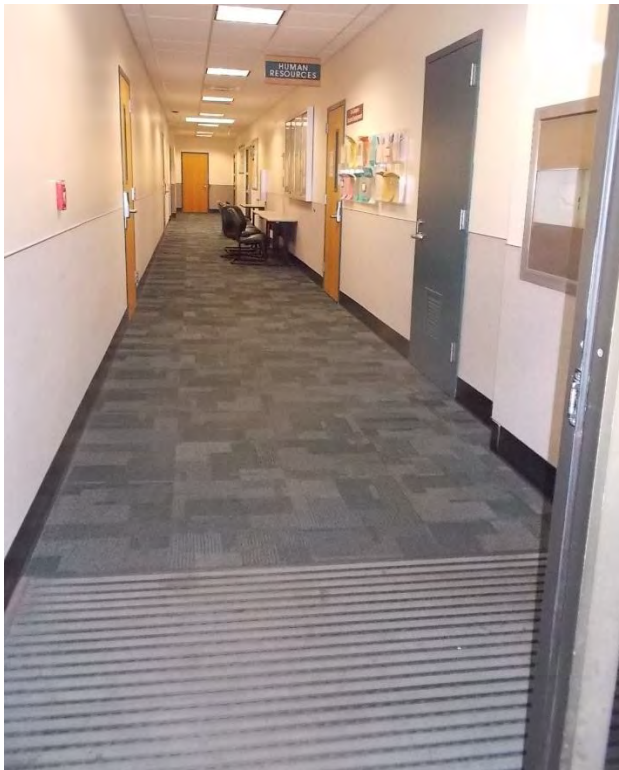
IF2. Second floor corridor; carpet tile, walk-off mat and rubber base in good condition.
