Appendices

Appendix A:
ADA Path of Travel Assessment Diagrams

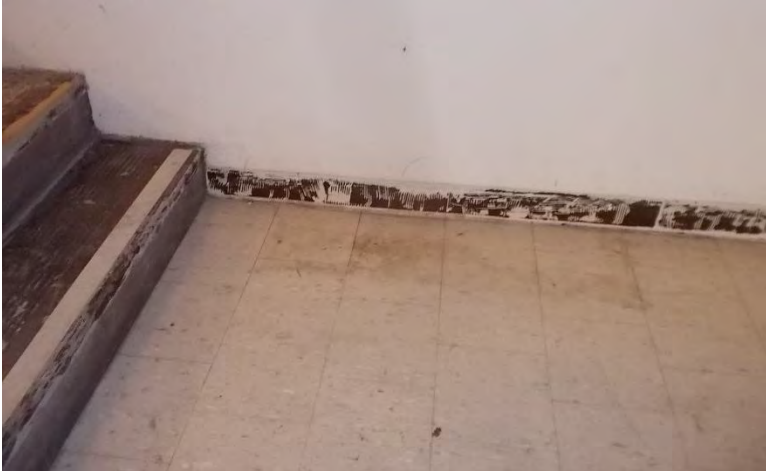
IF3. Basement; base damage at wall and stair riser.

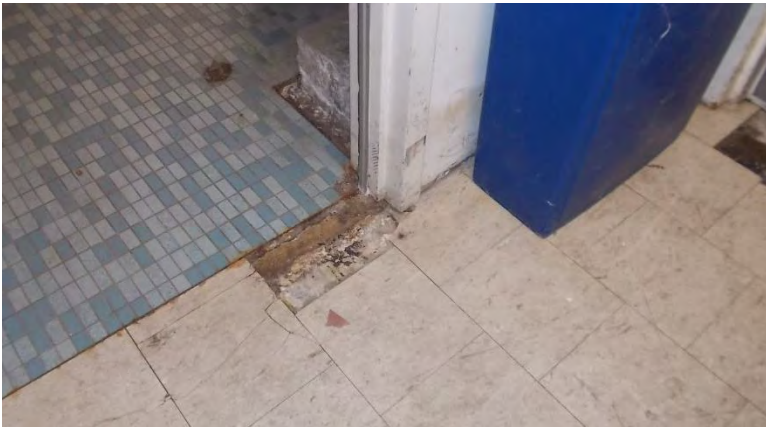
IF4. Basement; 9x9 VAT flooring damage.

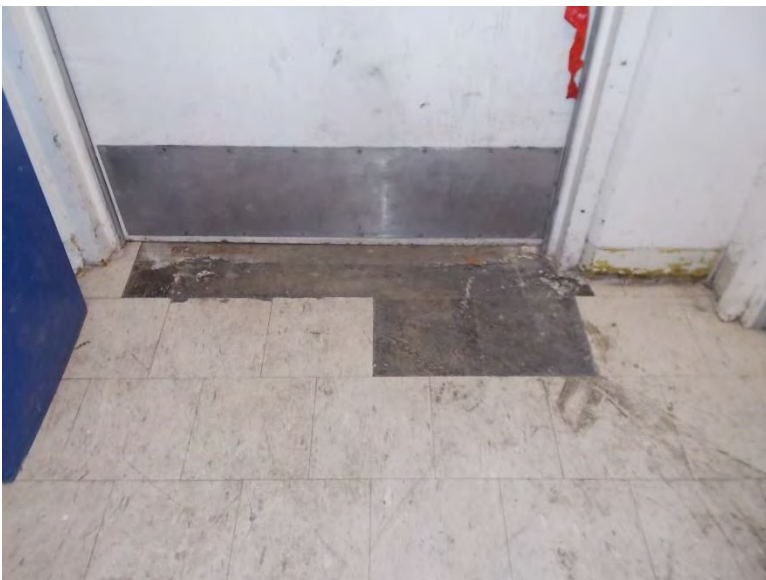
IF5. Basement; 9x9 VAT flooring damage.

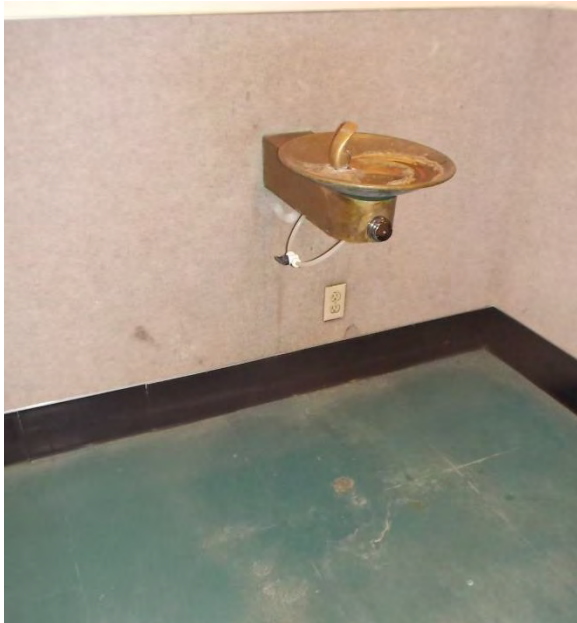
DF1. First floor single drinking fountain; hi-low drinking fountain not provided and flooring damaged.

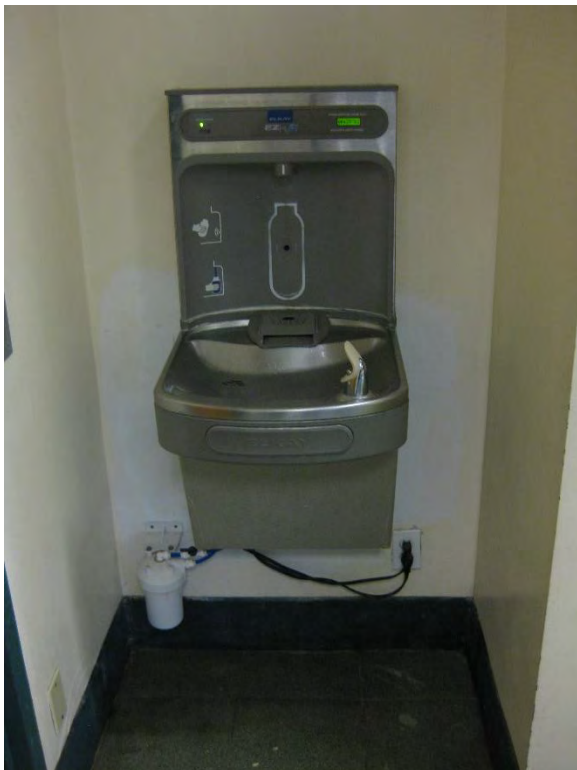
DF2. Bottle filling station/drinking fountain. Compliant maneuvering clearances not provided.

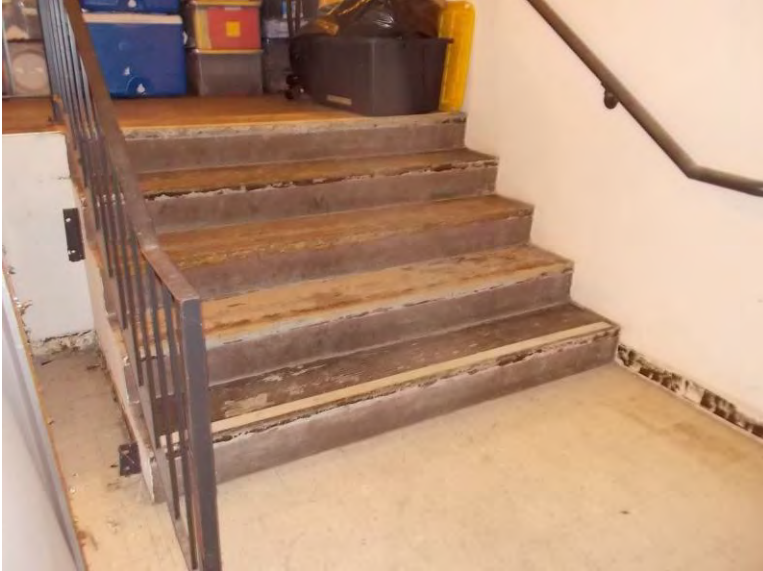
S1. Basement stairs; severely damaged materials, and non-compliant handrails.

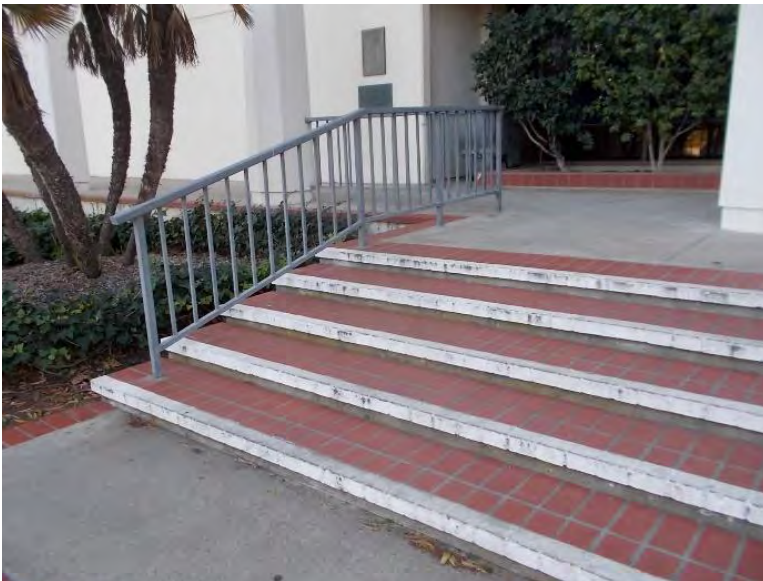
S2. Exterior east stairs; lower handrail extensions are non-existent, gripping surface is too wide, the top and bottom landings have excessive slope and are not level.

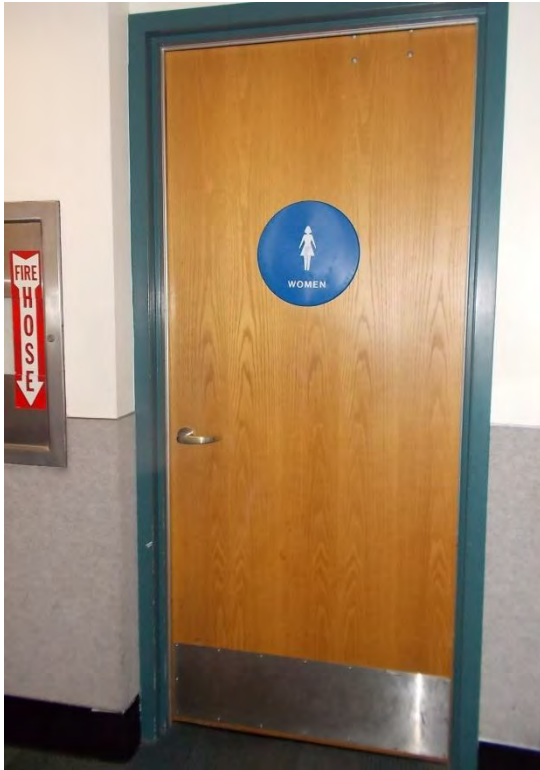
S1. Women's Restroom entrance; wall mounted room ID sign missing.

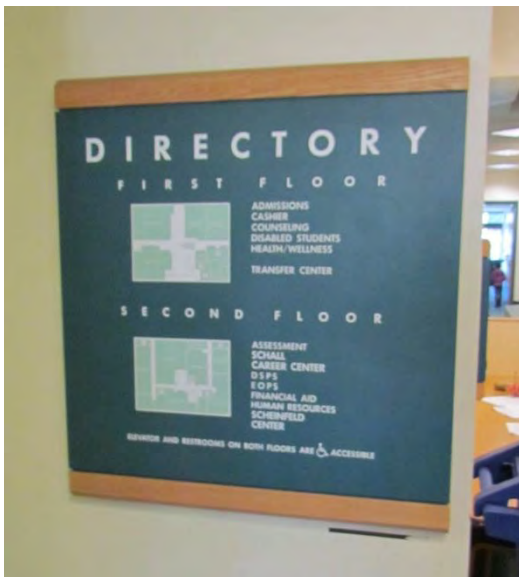
S2. Directory sign; no evacuation or other way finding signs are in the facility.

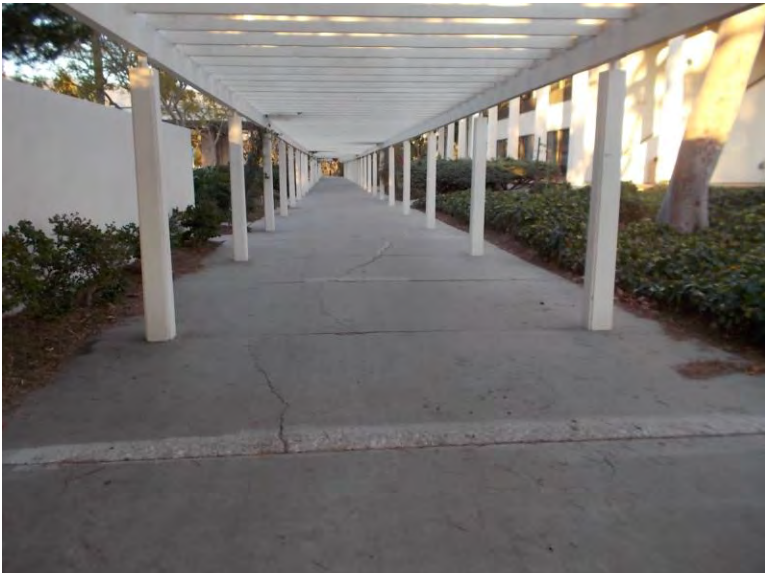
PT2. Exterior walkway Pergola; non-compliant path of travel. Concrete surface is cracked, uneven and has excessive cross slopes. ADA directional signage is not provided.

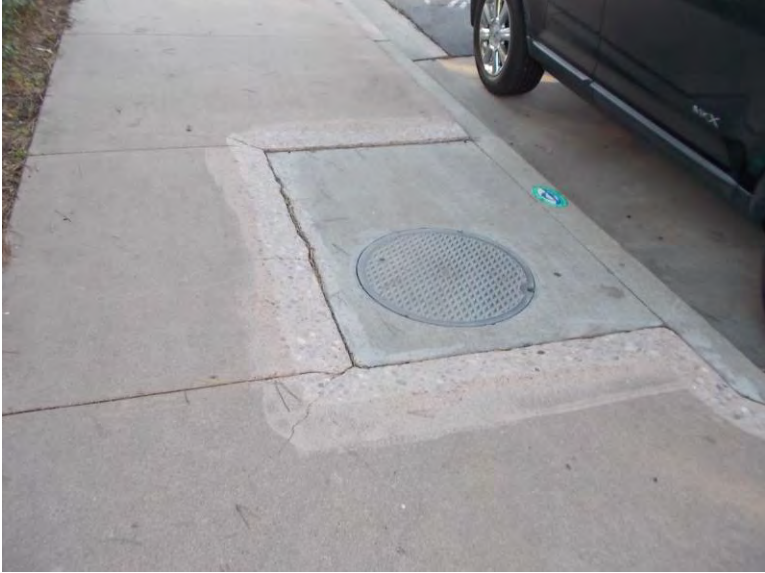
PT3. Exterior sidewalk; non-compliant path of travel. Abrupt changes in level.

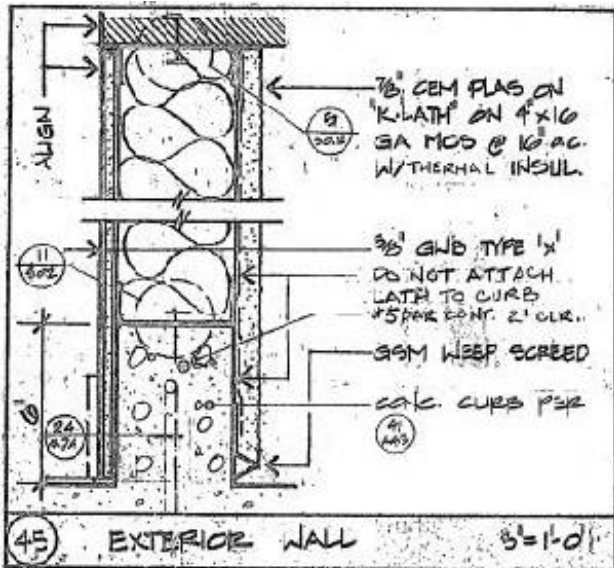
45 EXTERIOR WALL 3"=1'-0"

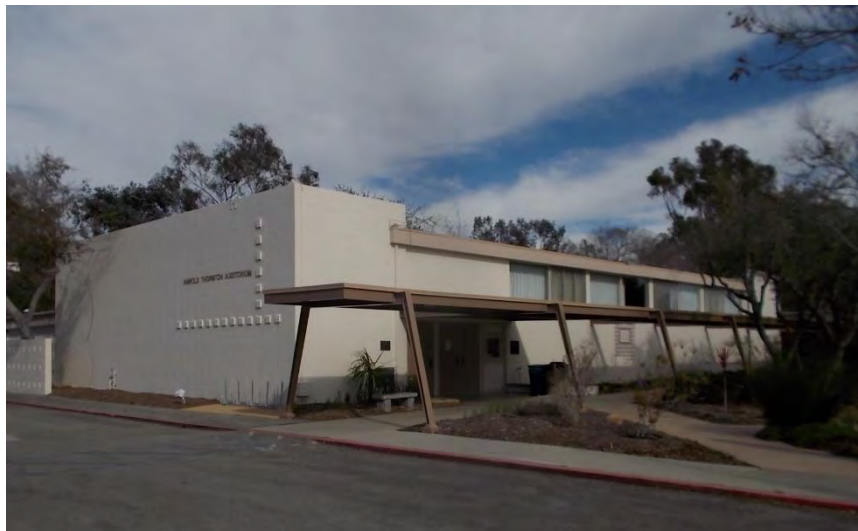
Prepared by
RJC Inc.

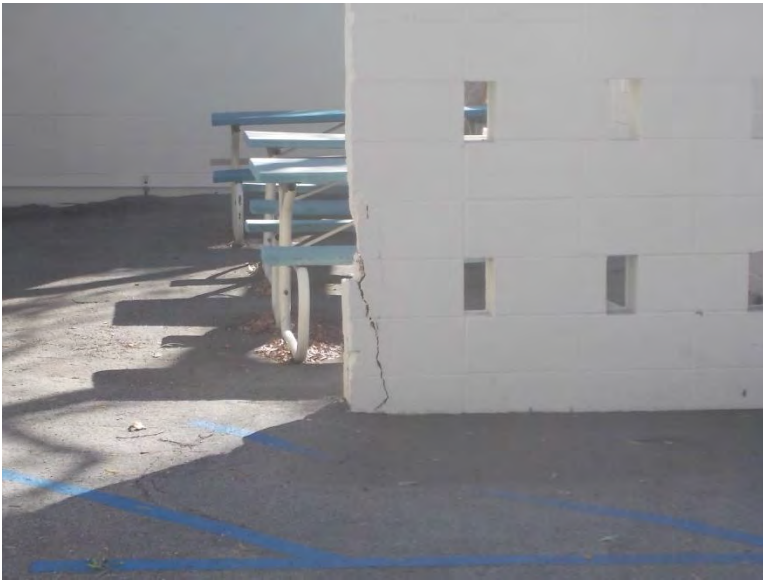
AE1. Exterior patio CMU wall; damaged.

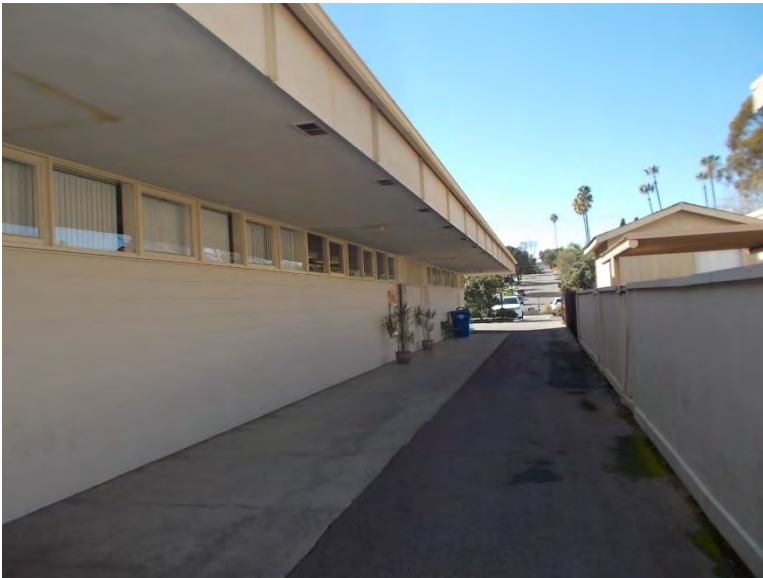
AE2. Exterior wall; painted CMU and wood, good condition.

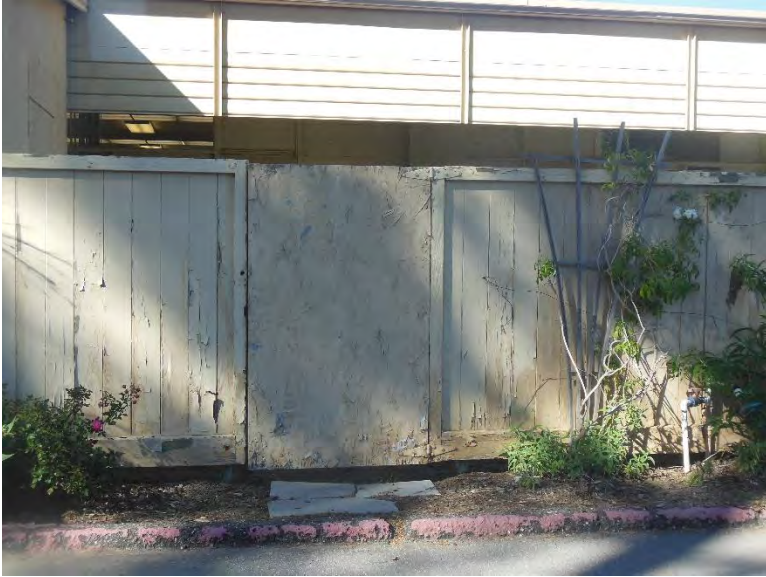
AE3. Exterior wood patio fence; damaged paint.

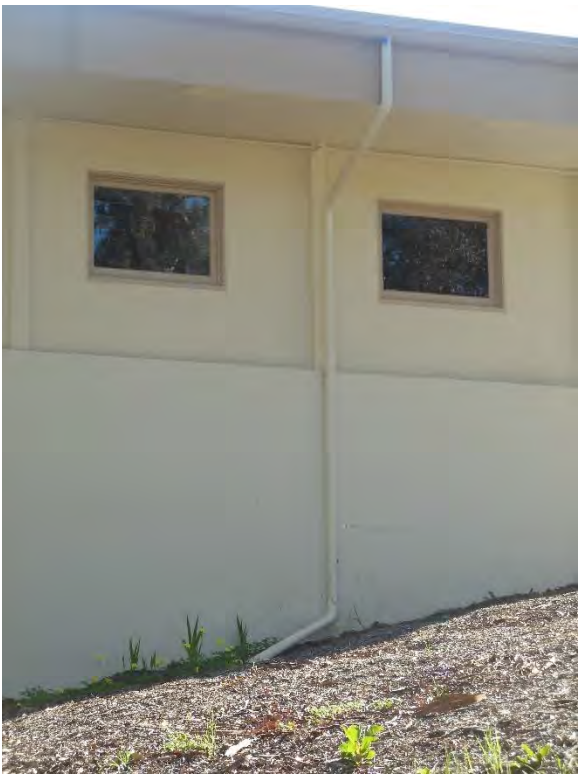
AE4. Exterior painted concrete and plaster.

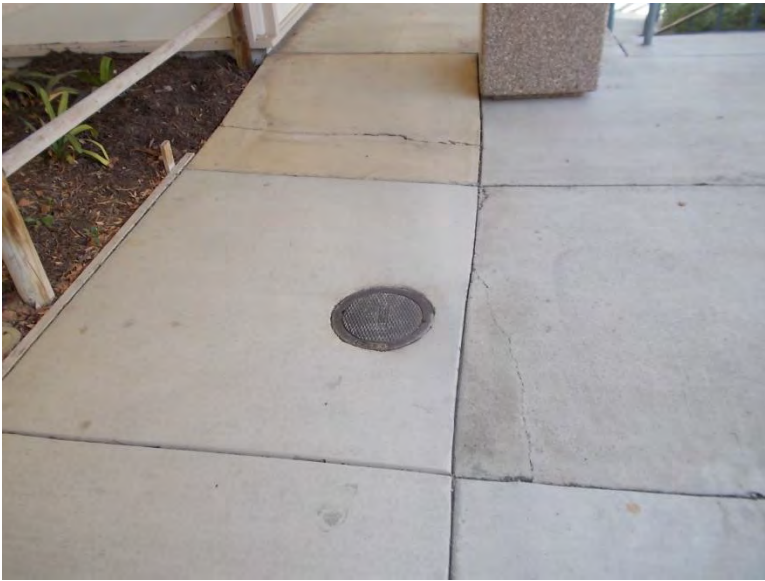
EF1. Exterior corridor walkway; cracked and degraded concrete.

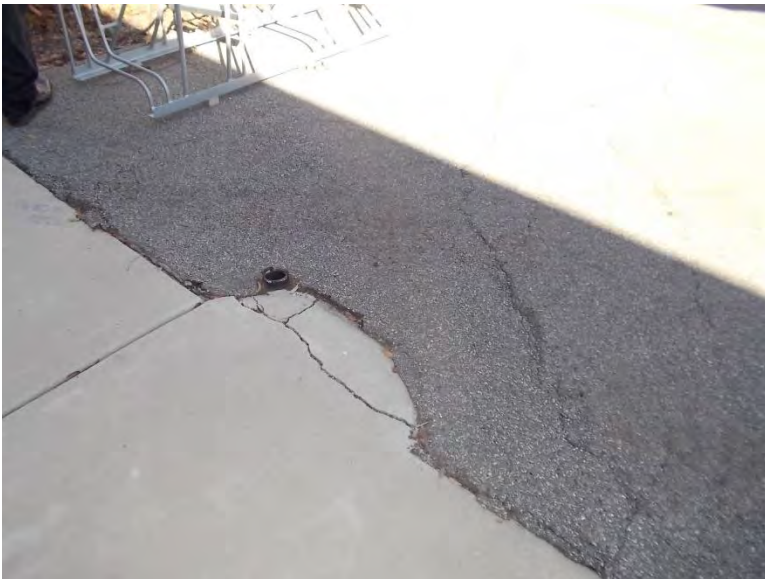
EF2. Exterior sidewalk transition; abrupt change in level.

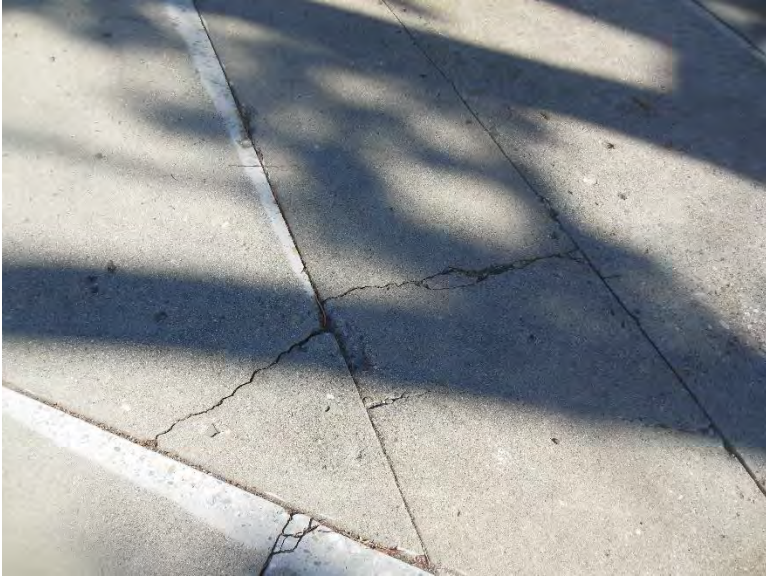
EF3. Exterior corridor walkway; cracked and degraded concrete.

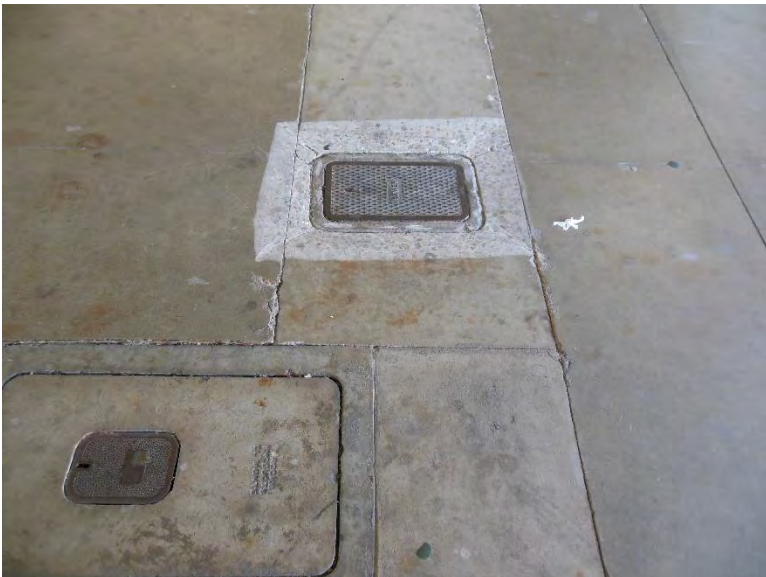
EF4. Exterior corridor walkway; abrupt changes in level.

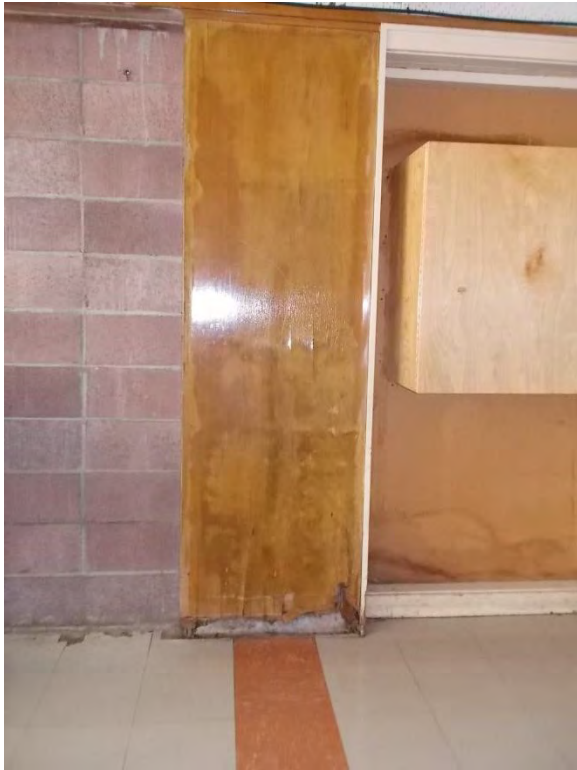
AI1. Auditorium; water damaged exposed CMU and wood finishes.

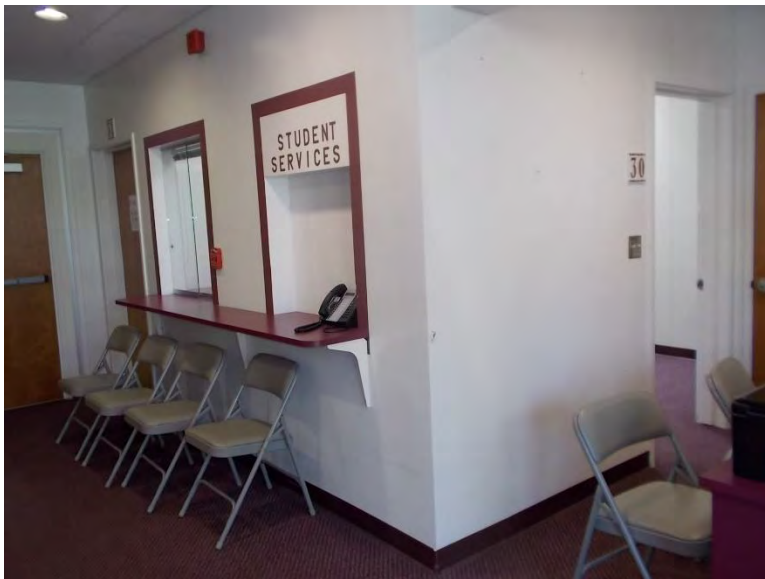
AI2. Office 29; painted drywall.

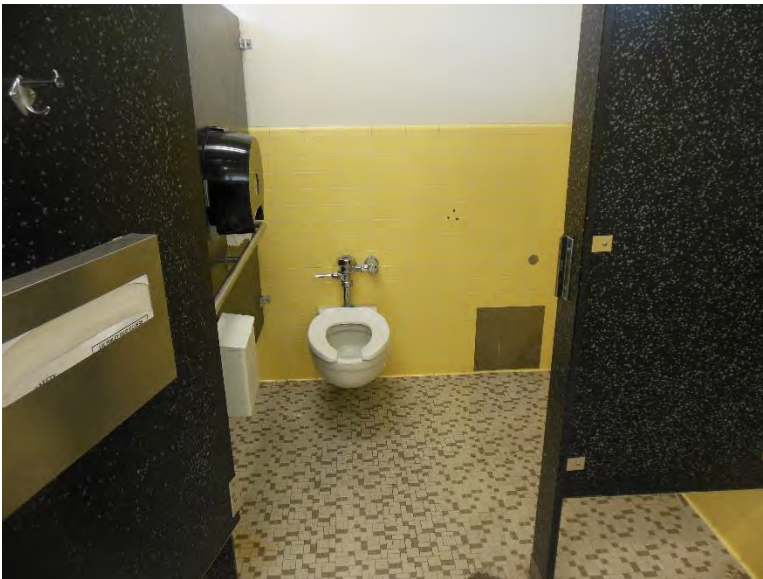
RR2. Women's Restroom; accessible stall, missing back handrail and stall size too small.

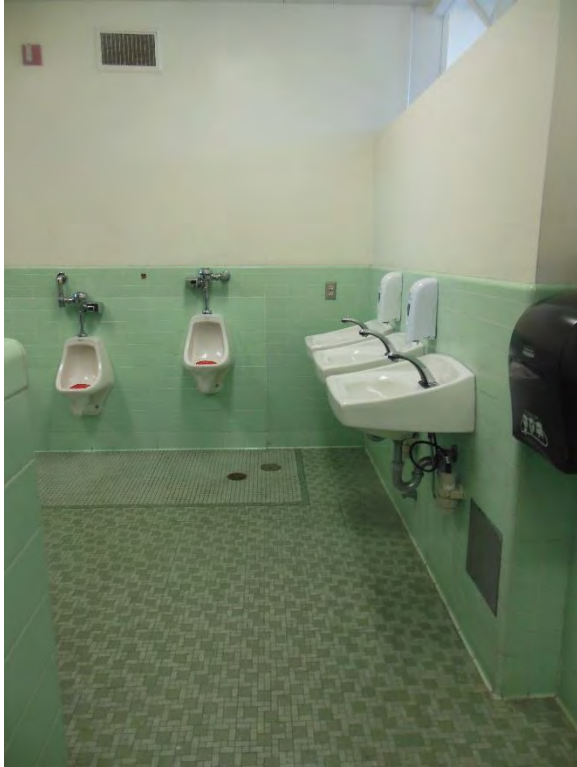
RR3. Men's Restroom; lavatories and urinals.

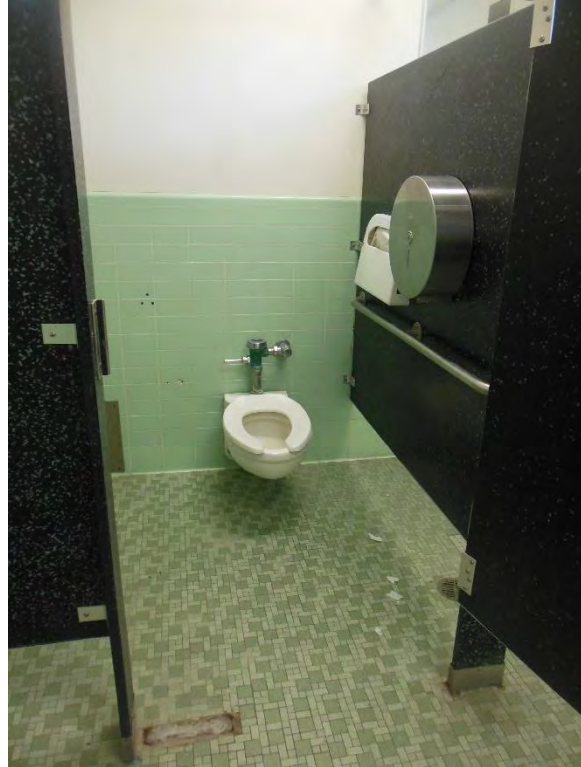
RR4. Men's Restroom; missing back handrail; and stall size too small.

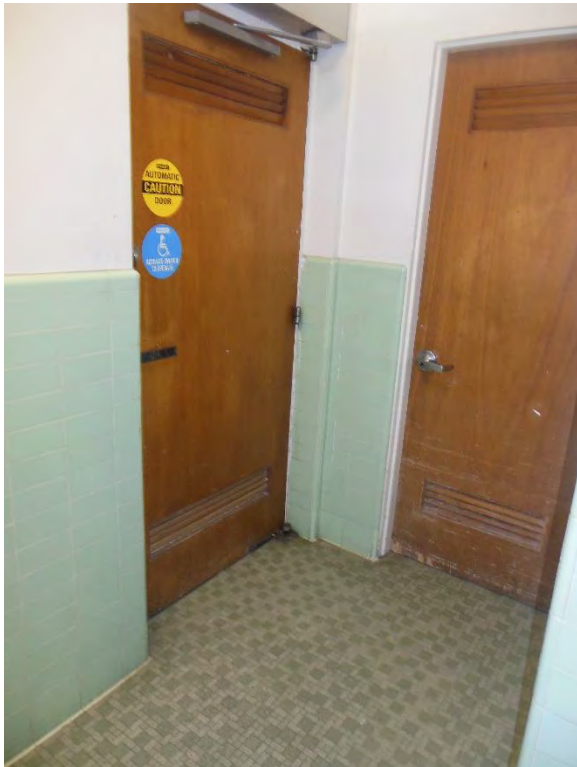
RR5. Mens foyer; door clearances not provided.

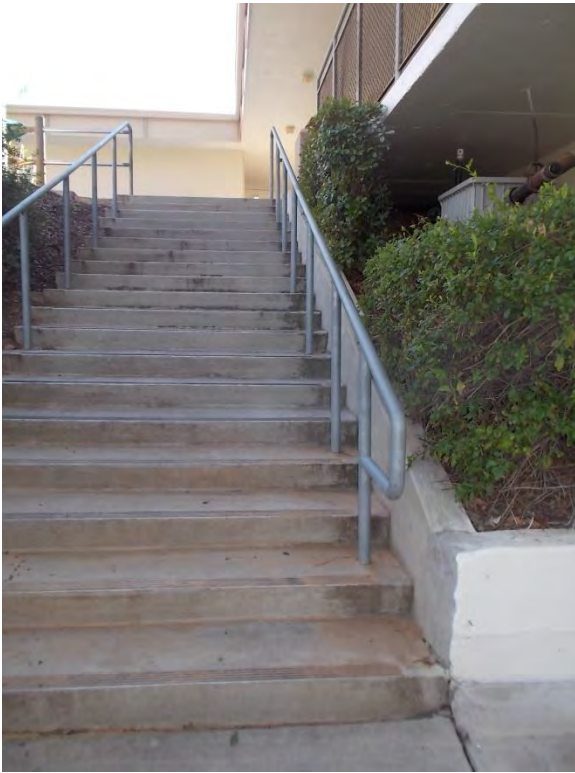
ST1. Exterior stairs to Auditorium; non-compliant handrails, and signage missing.

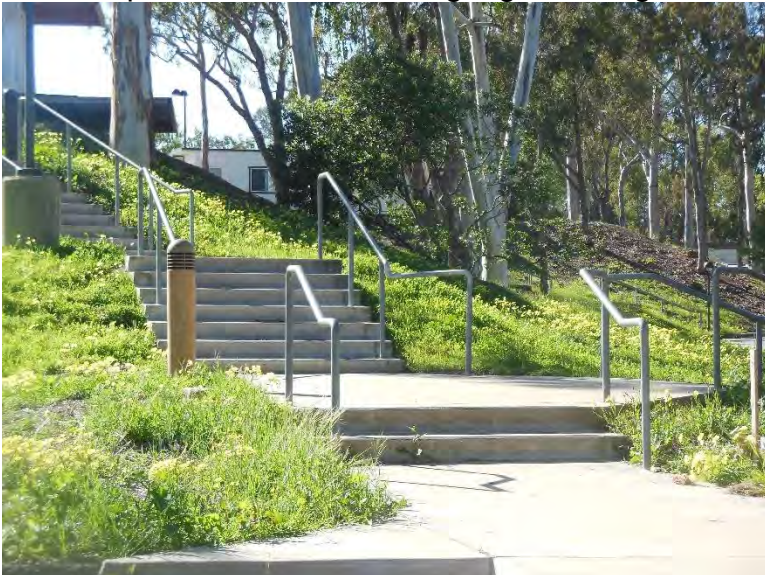
ST2. Exterior stairs from lower lot to upper campus; non-compliant handrails, stair nosing and signage missing.

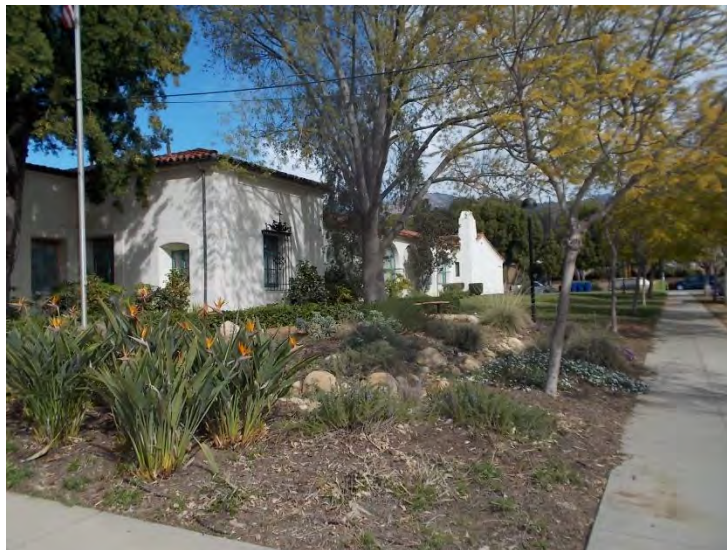
Prepared by
RJC Inc.

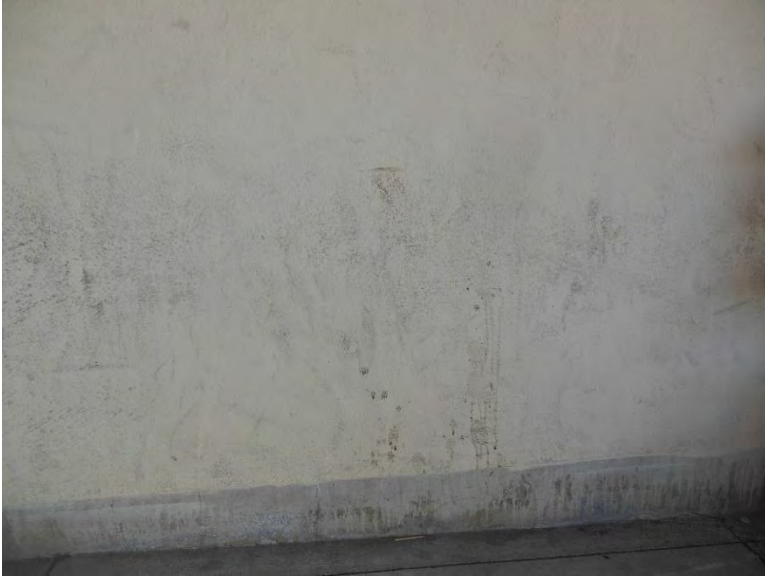
AE3. Permanent building exterior corridor wall; painted plaster damaged.

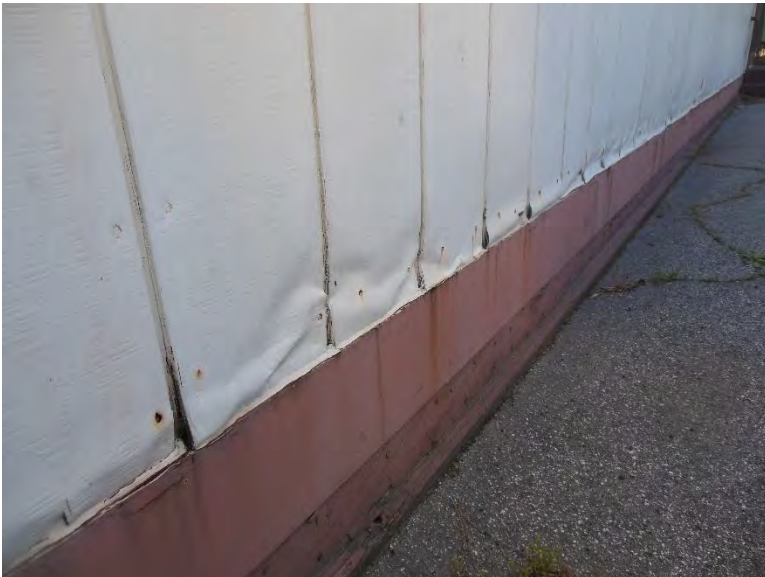
AE4. Portable building, exterior painted siding, damaged.

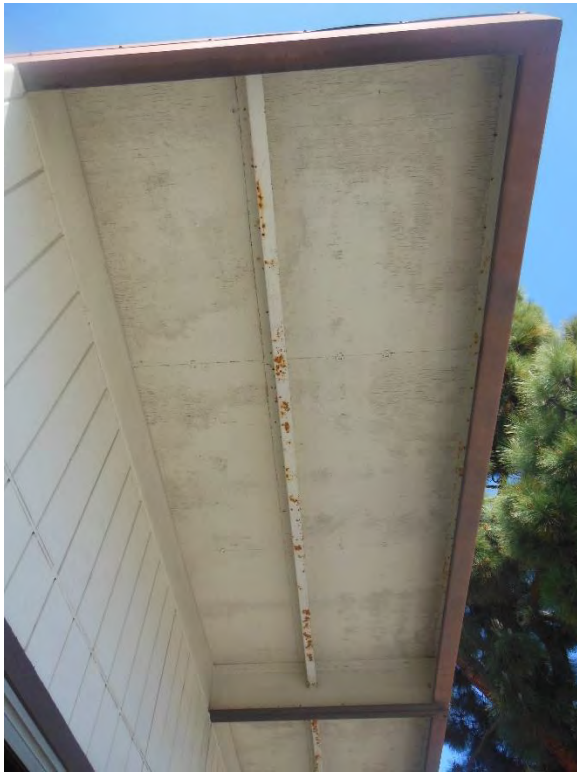
R1. Portable Classroom 28A; underside of roof overhang, rusted.

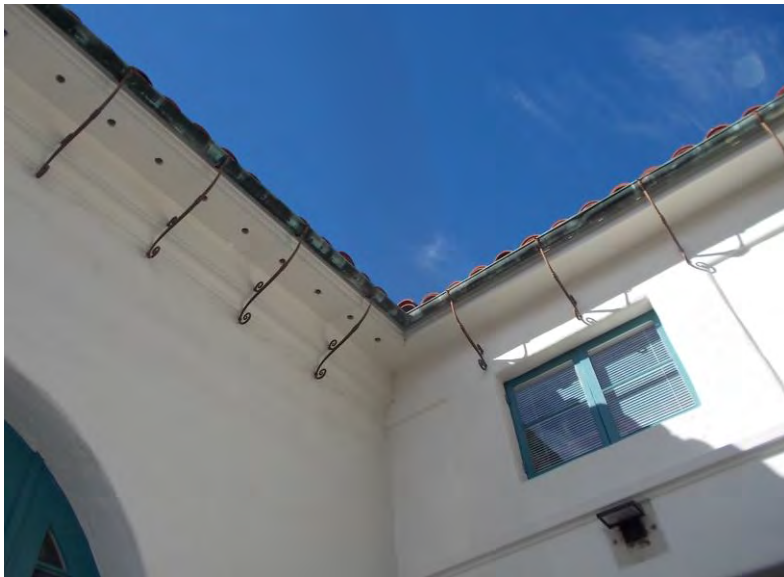
R2. Permanent buildings, copper gutters, downspouts and supports in good condition.

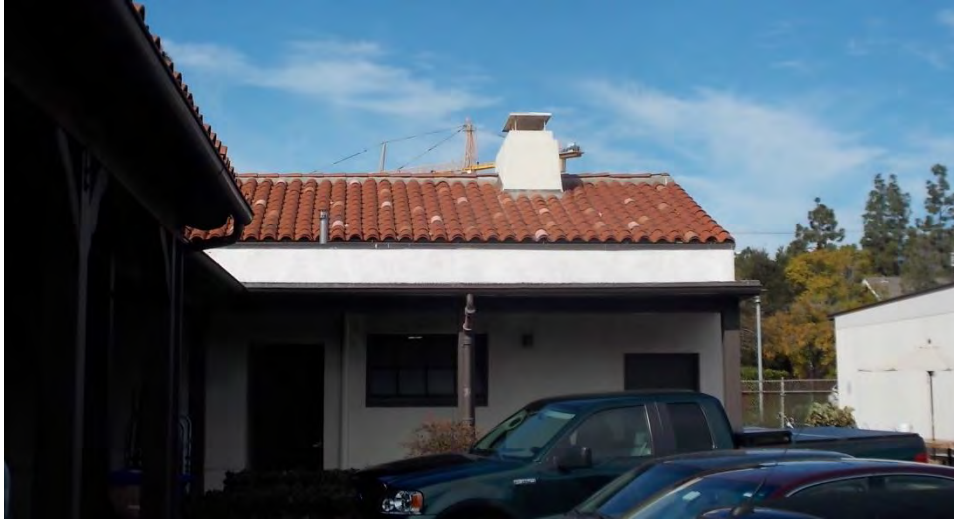
R3. Kitchen; clay tile and roof chimney/vent, and built-up roofing over walkway canopy.

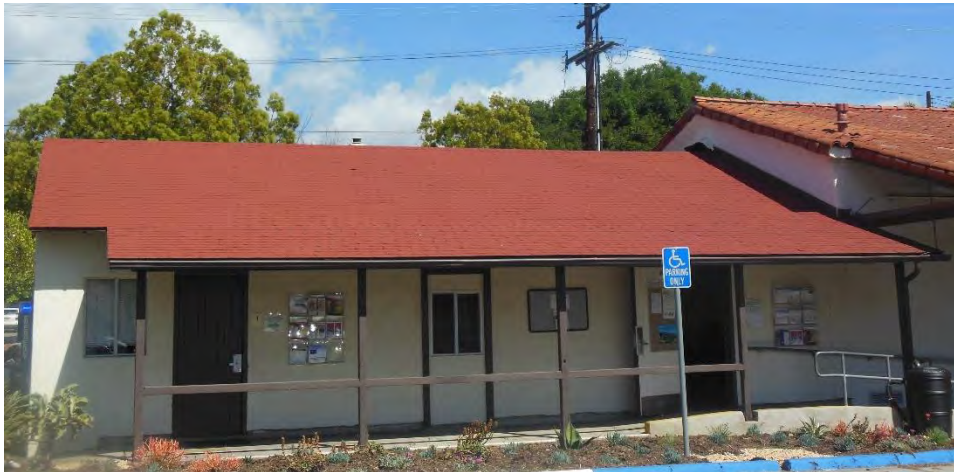
R4. Asphalt roofing over Offices 1, 2 and 3 in good condition.

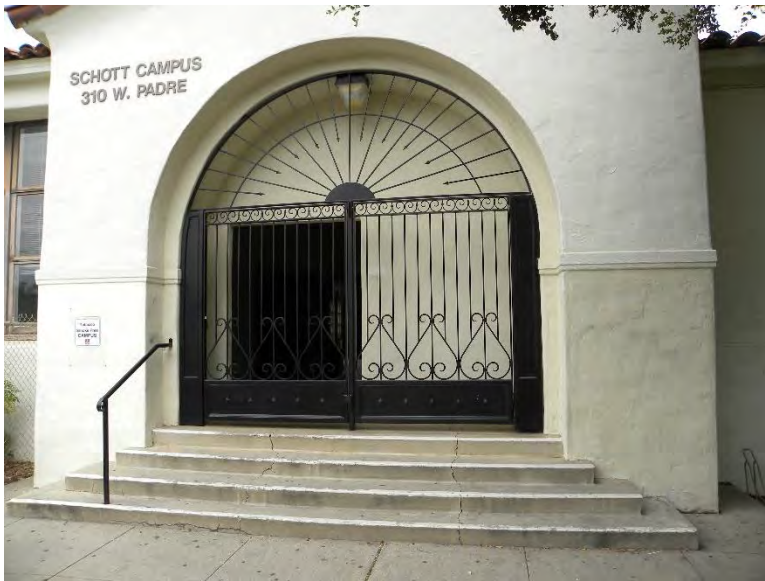
D1. Entrance from west side of site; missing handrails on right.

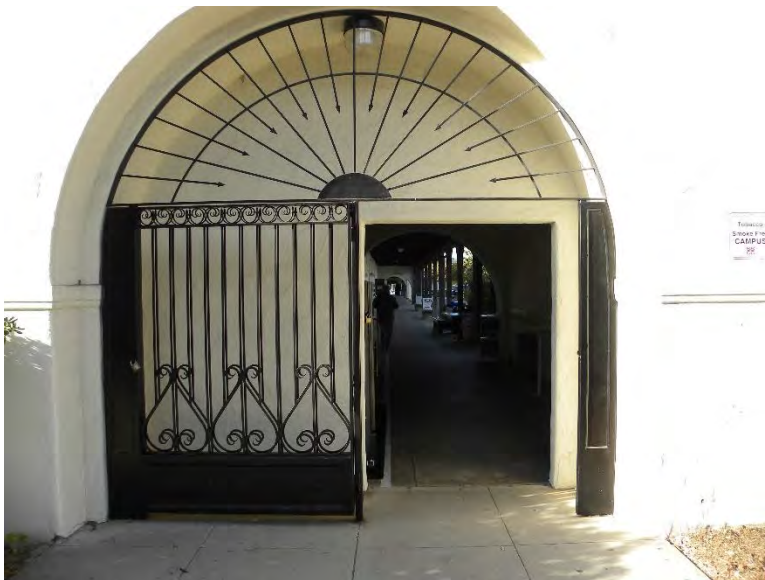
D2. Entrance from east side of site; missing ISA signage.

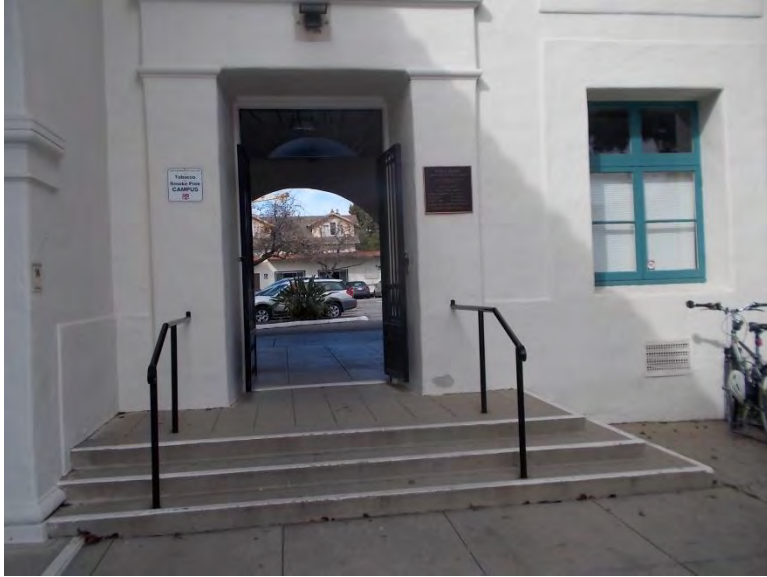
D3. Entrance from south side of site; non-compliant handrail returns.

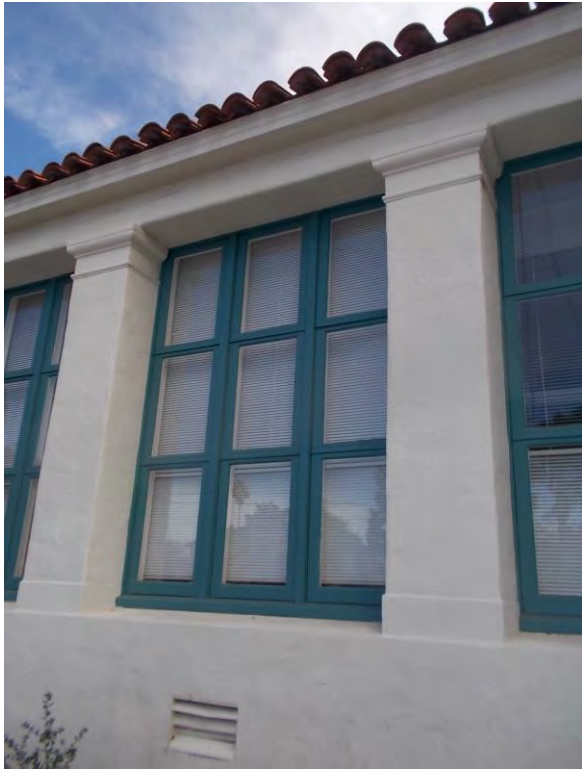
EW1. Exterior fixed wood windows; with new painted frames in excellent condition.

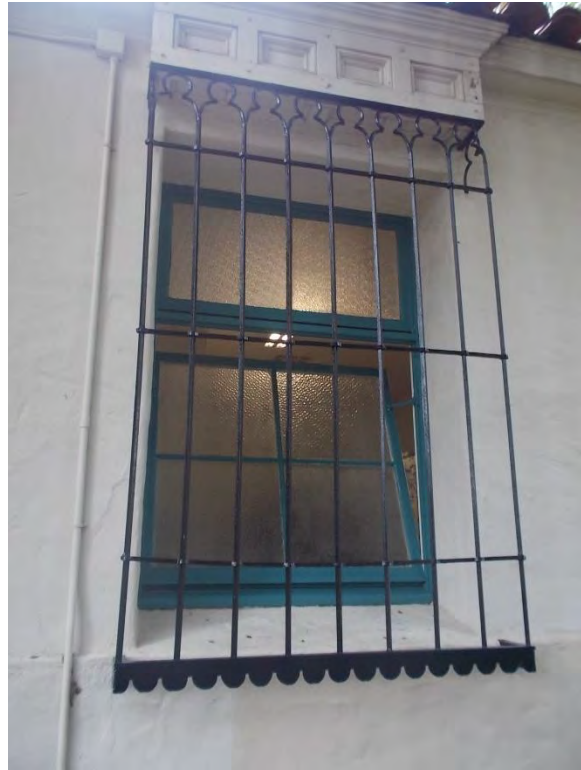
EW2. Women's restroom operable wood window with bars, and newly painted frame.

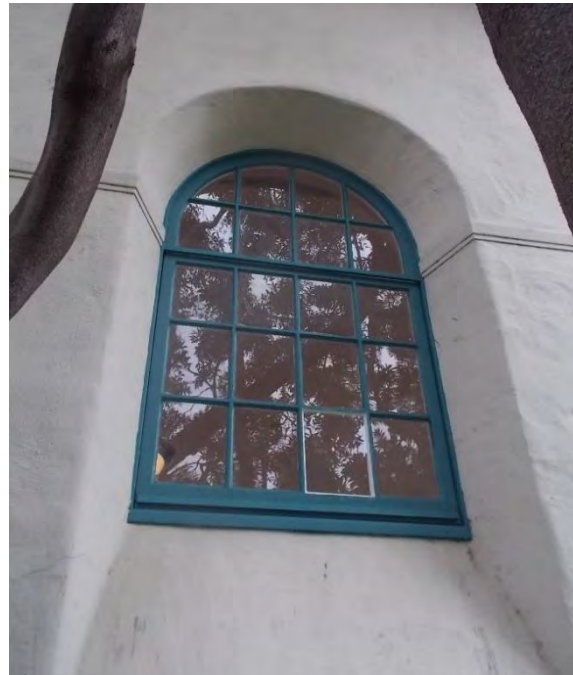
EW4. Exterior fixed wood windows; with newly painted frame in excellent condition.

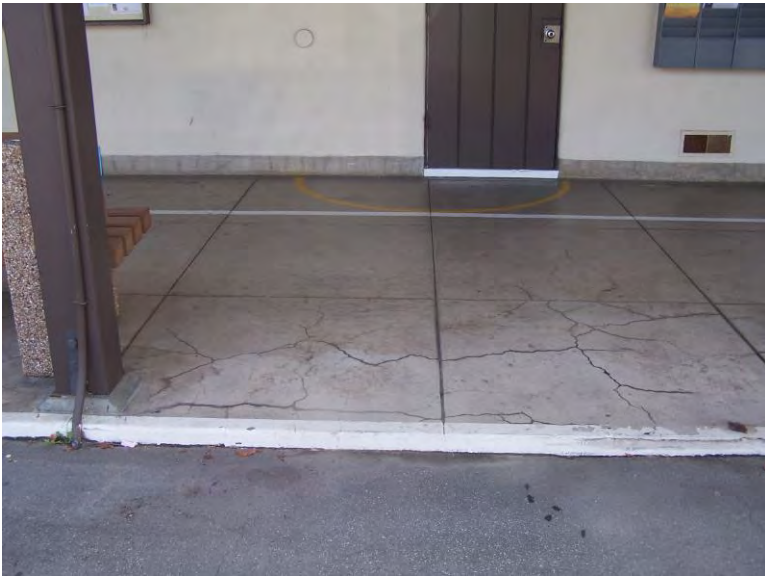
EF1. Exterior corridor walkway; cracked and degraded concrete.

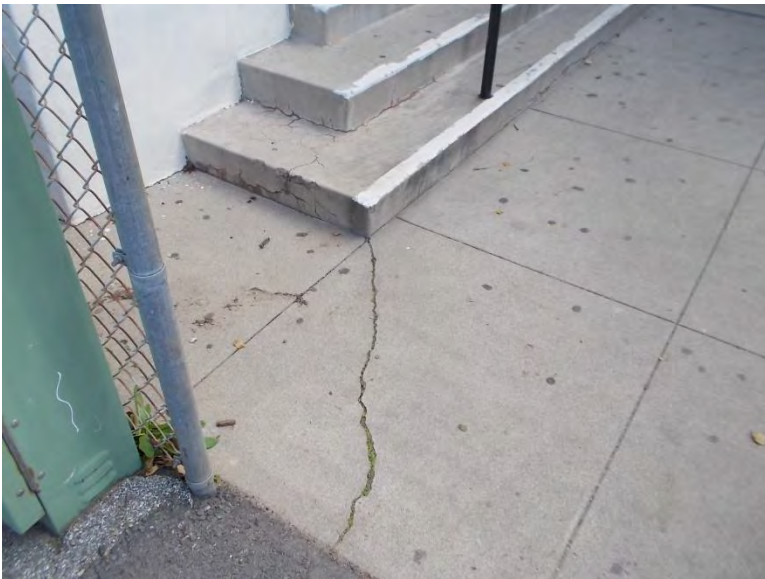
EF2. Exterior sidewalk, west side; cracked and degraded concrete.

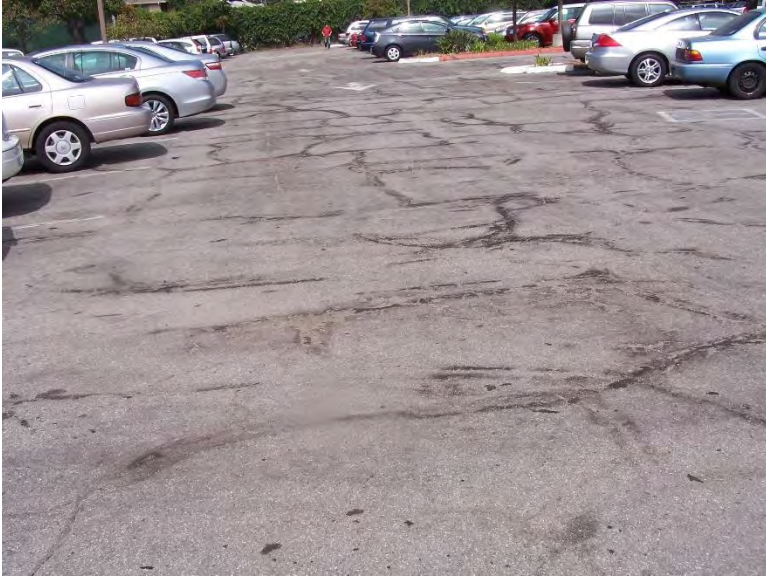
EF3. Asphalt parking lot; degraded materials, poor condition.

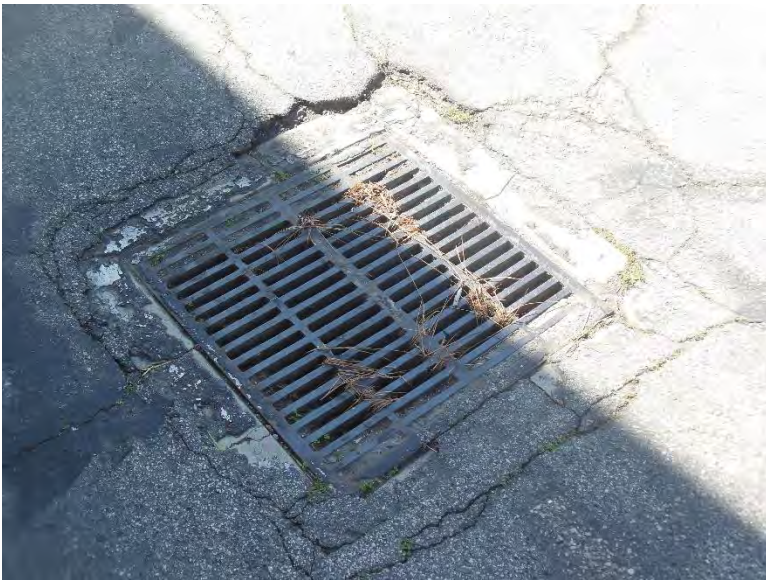
EF4. Drainage catch basin on parking lot with degraded surrounding asphalt materials.

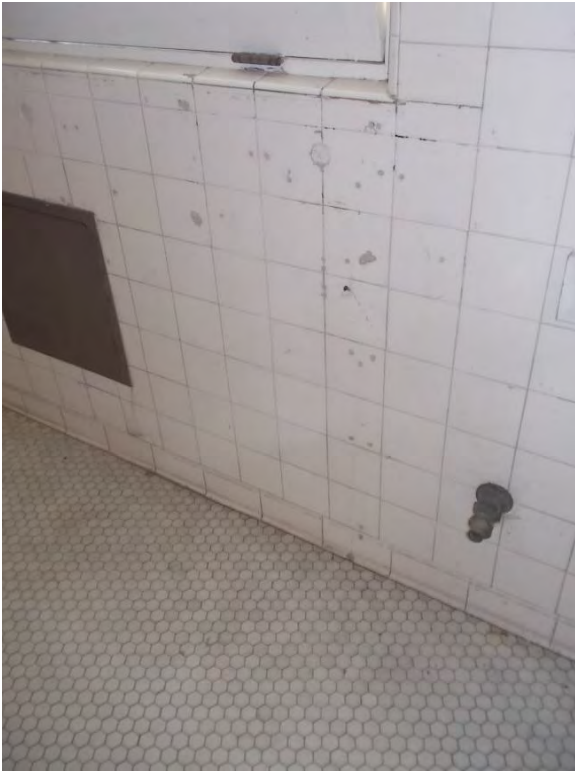
AI1. Women's Restroom, ceramic wall tile damaged.

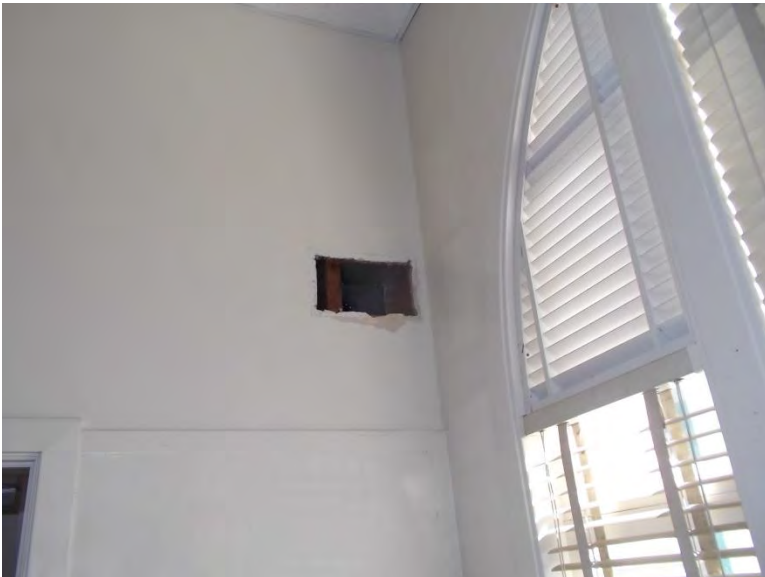
AI2. Office; hole in wall.

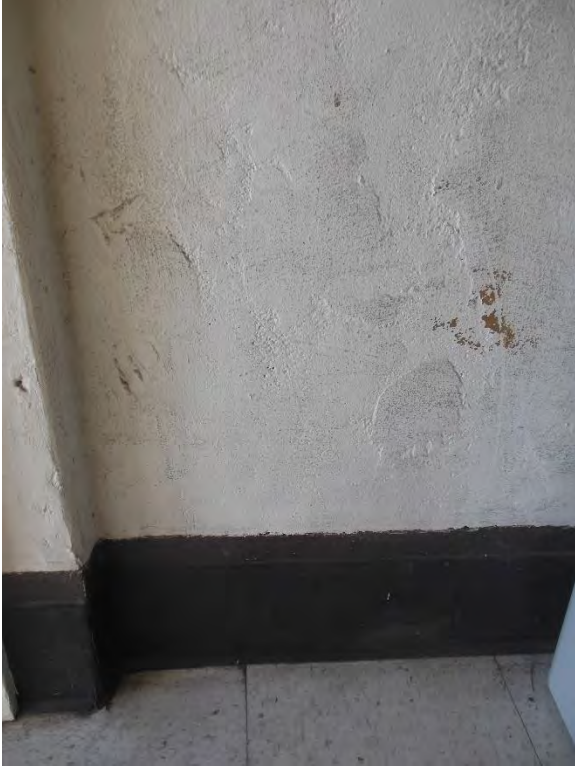
AI3. Office 11 foyer, plaster wall damage.

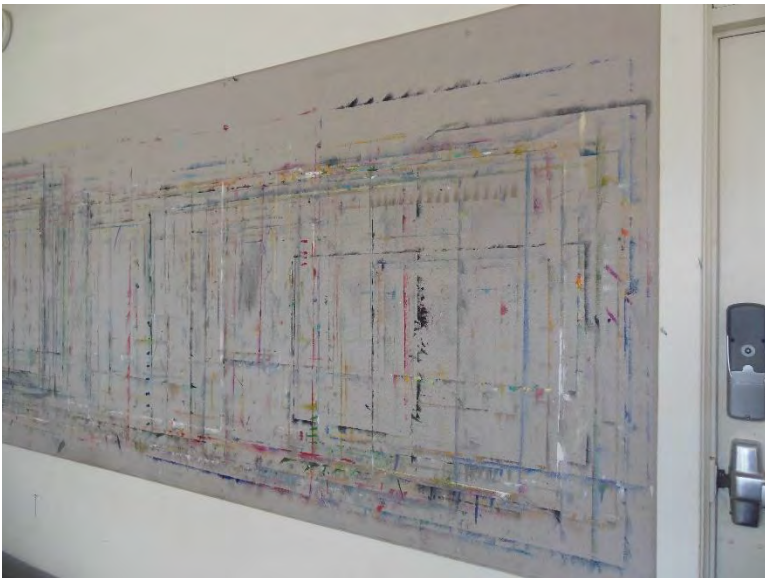
AI4. Classroom 22; fabric covered tackboard, paint damaged.

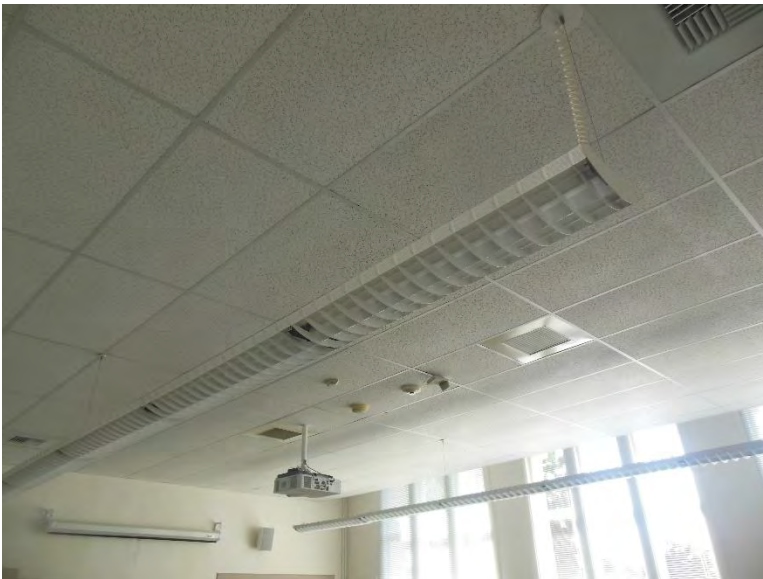
C2. Classroom; suspended ceiling system in good condition.
