Appendices

Appendix A:
ADA Path of Travel Assessment Diagrams

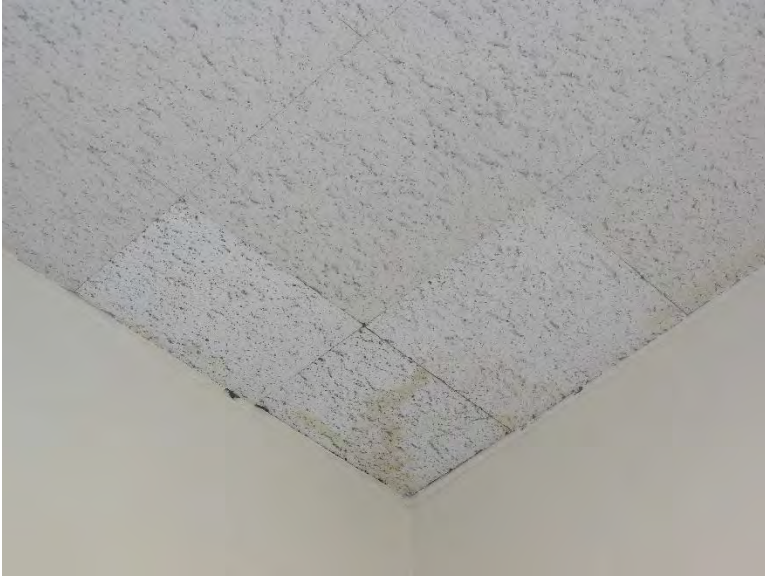
C3. Copy Room 10; glued on ceiling tile, damaged.

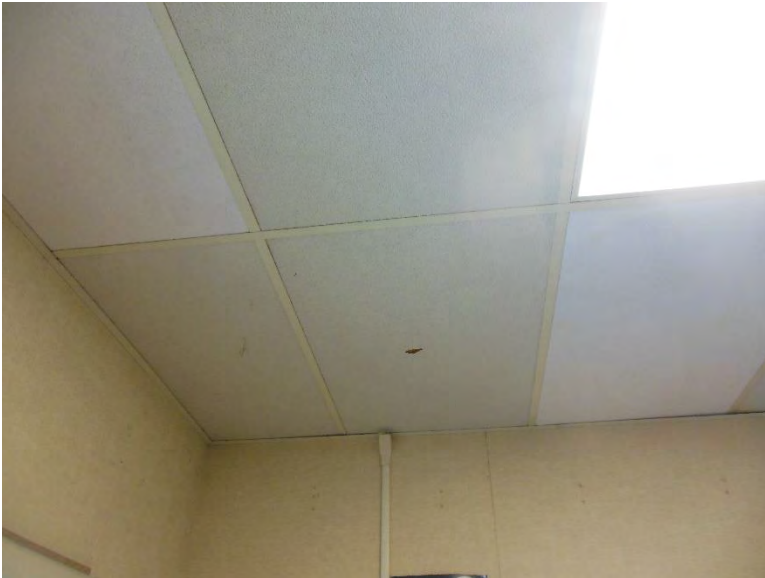
C4. Portable Classroom 29; damaged and miss-matched suspended ceiling tiles.

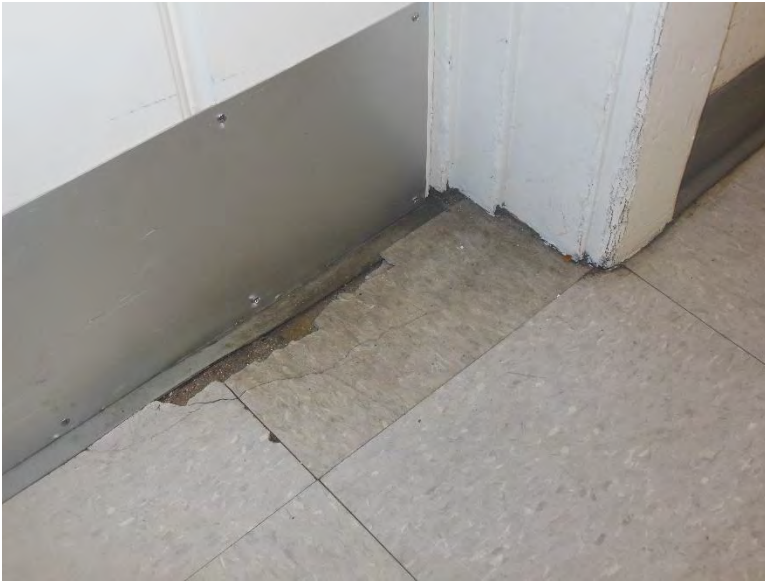
IF1. Main Office Room 8, damaged VCT at door.

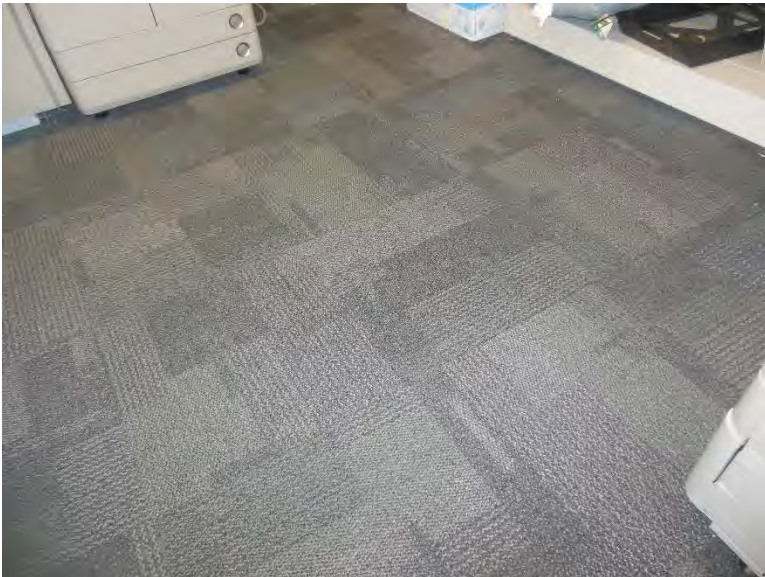
IF2. Copy room 10; carpet tile in good condition.

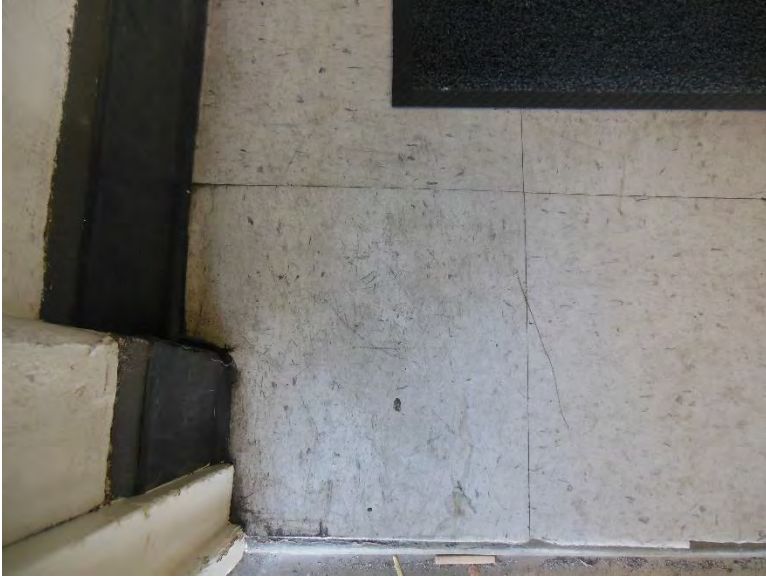
IF3. Office 11 foyer, VCT floor damage.

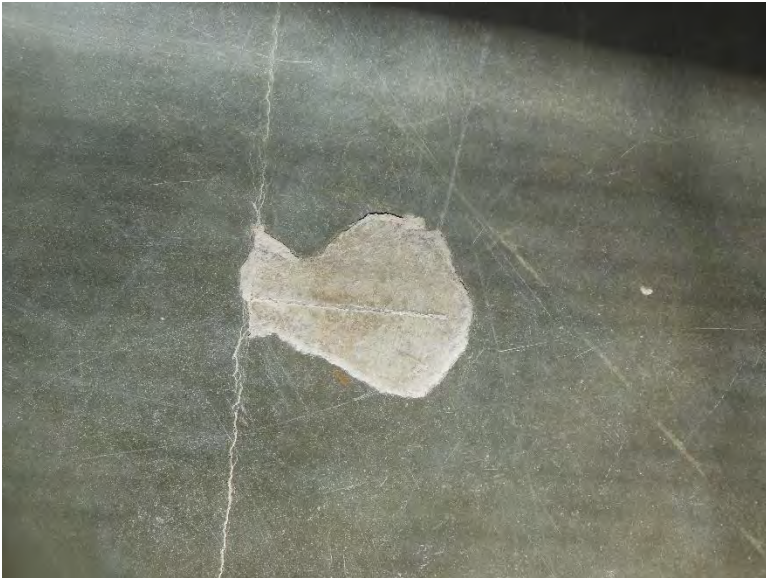
IF4. Classroom 22; concrete topping material damage.

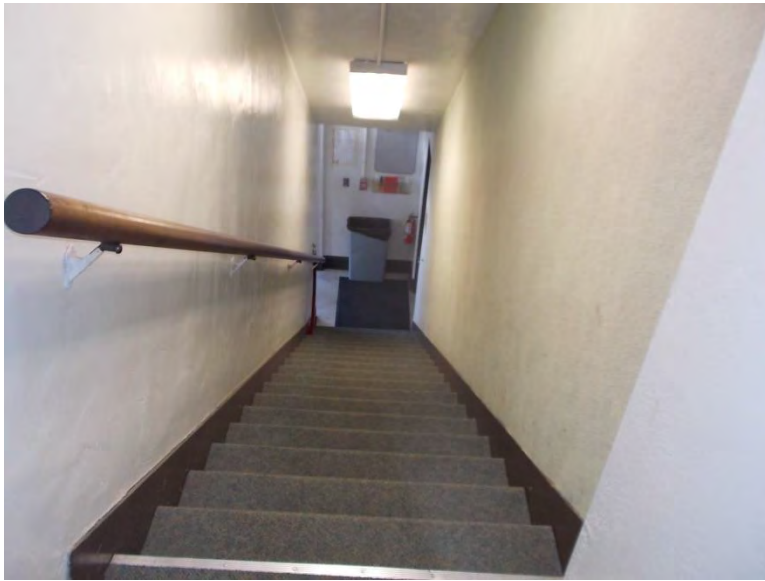
ST1. Interior stairs to Room 12; non-compliant stairwell width and handrails, and signage missing.

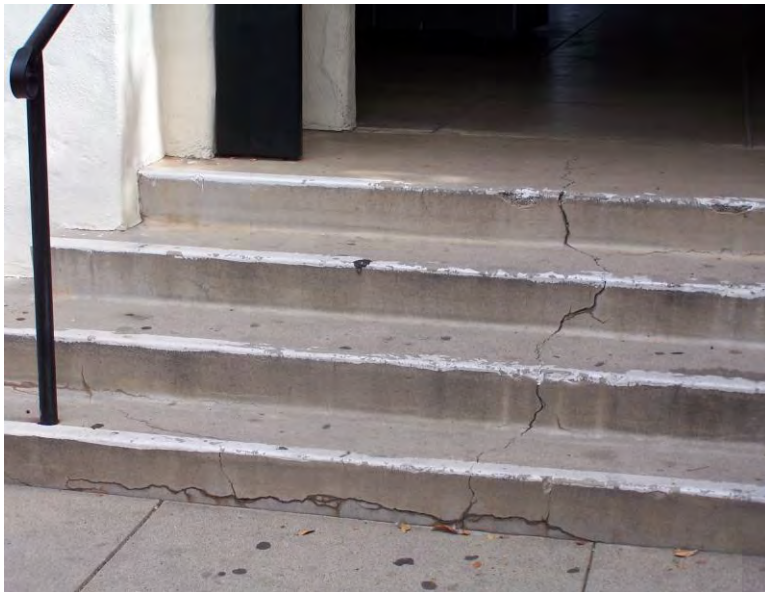
ST2. Stairs at west entrance; non-compliant handrails, stair nosing faded, and degraded concrete materials.

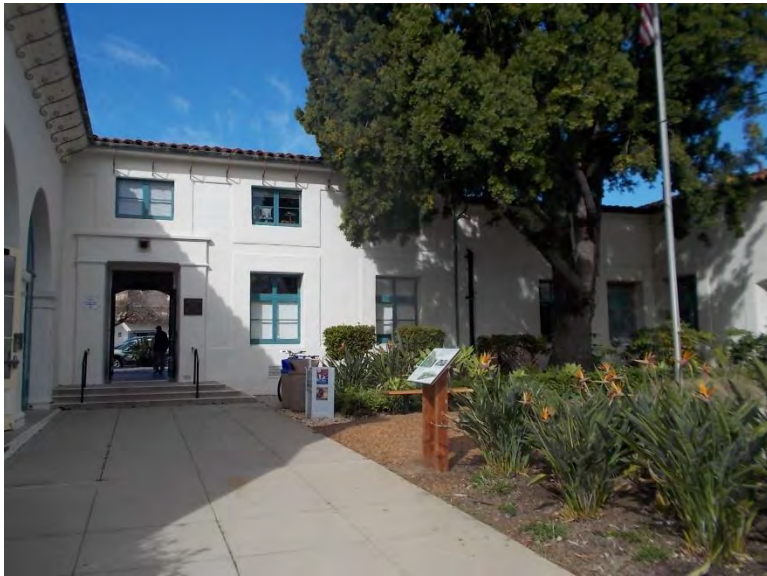
PT1. Exterior walkway to south entry; path of travel with excessive slopes, hazardous surface features, and no wayfinding signage.

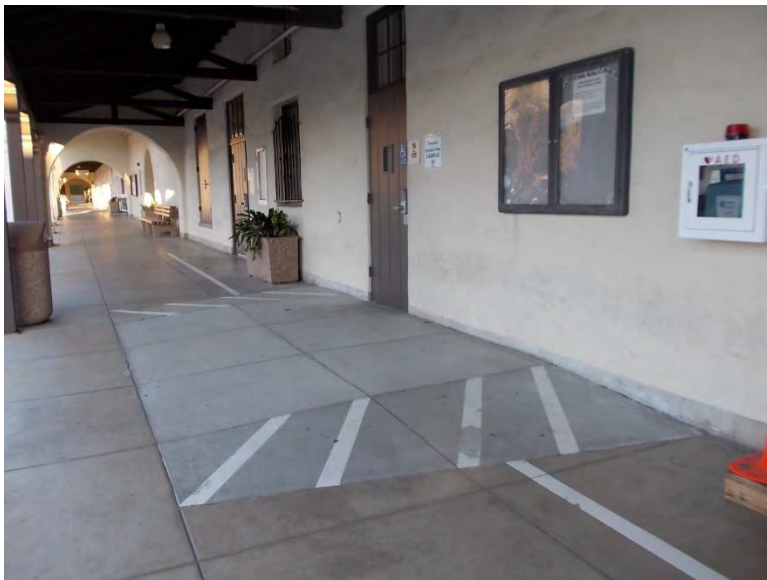
PT2. Exterior walkway; path of travel interrupted by ramp.

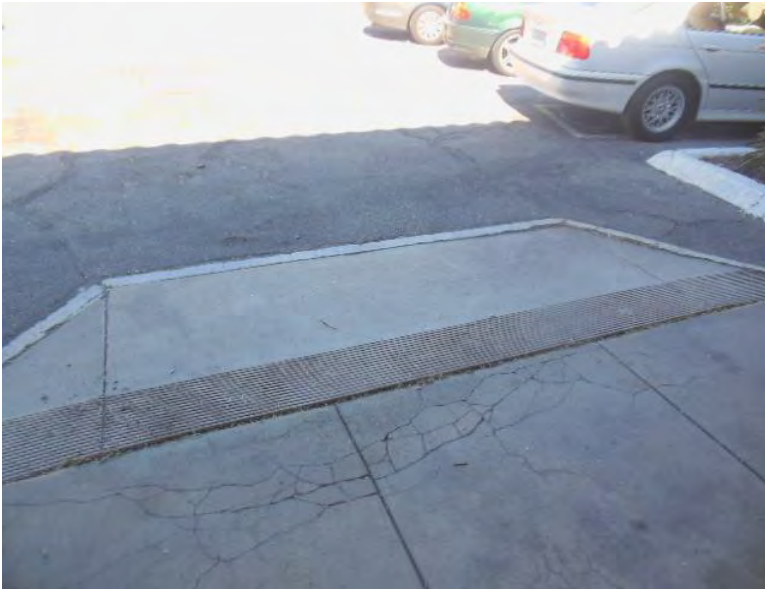
PT3. Curb ramp to parking lot; ramp cannot project into the path of cars, and are missing truncated domes. Concrete surface is cracked and degraded.

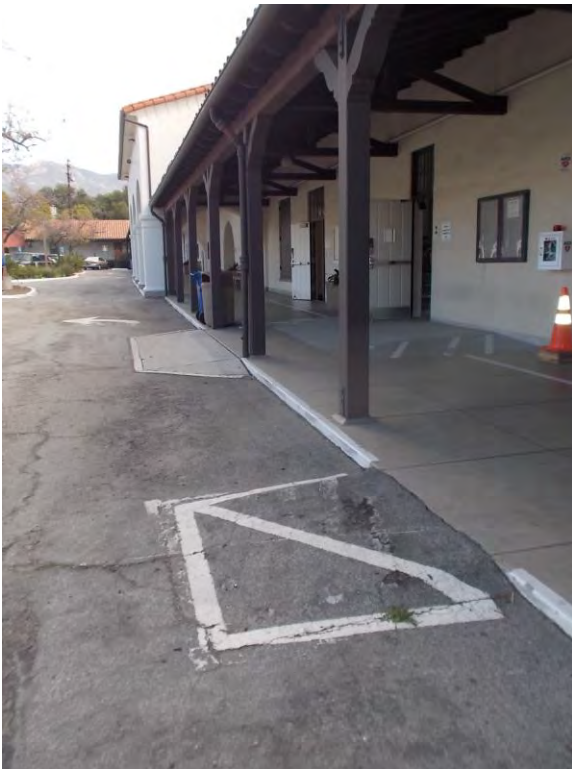
PT4. Curb ramps to parking lot; ramp cannot project into the path of cars, and are missing truncated domes. Asphalt surface is degraded.

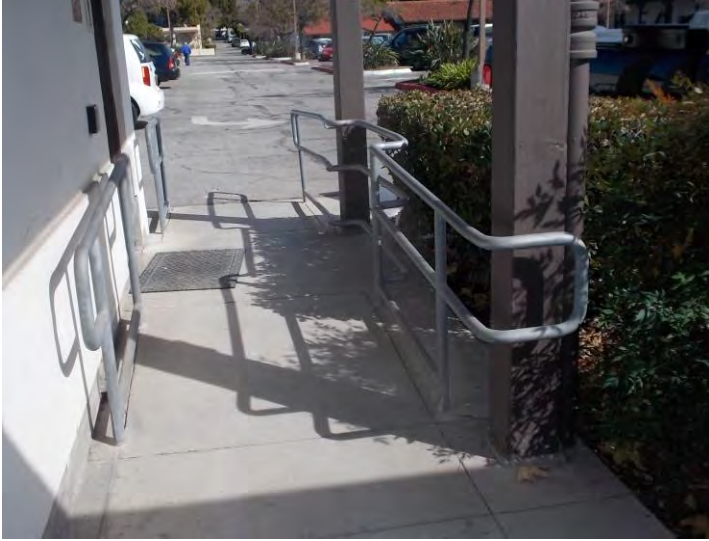
PT5. Ramped walk to Men's restroom; non-compliant handrails.

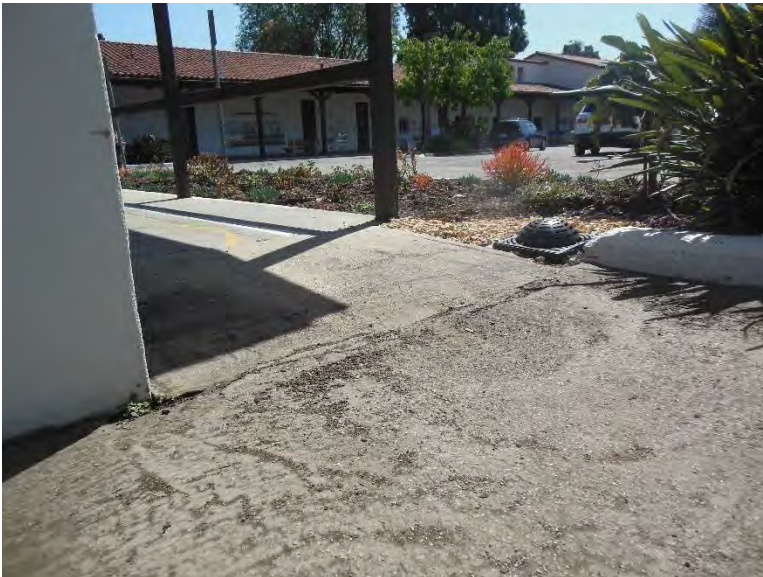
PT8. Exterior walkway; path of travel with hazardous surface feature and no level landing at bottom of ramp.

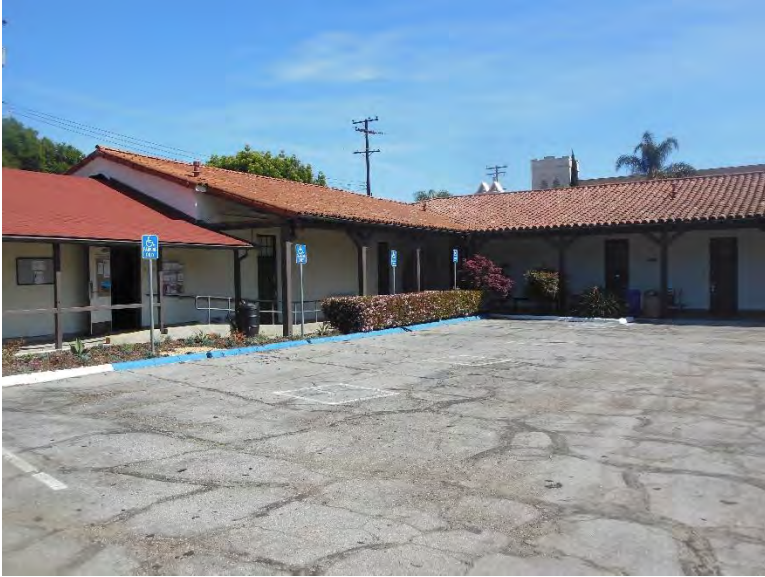
PT9. Accessible stall stripping degraded, layout not-compliant and no safe path from stalls to covered walkway.

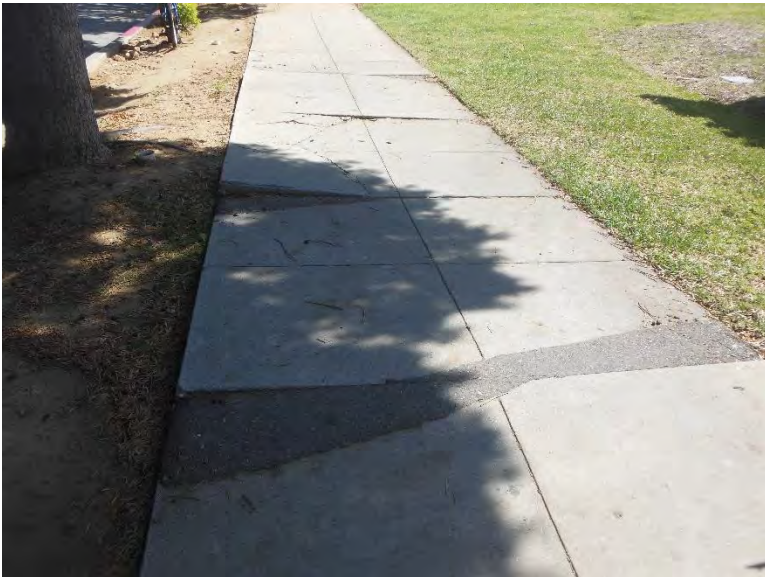
PT10. Public sidewalk at east side of site, near bus stop; abrupt changes in level, and excessive cross slope.
